# FAILURE ANALYSIS AND REDESIGN OF A WAGON WHEEL SHAFT FOR SUGAR CANE TRANSPORT

FERNANDO CASANOVA

**ABSTRACT:** In this study, a failure analysis of the wheel shafts of wagons for transporting sugar cane is carried out. Several shafts have broken with a small fatigue propagation zone and a large sudden-fracture zone. The material and load condition of the shafts were examined. Stress measurements on a vehicle with a similar suspension system were conducted to find the dynamic loads and calculate the impact factor. An impact factor higher than the one reported in the literature was found. According the manufactures, AISI 1045 steel was the material of the shaft; however, it was found that the material of some shafts did not have the specifications of AISI 1045 steel. Moreover, even if the shafts were made with good quality AISI 1045 steel, the stresses are so high that the element will fail due to fatigue. Finally, some recommendations are given to increase the reliability of the shafts, and a new design and manufacturing process are proposed

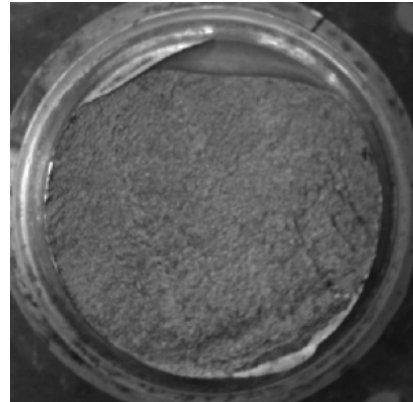
Figure 2. Fractured shafts

Fig. 2 shows the fracture surfaces where the fatigue propagation zone and the final fracture can be clearly

appreciated. Most failures have occurred in the change of section zone (zone A) where a bearing is located; also, a few fractures have occurred on the welded zone that joins the flange with the shaft, as shown in Fig. 3a, where it can be observed that the fracture occurred from several fatigue cracks initiated on the welding. On the welded zone of the flange, cracks also have occurred, as shown in Fig. 3b. On all the fractured surfaces, it can be noted that the final fracture zone is wider than the fatigue propagation zone, indicating a high stress condition. Bad surface finish at the change of section zone was observed.

Chemical composition of the shafts shown in Fig. 2a, and c is shown in Table 1. This table shows that the chemical composition of the material of the shaft shown in Fig. 2a, matches better with an AISI 1040 steel than with an AISI 1045 steel [1] which, according to the manufacturer, is the material that should correspond to the shafts.

Hardness was measured on the shafts shown in Fig. 2. The average values were: 203 HB, 211.4 HB, and 224.2 HB for the shafts shown in Figs. 2 a, b, and c, respectively. These results indicate no-homogeneity in the material.

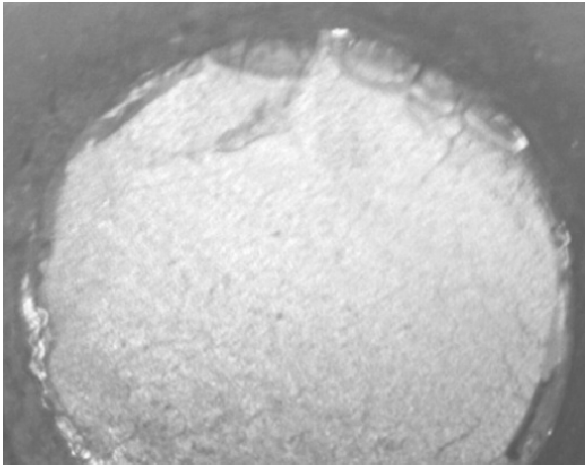
**Figure 3.** Failures at the welded zone: (a) fracture on the shaft, and (b) crack on the flange

Visual inspection allowed us to determine the existence of fracture problems in the change-of-section zone and in the welded zone. The martensite found in the HAZ is a factor that increases the fracture risk due to its low toughness. This could be improved with appropriate preheating and post-welding heat treatment. The chemical composition showed that

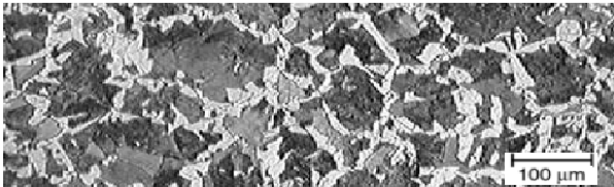
zone. Fig. 5 shows the microstructure of the material shown in Fig. 2a, and Fig. 6 shows the microstructure of the shaft shown in Fig 2c. Both materials present a ferritic-perlitic microstructure corresponding to annealed medium carbon steel. The main difference between the two materials is the high grain size of the material in Fig. 2a with respect to the material in Fig. 2c. This coarse grain could result in the low toughness that would explain the small fatigue propagation zone of this shaft.

**Figure 5.** Microstructure of the shaft shown in Fig. 2a: ferrite (white zone) and perlite (dark zone). 100X Nital 2%

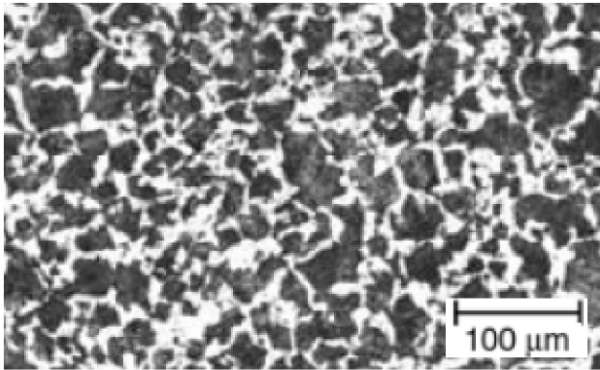
**Figure 6.** Microstructure of the shaft shown in Fig. 2c  
100X Nital 2%

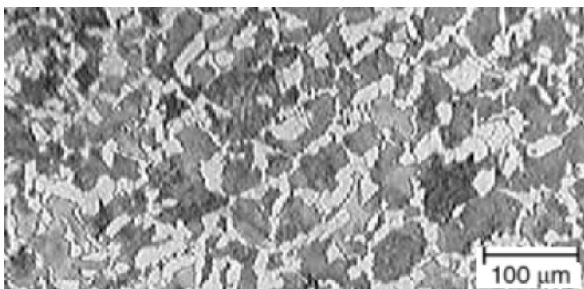
Fig. 7 shows the microstructure of the welding zone of the shaft shown in Fig. 3. The base material, the heat affected zone (HAZ), and the fusion zone are shown in Figs. 3a, b, and c, respectively. Martensite was found in the HAZ due to a lack of preheating during the welding process. This martensite is a factor that increases the risk of crack initiation in the shaft [2] and should be avoided. The fusion zone presents an acicular ferrite microstructure free of defects, where good mechanical properties are expected [2].

**Figure 7.** Shaft failed at the welded zone: (a) base material 100X, (b) HAZ 400X, and (c) fusion zone 400X. Nital 2%

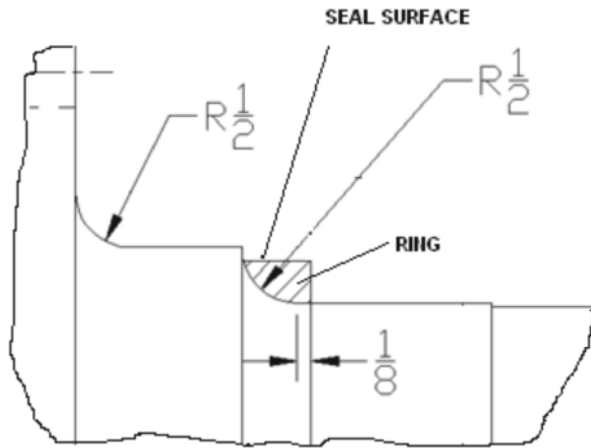
**Figure 11.** Section of the proposed shaft

Diameters on the shaft are difficult to change because of the assembly with the wheel. The radius at the change of section and the diameter at the seal zone are restricted by the bearing and the seal. To increase the radius of the rounding at the changing of section, eliminating the section of contact with the seal is proposed. On the new radius, a ring was placed on which the bearing was supported laterally and the seal was in contact in radial direction. Fig. 11 shows a section of the new shaft. The radius was increased to 12.7 mm ( $\frac{1}{2}$  in). With the new radius, the new  $K_t$  is 1.5 and  $K_e = 0.71$ . The decrease in the stress concentration factor increases the fatigue strength of the shaft and improves its reliability. If the safety factor is calculated again under the new conditions, the result

is  $n = 1.1$ , meaning that the shaft has infinite life. With the change in the shaft geometry, the increase in the bending moment is low because the distance between the resultant force and the maximum stress point is increased by only 3.175 mm (1/8 in), as seen in Fig. 11.
