## Analysis and repair of historical roof structures: Two examples, two different concepts

Rainer Barthel  
H. Maus

Two historical roof structures are presented. The history and sequence of alterations, damages and deformations during life time is described. The history is the key for understanding the damages and for developing the appropriate repair concepts. The two structures are similar but the alterations they suffered are different. A suspension truss is the main feature of both structures. Both structures show big deformations, but caused by different reasons. Two different concepts of repair measures are derived. The advantages and disadvantages of the measures are discussed.

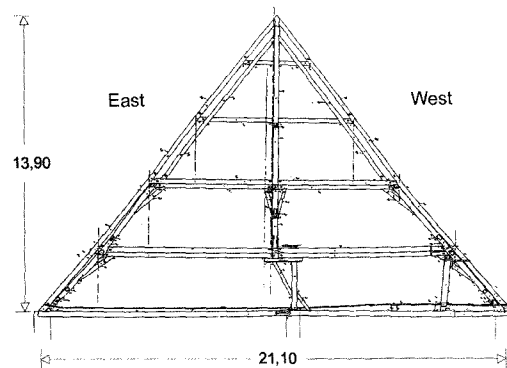
Figure 2  
Cross section (Drawing of Franz Hölzl, Munich)

shows a big settlement only in the middle. Deflection lines due to bending are visible only in the longitudinal section (Fig. 3) but not in the transverse section (Fig. 2). The structure was prevented from collapse mainly by the horizontal beam at the middle axis.

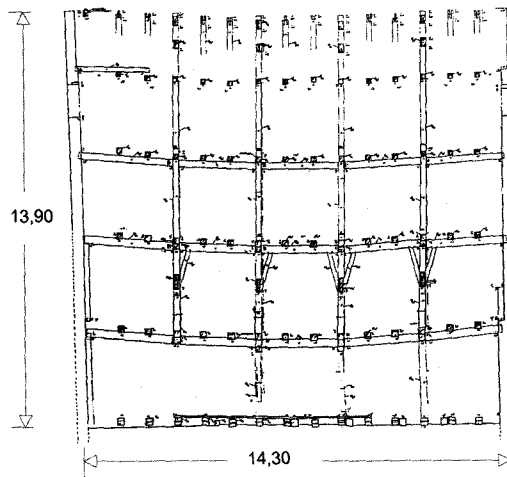
Figure 3  
Longitudinal section (Drawing of Franz Hölzl, Munich)

2. A lot of joints are drawn apart, especially in the upper part of the structure. Wooden nails are broken.
3. There are big deformations of the upper floors. The sag between the gable walls is 42 cm (Figs. 3 and 4).

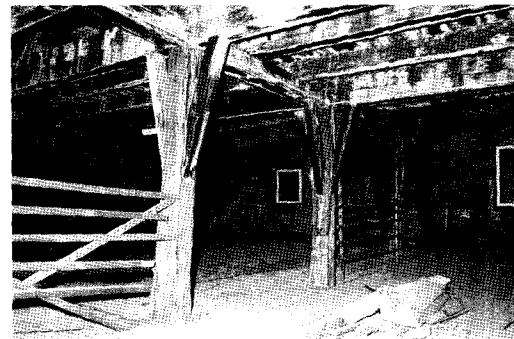
Figure 4  
Second storey inside the roof structure, the king posts in the middle axis

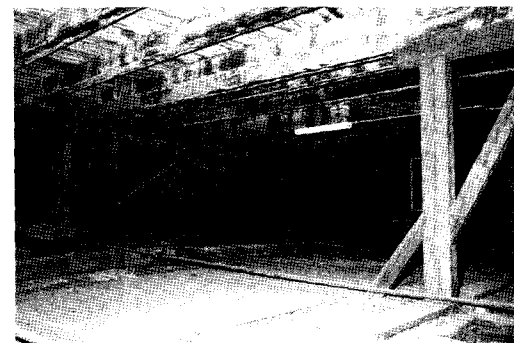
The structure consists of 14 rafters at each side connected by horizontal beams at five levels. In addition four principal trusses stiffen the structure. Above the first storey a continuous beam with a cross section of 27 by 30 cm is spanning in longitudinal direction between the gable walls. This beam is hanging at king posts which are connected to a suspension truss in the third and fourth storey (Fig. 4). In the year 1726 an additional truss was built in at the first storey parallel to the west side (Fig. 5).

Figure 5  
First storey inside the roof structure, the truss visible in the background dates from 1726

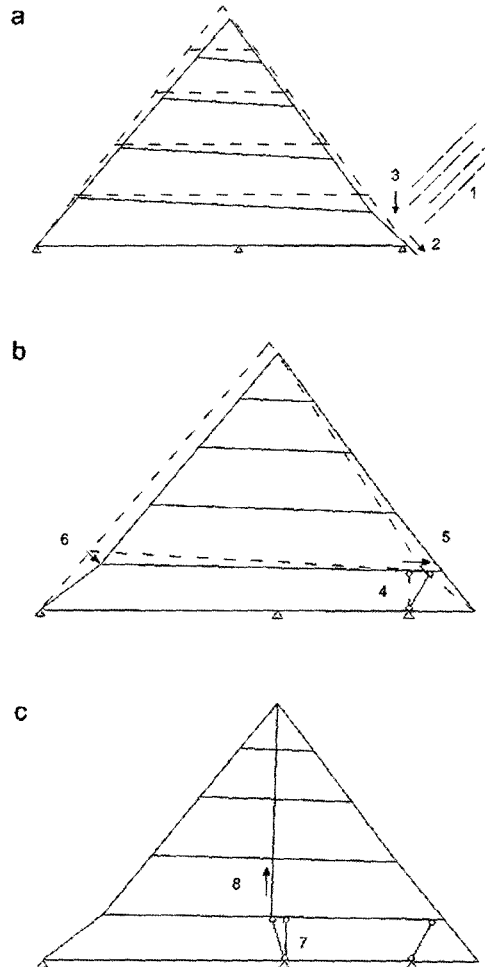
Figure 6

Soon after the erection damages along the eaves at the west side occurred due to a leaking roofing (Fig. 6a and Fig. 8). The joints between the rafters and the anchor beams were destroyed and failed. The rafters slid outwards and down to the masonry. The entire roof settled and got into an inclined position.

At the end the settlement of the upper floors was 42 cm. The struts were built in order to create a support in the middle of the span (Fig. 6c). The self load of the roof is now supported by these struts. The forces in the suspension structure changed from tension to compression. Some joints which were designed to take tension forces only could not take compression forces and fell apart.

Sequence of damages and repair measures 1) leaking roofing 2) destroyed connections between rafters and anchor beams 3) vertical deformation 4) new truss in order to stop the deformation 5) horizontal deformation 6) rotation of the inclined strut 7) new columns in order to stop the vertical deformation 8) compression instead of tension

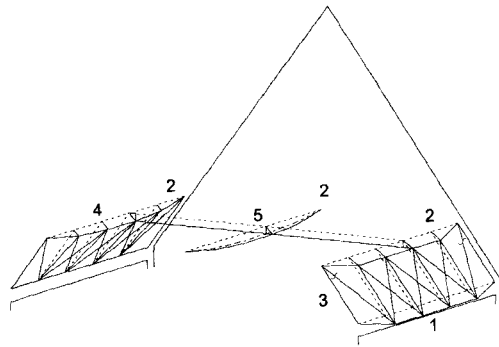
The deformations described occurred in the middle between the gable walls. At the gable walls the movements are restricted because of the connection of the structure to the masonry. A complicated three dimensional deformation figure was created (Fig. 7): At the west side all rafters slid downwards. Braces connecting the gable wall and the structure failed. At the east side there was no settlement at the eaves. The

horizontal beam at the second level, running from gable wall to gable wall, was bent but did not fail. The deflection line shows a horizontal and a vertical component. In a similar way the heavy beam in the middle was bent. It is also fixed at the gable walls. Therefore the three dimensional deformation figure

Figure 7  
Three dimensional deformation figure

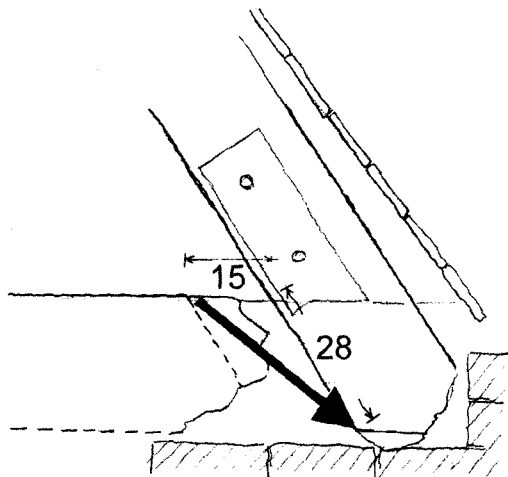
1. Along the eaves on the west all joints between the ends of the rafters and the anchor beams are rotten.

Figure 8  
Damages at the west side

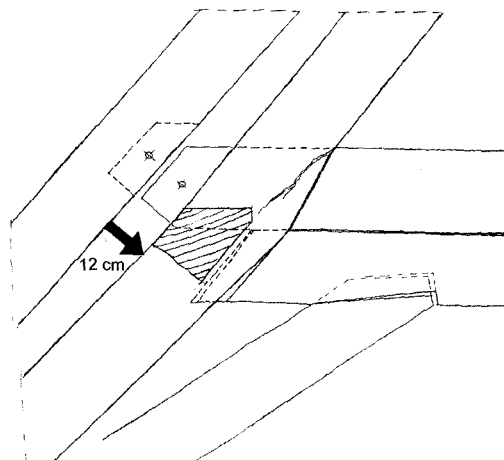
About a hundred years after the erection of the roof the truss was added in order to stop the movements. This truss took the big vertical loads of the roof and prevented the roof from further vertical movements. However the truss caused additional damages. The truss is a vertical support not a horizontal one. The horizontal thrust of the roof had no support. A new mechanism was created (Fig. 6b). The entire roof moved to the west. The truss got inclined. At the east side the movement to the west also caused a vertical movement. The lower support is a centre of rotation for the struts of the principal trusses. This movement was hindered only by the rafters. The rafters are continuous beams going from the eaves to the ridge. As a result the connection between the rafters and the principal trusses were drawn apart (Fig. 9). The wooden nails failed.

Figure 9  
Joints drawn apart at the east side

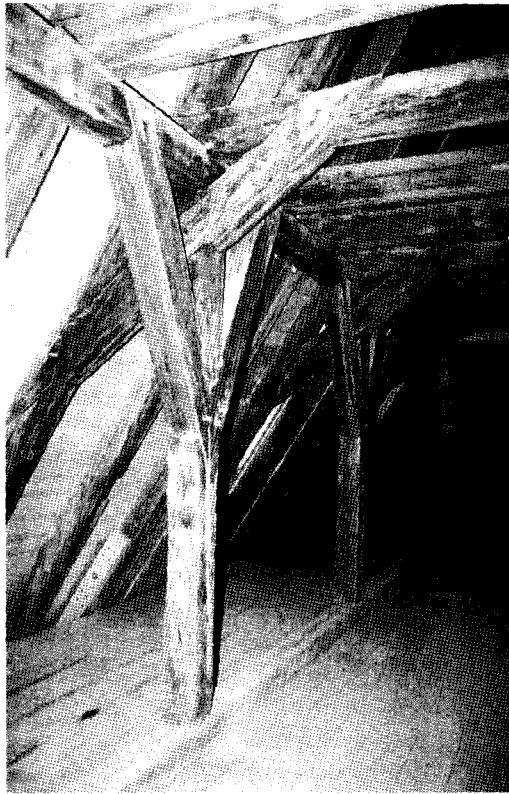
1. local damages due to a leaking roofing, mainly at the west side
2. big deflections at all the floors
3. broken joints due to overloading, especially at the connection of the braces and the rafters in the second floor (Figs. 13, 14).
4. local damages caused by fire. These damages are dated from the time of second world war. The repair was done very roughly.

Figure 13  
Second storey inside the roof structure, connection between rafter, brace and vertical strut

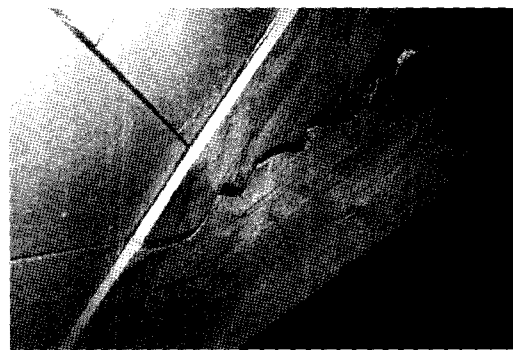
During the first period of time the structure had to span 13.35 meters and had to take the entire load of all floors. The suspenders and the suspension truss itself were strong enough. But there were problems in transferring the forces to the outer supports because of the distribution of stiffness inside the overall structure. The load path with the highest stiffness is the path from the suspension truss directly to the braces and to the rafters. The principle truss is not as stiff as the rafters due to the deflections of the horizontal beams which support the vertical struts. However the joints between the braces and the rafters were not strong enough. They are halved joints with

carving. Deformations occurred and the principle truss had to take over the loads. Bending moments caused big deflections. A statical calculation, considering the damaged joints at the rafters, confirms that.

Figure 14  
Overloaded joint between rafter and brace in the second storey

The result of a lot of discussions was extremely simple. Upon the upstand beam in the first storey along the middle axis a few small steel columns were positioned. They take the loads of the upper floors and transfer them directly to the middle wall underneath. The king post is now under compression instead of tension. The compression is very small and the design of the joints make it possible in this case. The stiffness of the entire roof structure became much higher even against horizontal loads. No further

measures were necessary. The overloaded joints could stay in place without repair. They are a part of history.

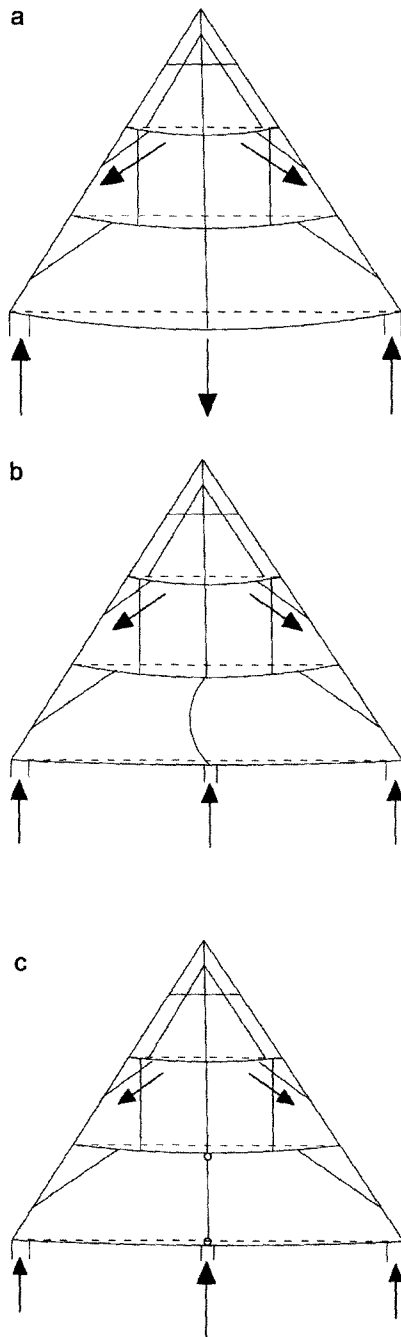
The analysis of the statical behaviour and the sequence of alterations and damages lead to the following conclusions (Fig. 15):

Probably the deflections were the reason for the wall which was built underneath. The wall took over the loads of the floor. The forces at the suspenders and the suspension truss were reduced. However further deformations occurred and the suspenders buckled.

Figure 15  
Sequence of statical systems
