The experimental earthen cottages at Amesbury, England: A long term condition assessment

Richard Burt

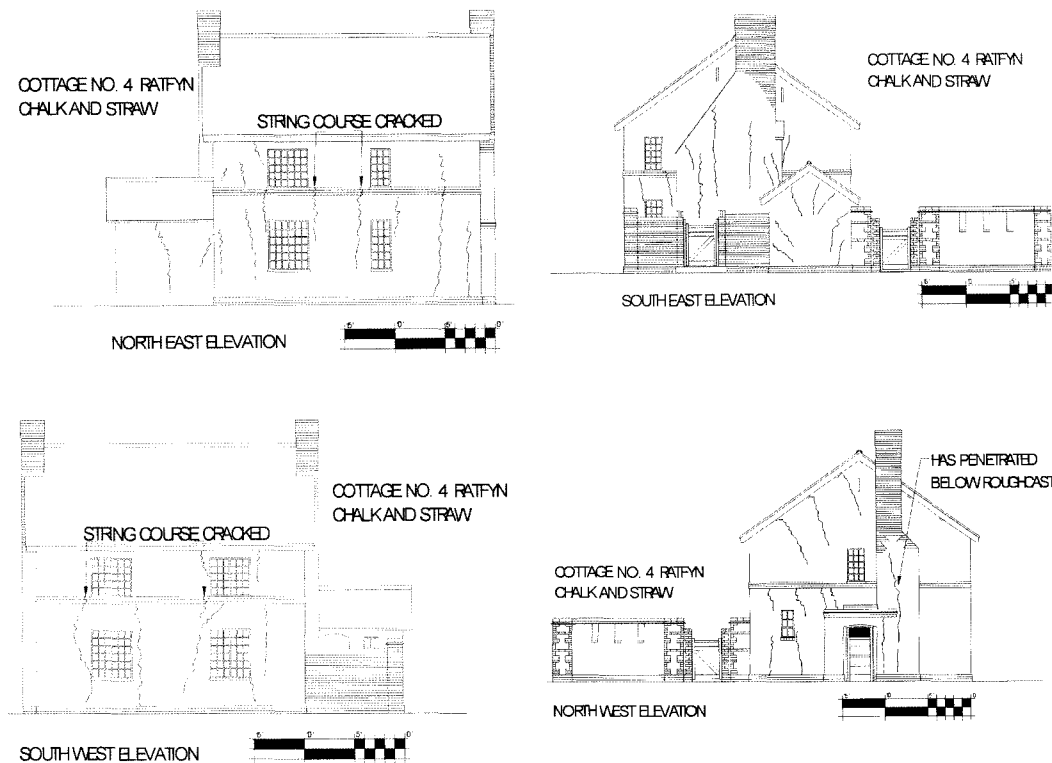
Figure 3
Cracking to cottage n° 4 Ratfyn. Summer 1927

cracking to the four elevations of the cottages are shown in figure 3. The report states the cracking was quite extensive and the cracks have penetrated below the roughcast in nearly every case. The cracks were reported as being approximately 4 in. deep. The cracking had penetrated through internal plaster in two places: in the wall of the outbuilding on the northeast elevation, and over the lintol on the first floor, although the exact position was not noted. The horizontal string-course below the first floor windows was also cracked on the northeast and southwest elevations. The report states the cause of the cracking as was «due to the shrinkage of the mass of the wall following the evaporation of the water». The report also makes note of some leakages through «straight joints» at the junction of brickwork and chalk and on the northwest elevation where the roof purlins pass through the gable (DSIR 36/2197 1927, 6).

ramming. It was again suggested that the cracking was due to the shrinkage of the walling material and that the wall failed along its weakest planes, between openings. A number of reasons were suggested for the shrinkage. The suitability of wire netting reinforcement to check the cracking was questioned. It was also suggested that a greater bulk change occurred to the wall due to moisture changes in materials used, particularly, the chalk which had a moisture content of approximately 20%. The report suggested that the cracking had finished and any further movement would be taken up by the cracks (DSIR 36/2197 1927, 5–6).

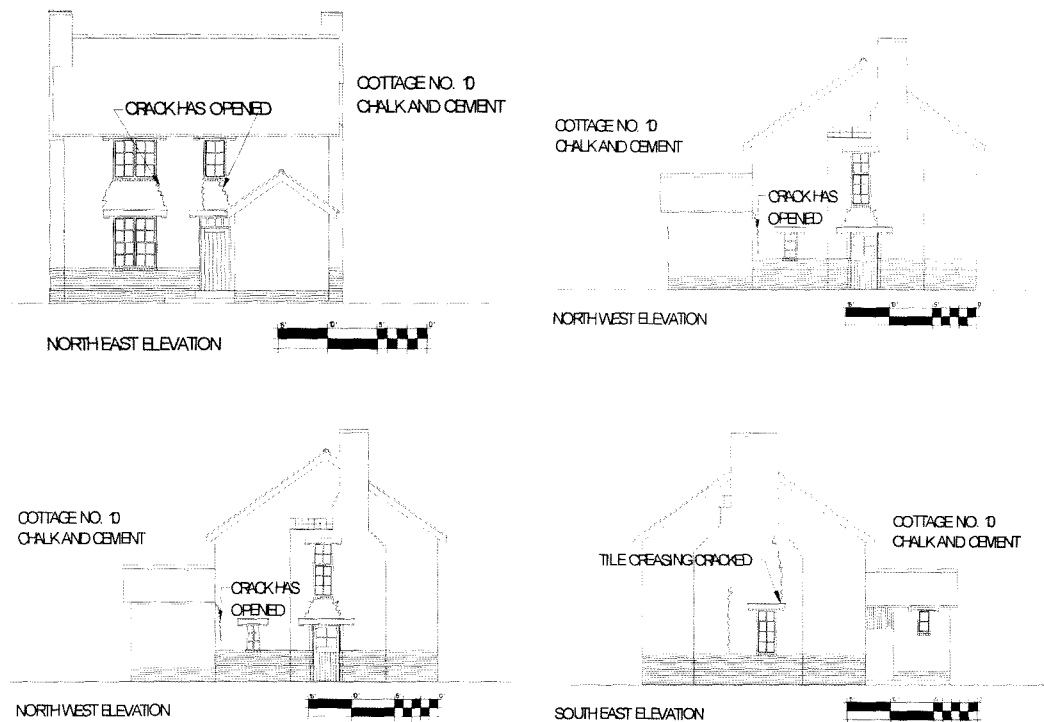
Figure 4
Cracking to cottage n° 10. Summer 1927

The report stated that the walls have cracked badly in places, but the cracks were not as numerous as cottage n° 4 Ratfyn. The cracking to the four elevations of the cottages are shown in Figure 4. Cracks were described as starting at the corners of cills and lintels and running vertically. Some of the cracks were described going through to the inside, and, in some cases, the cracks were as much as 1/20 in. wide. The walls of the cottage were described as being dry except where moisture had penetrated through cracks. One damp patch in particular on the southeast wall was caused by bad walling material and a suggestion was made that this was due to bad

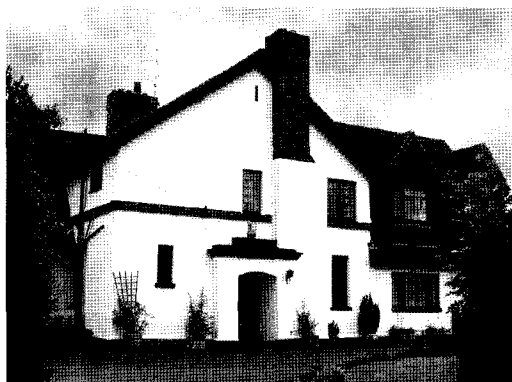
Figure 5
Cottage No. 4 Ratfyn - Northwest Elevation in 2002

This cottage has undergone the most extensive changes since 1945. It is interesting to note this was the only one of the three cottages that was not a listed building. This cottage underwent two major phases of extensions and alterations. In 1979 a two-storey pitched roof addition was added to the northeast elevation. This addition can be seen to the left of the main cottage on figure 5 and the right of the main cottage on figure 6. It contained two garages at the ground floor level and a bedroom, sitting room and bathroom at first floor level. The extension was of cavity masonry construction with a white-painted-cement-render finish. Between 1979 and 1988 a conservatory was added between the cottage and the original outhouse, this can be seen in the center of figure 6. In 1988 a second two-storey-pitched roof extension was added to the southwest elevation. This addition can be seen to the right of the main cottage on figure 5 and the left of the main cottage on figure 6. This extension contains a new study, and dining room and a garage on the ground floor, and three bedrooms and a bathroom on the second floor. This extension was also constructed in cavity masonry with a cement-render finish.

An inspection of the earth walling materials was also carried out and the walls were found in a satisfactory condition. It was apparent that the original rendering was replaced. Documents in the possession of the current owner would suggest that the cottage was re-rendered in 1969 with a proprietary textured coating called «Thermo/tex». The owner expressed some concern about the internal plaster adhering to the chalk walling and showed the author an area of damp walling adjacent to the fireplace in the living room. It was apparent that the wall was very damp and further inspection of the wall on the outside revealed that a new patio had bridged the damp proof course.

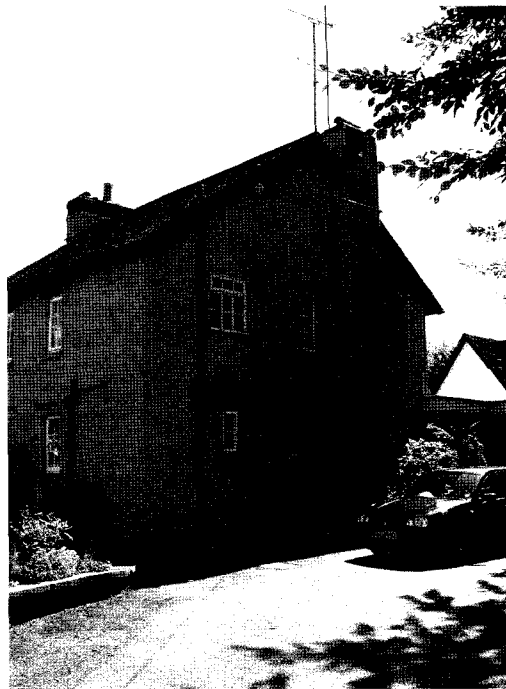
Figure 7
Cottage n° 5 Ratfyn. Northwest Elevation in 2002

building to the same extent as additions to cottage n° 4 Ratfyn. This cottage has undergone three phases of additions. In 1972 a single story flat roof addition was added to the southwest elevation. This addition can be seen to the right of the cottage in Figure 7 and to the left of the cottage in Figure 8. This extension was constructed using cavity masonry with a roughcast-cement-render finish. In 1982, the fuel store on the southeast elevation was extended by several feet using cavity masonry to form a utility room. This extension was consumed by a much larger two-storey-pitched-roof extension on this elevation in 1993. This again, was built using cavity masonry with a roughcast finish and contained a sitting room at ground floor level and a dressing room at first floor level. This extension is shown on the right of Figure 8. This addition was much more in keeping with the original cottage in terms of scale and details. Many of the details such as the timber verge details and lintol details, were copied on the addition. This attention to detail and scale was a result of the cottage being

The original chalk pisé walls were re-rendered in 1999. This was done to a high standard and care was taken to identify a suitable render for the property. The new render consisted of a lime-based base-coat, a butter-coat (with roughcast) and a 3-coat lime-wash finish. The local authority who provided approximately 10% of the cost of the work approved this work. An inspection of the cottage revealed it to be in excellent condition and it was noted that the external ground level was kept well below the damp proof course.

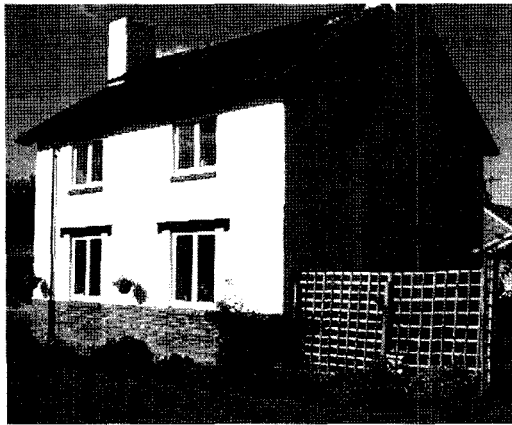
Figure 9
Cottage n° 10. Southwest Elevation in 2002

This cottage remains the least unaltered of the three cottages. Figure 9 shows the southwest elevation that remains almost unchanged. The only changes were a small-pitched roof porch that has been added to the northwest elevation, to the right of the cottage in figure 10, and a small flat roof conservatory between the cottage and the fuel store, to the left of the fuel store.

This cottage was also a grade II listed building. An inspection of the cottages walls revealed that they were in a satisfactory condition. The original external finish was still on the cottage as the outlines of some

of the cracks shown in the 1927 report (Fig. 4) were still visible. Figure 11 shows evidence of one of the shrinkage cracks between ground and first floor windows.
