## FAULT-INDUCED DEFORMATION IN HOUSES AND STREETS OF LORCA CITY (SPAIN) DURING THE LAST CENTURIES

Joaquín García-Mondéjar<sup>1\*</sup>, Carlos Sanz de Galdeano<sup>2</sup>, Andrés Martínez Rodríguez<sup>3</sup> and Juana Ponce García<sup>3</sup>

García-Mondéjar, J., Sanz de Galdeano, C., Martínez Rodríguez, A. and Ponce García, J. (2017): Fault-induced deformation in houses and streets of Lorca city (Spain) during the last centuries. *Revista de la Sociedad Geológica de España*, 30(1): 3-19.

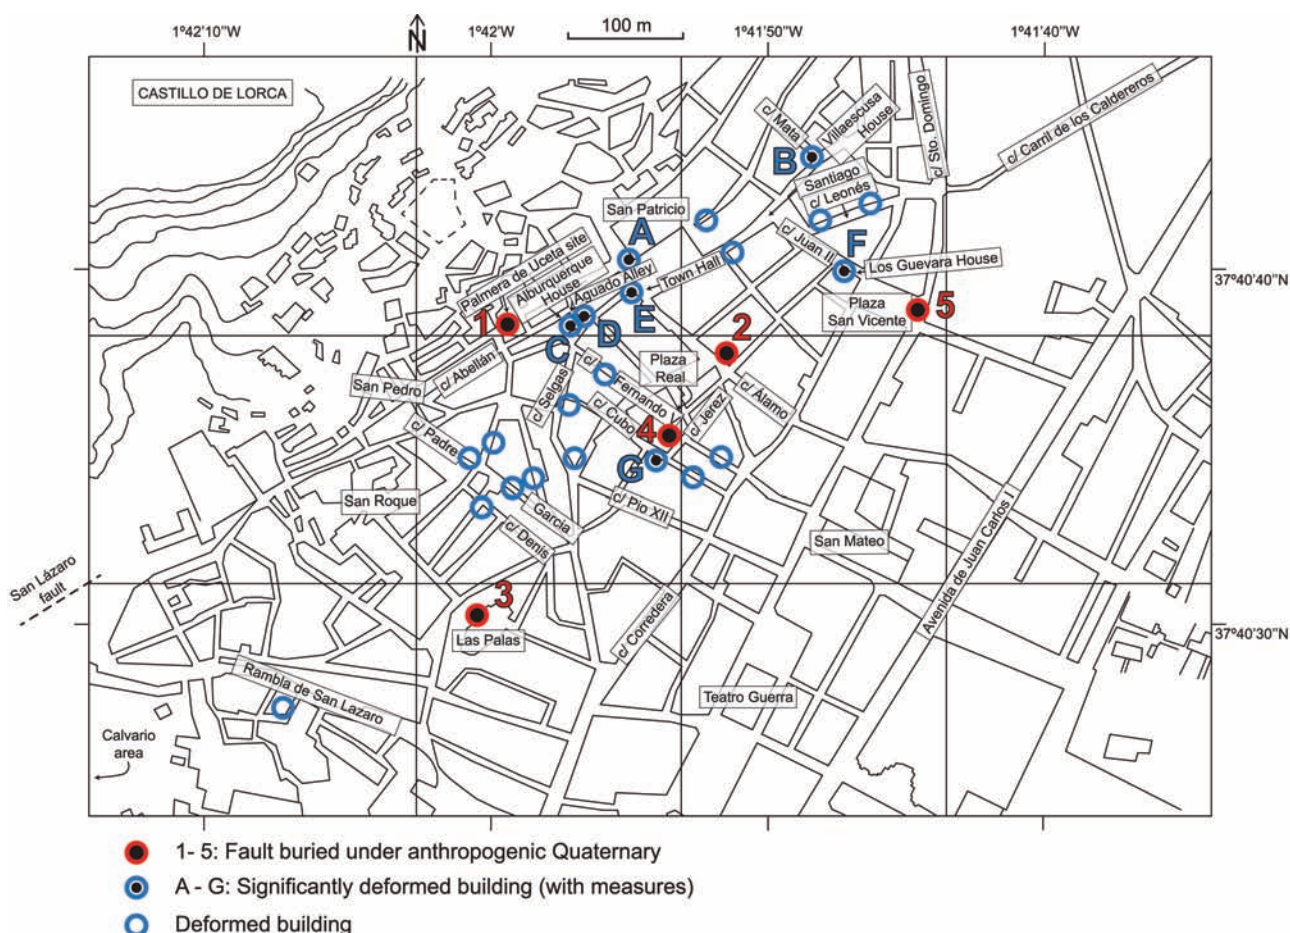
**Fig. 2.-** Map street plan of the older part of Lorca city with location of buildings with significant deformation and measurements (points A to G: A- San Patricio Church; B- Villaescusa House; C- Albuquerque House; D- Selgas Street House; E- Town Hall Building; F- Los Guevara House; G- Cubo and Jerez streets intersection). Archaeological sites with fault traces are represented by points 1 to 5 (1- Palmera de Uceta outcrop; 2- Álamo Street outcrop; 3- Las Palas outcrop; 4- Plaza Real outcrop; 5- San Vicente outcrop). Other deformed buildings are identified with empty circles.

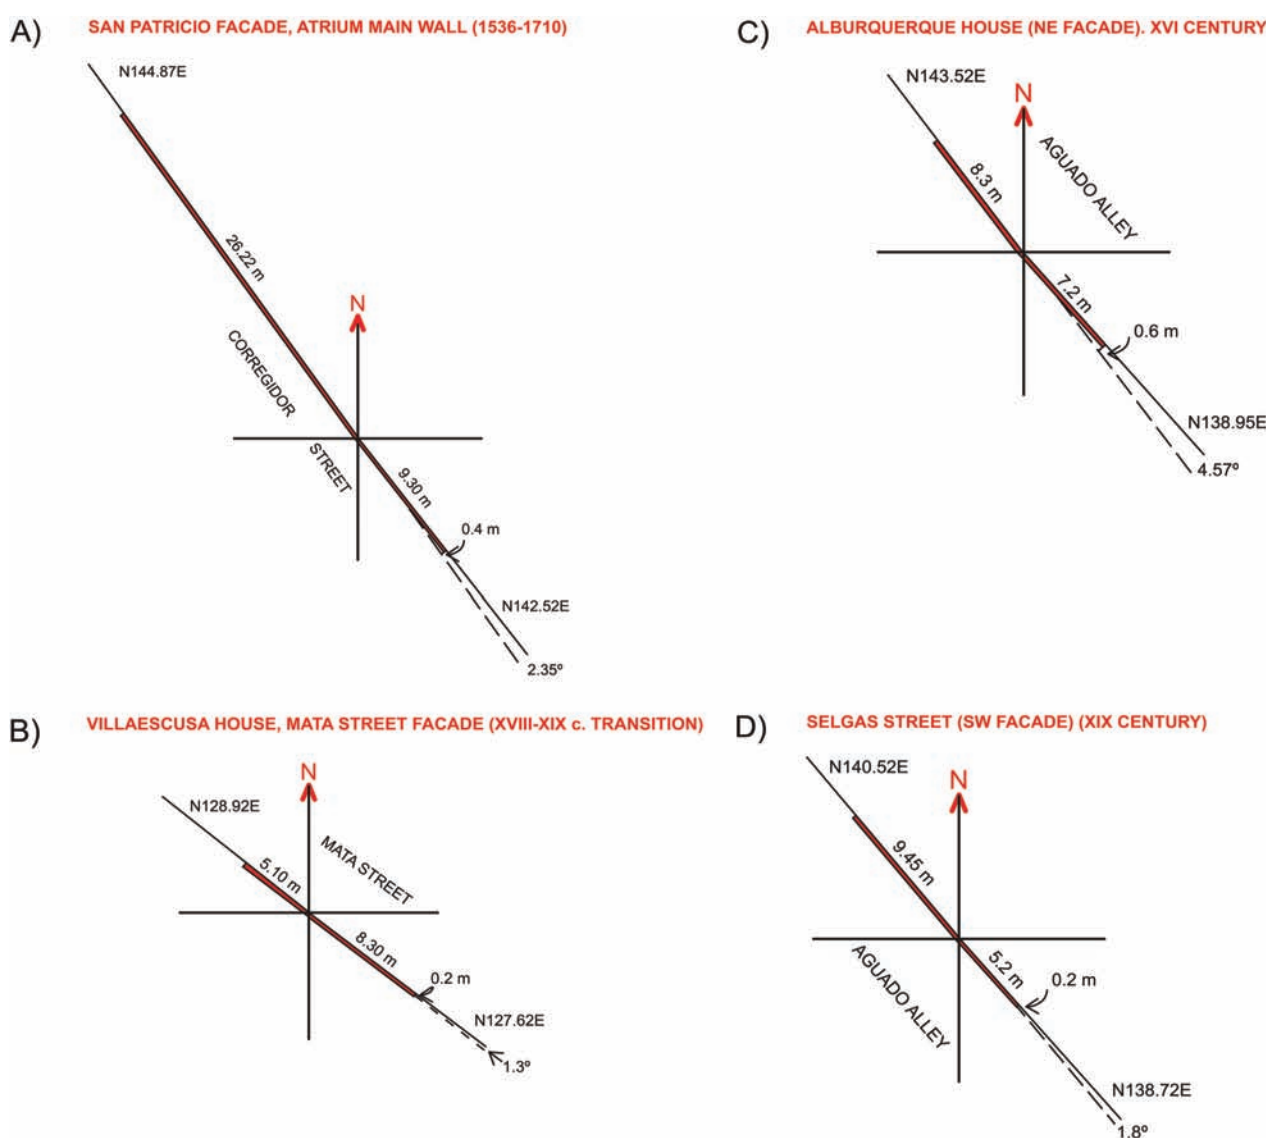
**Fig. 3.-** Cross-sections of the deformed facades represented in points A to D in Figure 2. A) Horizontal section of the lower part of the atrium main wall in front of San Patricio Church facade (point A), showing two segments deflected 2.35°. B) Horizontal section of the lower part of Villaes-cusa House, Mata Street facade (point B), showing two segments deflected 1.3°. C) Horizontal section of the lower part of the Alburquerque House, Aguado Alley facade (point C), showing two segments deflected 4.57°. D) Horizontal section of the lower part of Selgas House, Aguado Alley facade (point D), showing two segments deflected 1.8°.

This site corresponds to point A in Figure 2. The San Patricio ex-collegiate church was built between 1536 and 1710. The main wall of the atrium, parallel to the main facade of the church is 35.5 m long and is oriented NW-SE. It belongs to a single constructive unit originally plane. However, looking carefully at this wall it is evident that it is made up of two vertical planes with a slight difference in orientation. In horizontal section the atrium wall shows two segments (Fig. 3A). The northern segment is 26.22 m long and is oriented N144.87°E (mean value of 17 geological compass measures). The southern segment is 9.30 m long and is oriented N142.52°E (mean value of 9 geological compass measures). Therefore, both orientations differ in 2.35° and show 0.4 m of maximum deflection. The intersection line between the two planes of the atrium wall does not apparently have any correspondence in the church facade. However there are some vertical cracks in the southern part of this facade in front of that intersection line, and there is evidence that the SE part of San Patricio is the most damaged area of the building (e.g., Rodríguez-Pascua *et al.*, 2012, their Fig. 13).

The deformation described here is, therefore, concentrated in the lowermost part of the building, nearly the street level. Discontinuous stone blocks at the base are seen projected up to 0.1 m out of the vertical plane of the wall, giving testimony of the reported deformation. The outer profile of these blocks draws a straight line 2.8° oblique to the base wall, very close to the 2.35° deformation angle of the atrium reported above. They are interpreted as pieces of wall left behind during the rotation process.

The Villaescusa House is located in point B of Figure 2. Its main facade lies in the Villaescusa Street but we analyse here the Mata Street facade (Fig. 3B). This important building was built in the transition between the XVIII and XIX centuries.

The Mata Street facade is 13.40 m long and is oriented roughly NW-SE. In horizontal section it consists of two rectilinear segments with slightly different orientations. The NW segment is 5.10 m long and is oriented N128.92°E (mean value of 10 geological compass measures). The SE segment is 8.30 m long and is oriented N127.62°E (mean value of 8 geological compass measures). Therefore the difference in orientation is 1.3° and the maximum deflection of the facade is 0.2 m (Fig. 3B). A thing to note here is that the facade deflection is only present in the lower part of the building, with the upper story and eaves rectilinear.

The Aguado Alley facade is 15.50 m long and is made up of two rectilinear segments in horizontal section (Fig. 3C). The NW one is 8.30 m long and is oriented N143.52°E (mean value of 8 geological compass measures). The SE one is 7.20 m long and is oriented N138.95°E (mean value of 7 geological compass measures). Both segments differ 4.57° in orientation and 0.6 m in maximum deflection (Fig. 3C).

The Aguado Alley facade is 14.65 m long and consists of two segments in horizontal section. The NW segment is 9.45 m long and is oriented N140.52°E (mean value of 8 geological compass measures). The SE segment is 5.2 m long and is oriented N138.72°E (mean value of 6 geological compass measures). The difference in segment orientations is 1.8° and the maximum deflection is 0.2 m (Fig. 3D). As in previous cases, the deformation of this facade is bigger in the lower part of the building and it diminishes towards its upper part (Fig. 5A, right part).

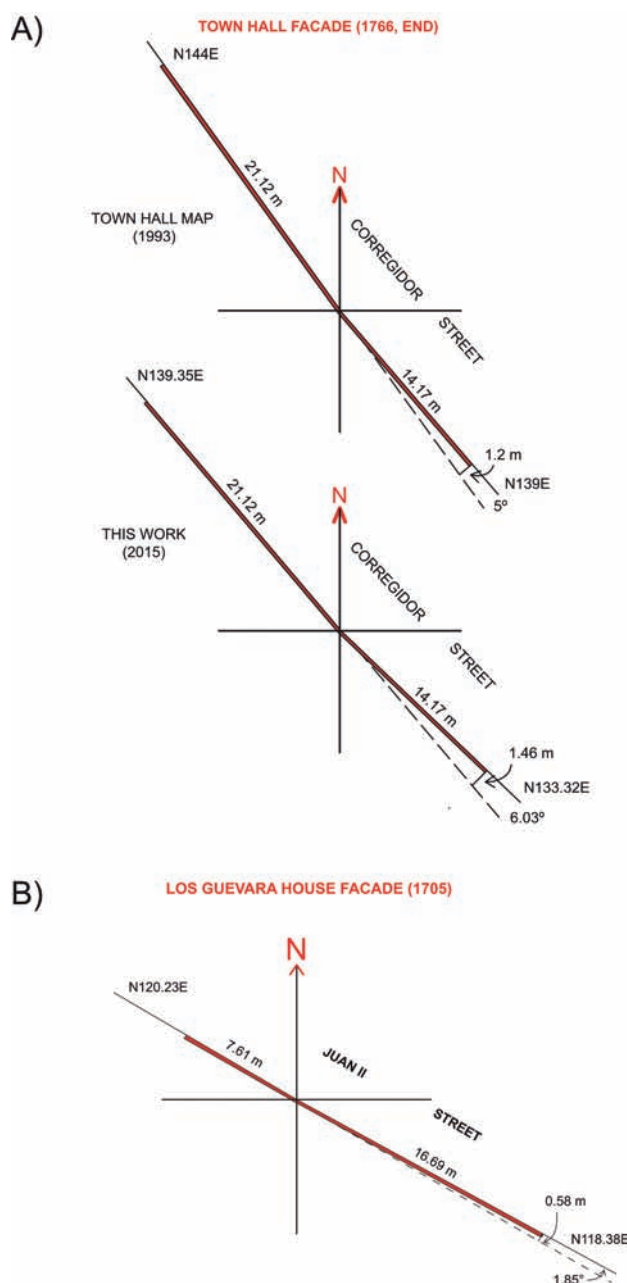
**Fig. 4.-** Cross-sections of the deformed facades represented in points E and F in Figure 2. A) Horizontal section of the lower part of the Town Hall facade (point E) showing two segments deflected 5° (upper part, Town Hall map 1:500 scale, 1993), and 6,03° (lower part, this work). B) Horizontal section of the lower part of the Los Guevara House facade (Juan II Street, point F), showing two segments deflected 1.85°.

In the Town Hall map (1993), the Town Hall main facade has a N segment 21.12 m long and oriented N144°E. Its S segment is 14.17 m long and oriented N139°E. The difference in orientation is 5° and the maximum deflection is 1.2 m (Fig. 4A up).

Our Town Hall main facade section has a N segment 21.12 m long and oriented N139.35°E (mean value of 12 geological compass measures). The S segment is 14.17 m long and is oriented N133.32°E (mean value of 5 geological compass measurements). The difference in orientation of both segments is 6.03° and the maximum deflection is 1.46 m (Fig. 4A down). These deviations are clearly seen in a photograph taken from the N (Fig. 5B). As in previous cases deformation is bigger at the base of the facade and it diminishes upwards. In this case the lower colonnade of the southern part of the building is significantly inclined to the SW, accompanying that difference in deformation.

The relative difference in orientation between segments is similar in the Town Hall map section (5°) and our section (6.03°); however, the general orientation of the facade departs around 5° from the Town Hall section to ours. We attribute this difference to a localized error in the drawing of the Town Hall map owing to its small scale.

Los Guevara House main facade dates from 1705. It faces Juan II Street and is represented by point F in Figure 2. This facade consists of two rectilinear segments in horizontal section differently oriented (Fig. 4B). The W segment is 7.61 m long and is oriented N120.23°E (mean value of 14 geological compass measures). The E segment is 16.69 m long and is oriented N118.38°E (mean value of 14 geological compass measures). The difference in segment orientations is 1.85° and

the maximum deflection is 0.58 m. As in similar cases described previously, the deformation of this facade is bigger in the lower part and it diminishes progressively towards the eaves. Work in progress with other details will complete description of this house in the future.

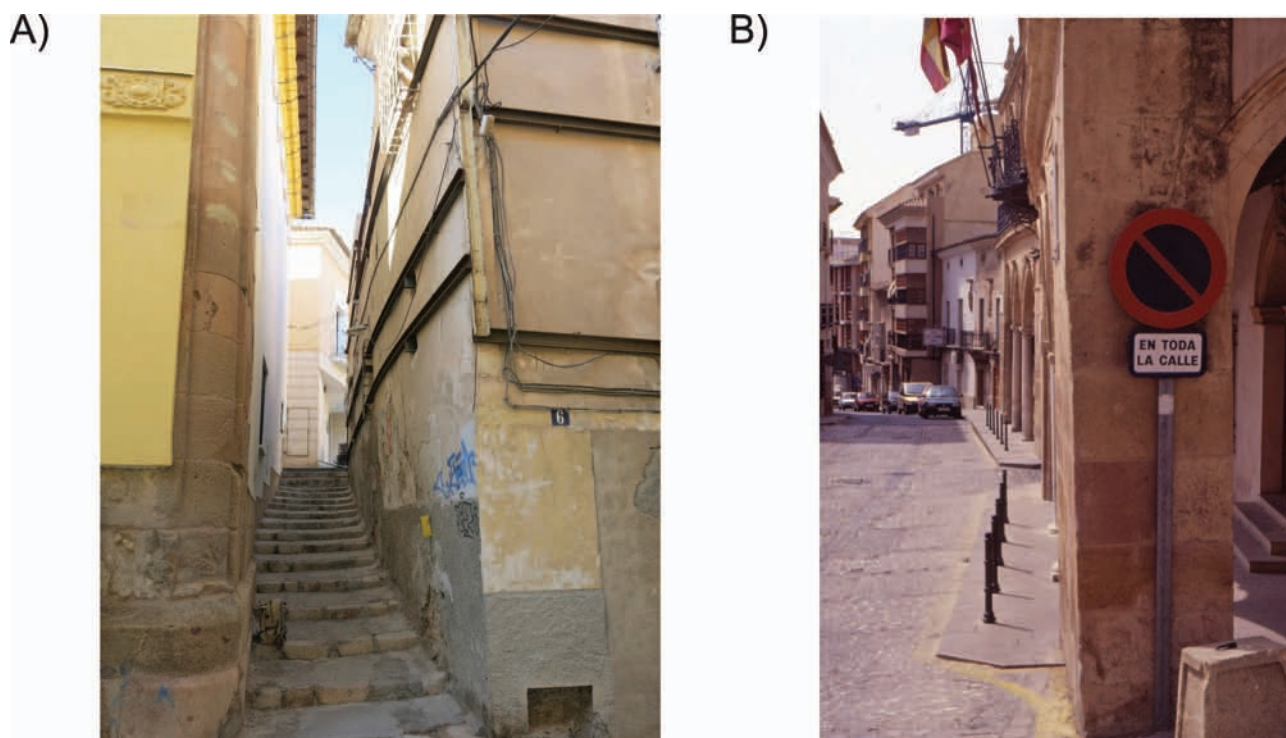
As in San Patricio Church and Villaescusa House, the maximum deflection is located in the lower part of the building, and it diminishes progressively towards the eaves where it is practically imperceptible (Fig. 5A, left part).

**Fig. 5.-** Photographs of deformed buildings shown in figures 3 and 4 (points C, D and E in Fig. 2). A) Picture from the Aguado Alley taken from the S. The Albuquerque House (point C) and Selgas Street House (point D) facades are seen to the left and right, respectively. Both and the proper Aguado Alley are deflected in the same direction, towards the NE. The upper part of the Selgas facade shows lesser deformation and the corresponding upper part of the Albuquerque facade is not deformed. B) Picture of the Town Hall main facade taken from the N. The southern part (background) is horizontally deflected to the NE and vertically inclined to the SW, with maximum deformation in the lower colonnade.

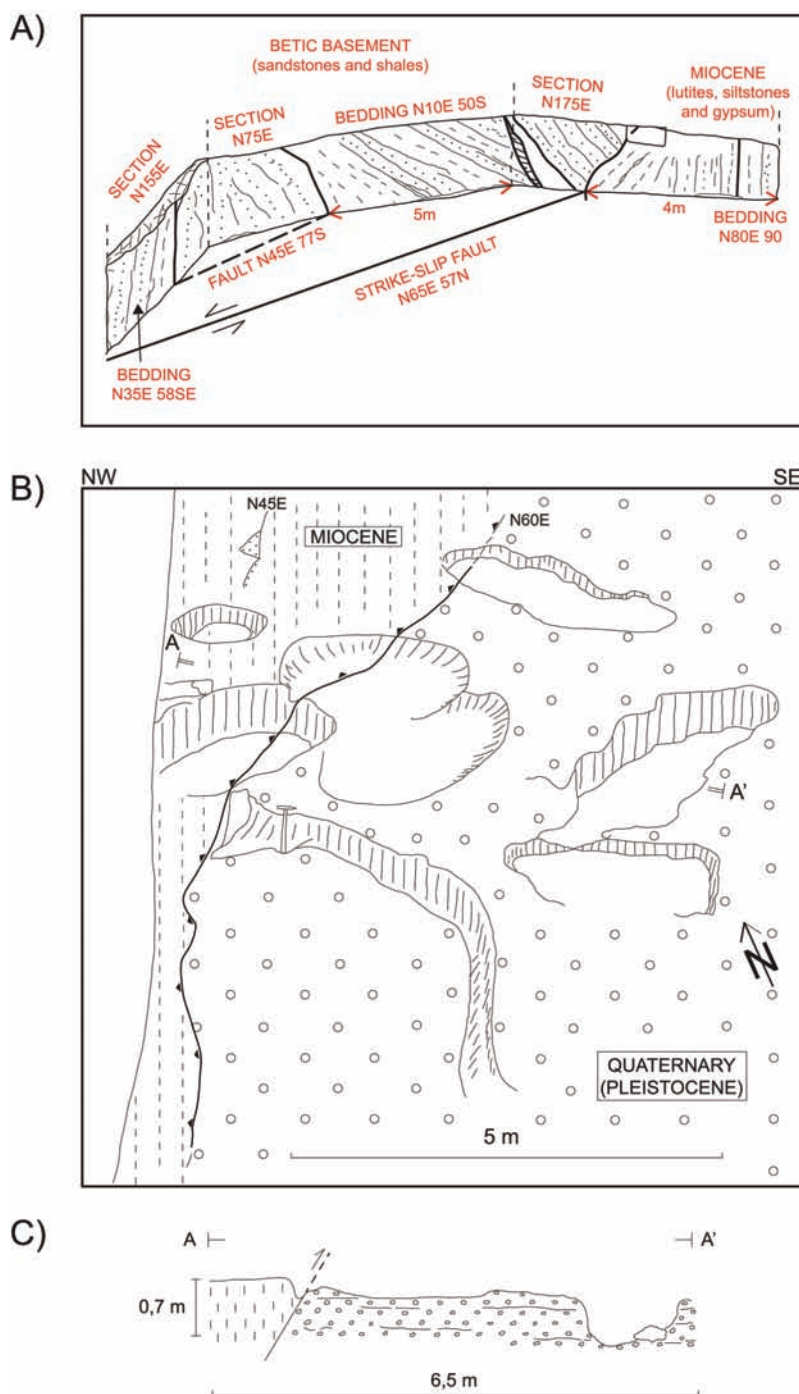
A main fault oriented N065°E with dip 57°N separated two sedimentary successions. The northern one consists of fine-grained sandstones and shales (Fig. 6A), attributed to the Betic basement (most probably Permian/Triassic). The southern succession is 4 m thick and consists of greenish lutites with silty and sandy beds and scattered gypsum crystals. In an outcrop 10 m to the NE, these lutites enclosed red polymictic channelized conglomerates. This succession is attributed to the Miocene by comparison with similar facies described in García-Mondéjar *et al.* (2014a).

Therefore, the fault shown in Figure 6A separates series of different age. The main fault plane dipping NW suggests a reverse component, and at least three subordinate

**Fig. 6.-** Geological outcrops from archaeological excavations in points 1 and 2 of Figure 2. A) Vertical sections with different orientations at Palmera de Uceta Street in 2005 (point 1). Materials of the Betic basement are separated from a Miocene series by a N065°E oblique-reverse fault with three subordinate strands. B) The Álamo archaeological site exposed during a 2007-2008 excavation (point 2). Plan view drawing of the archaeological site after extraction of the anthropogenic Quaternary, taken from a photograph. Miocene (left) and Quaternary (right, Late Pleistocene) are separated by a reverse fault oriented N045°E-N060°E. Depressed structures at surface correspond to holes left by the archaeological excavation. C) NW-SE geological cross-section of the Alamo site (see A-A location in B), showing the vertically-dipping Miocene superposed to the horizontally-dipping Quaternary. Modified from García-Mondéjar *et al.* (2014b, their Fig. 2).

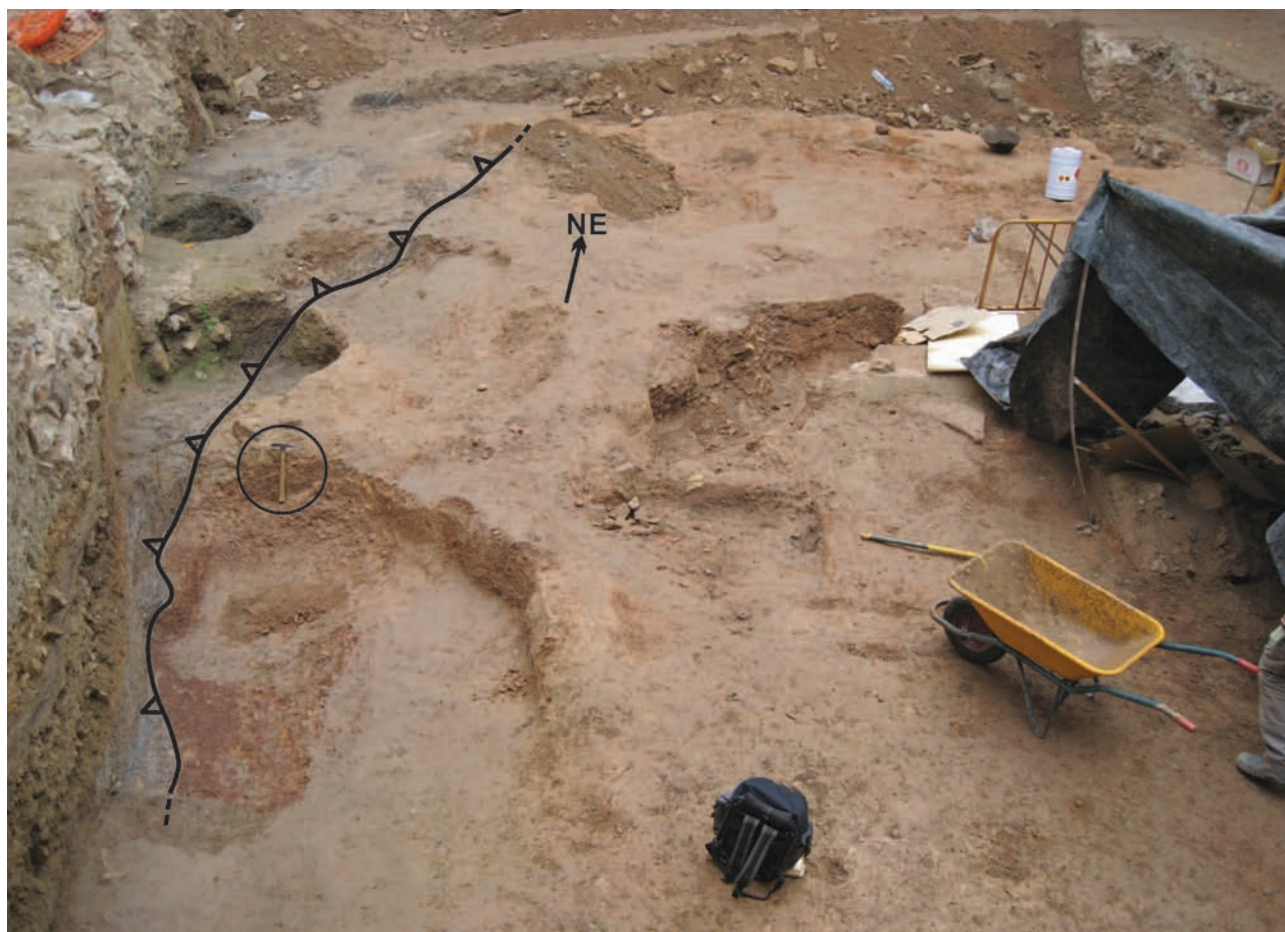
**Fig. 7.-** Photograph of the Álamo Street outcrop exposed during the 2007-2008 excavation works (point 2 in Fig. 2). The plan view shows geological units after extraction of the anthropogenic Quaternary. A reverse fault oriented SW (foreground, N045°E) to NE (background, N060°E), separates Miocene lutites (left) from Late Quaternary conglomerates (right). View from the SSW. A schematic drawing is shown in Figure 6B.

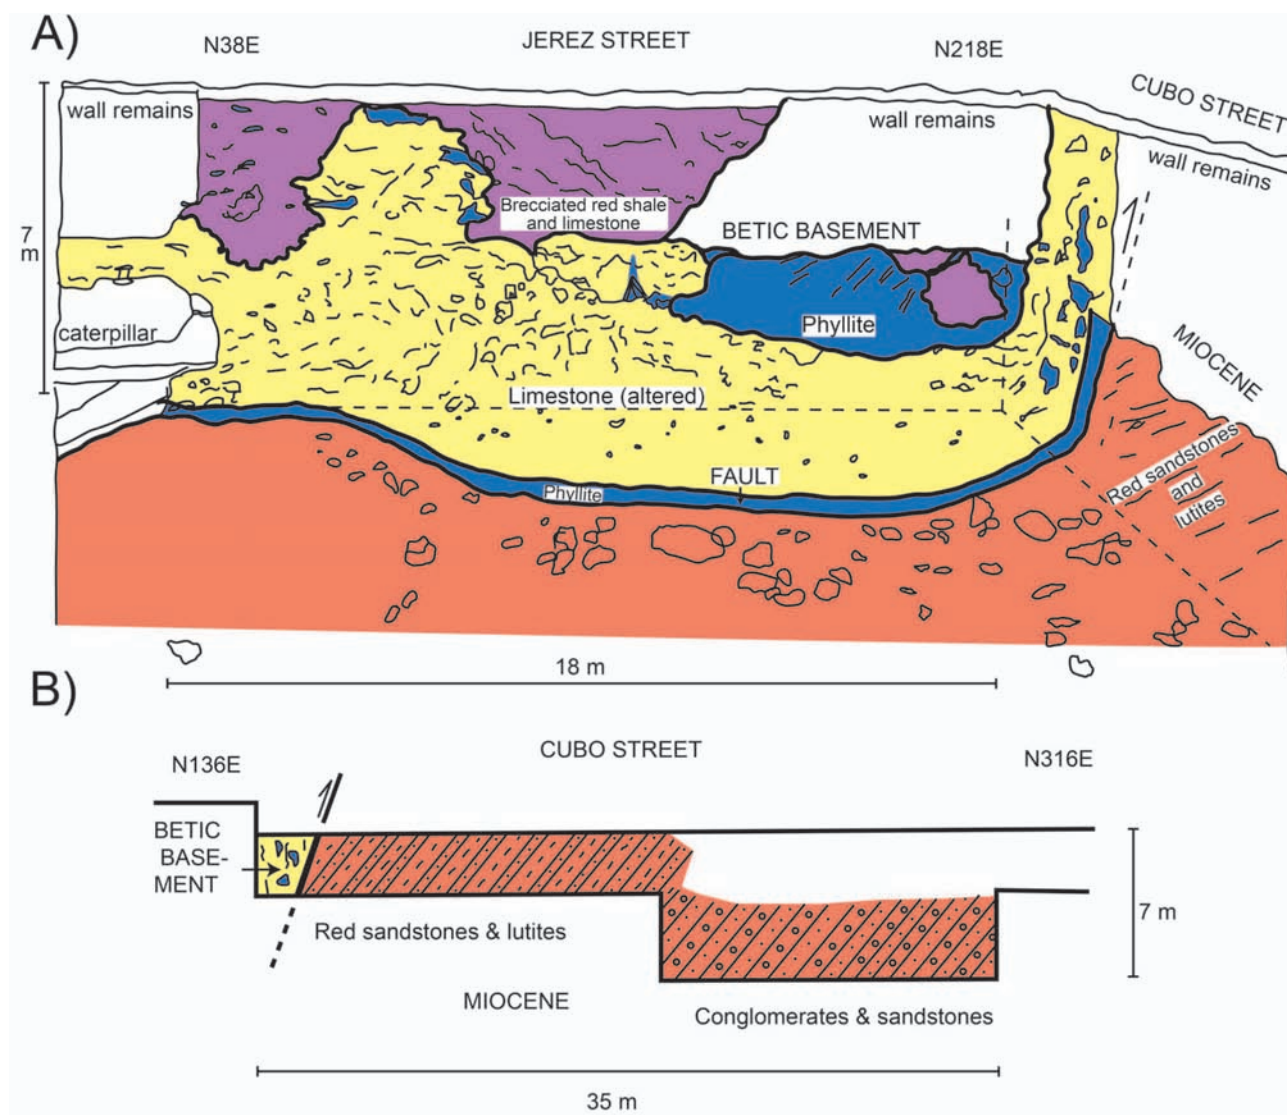
The units described are separated by a fault coated by a 0.5 m thick phyllite band, approximately parallel to Jerez Street (N038°E), with 70° dip to the SE (Figs. 8 and 9). According to the exposed data it is a reverse fault with a slightly sinuous trace.

**Fig. 8.-** Plaza Real excavation site (point 4 in Fig. 2). A) Drawing from a picture taken from the NW. A Miocene series (foreground) is separated from Betic materials (background) by a fault coated with phyllite. B) SE-NW cross-section showing the Miocene and Betic materials separated by a fault.

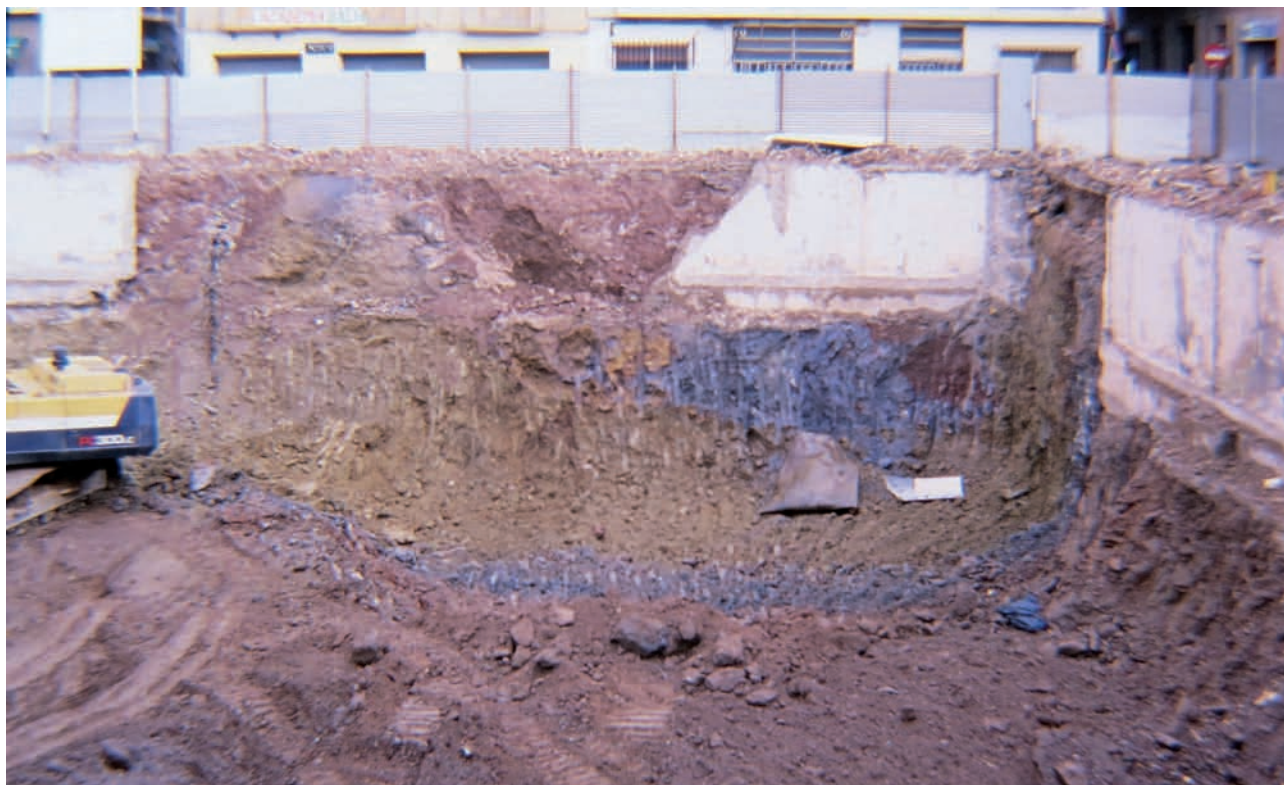
**Fig. 9.-** Plaza Real excavation site (point 4 in Fig. 2). Picture taken from the NW. A hole 7 m deep shows a Miocene series in the foreground and, separated by a fault, Betic materials in the background. Caterpillar on the left for scale. A drawing of this outcrop is presented in Fig. 8A.

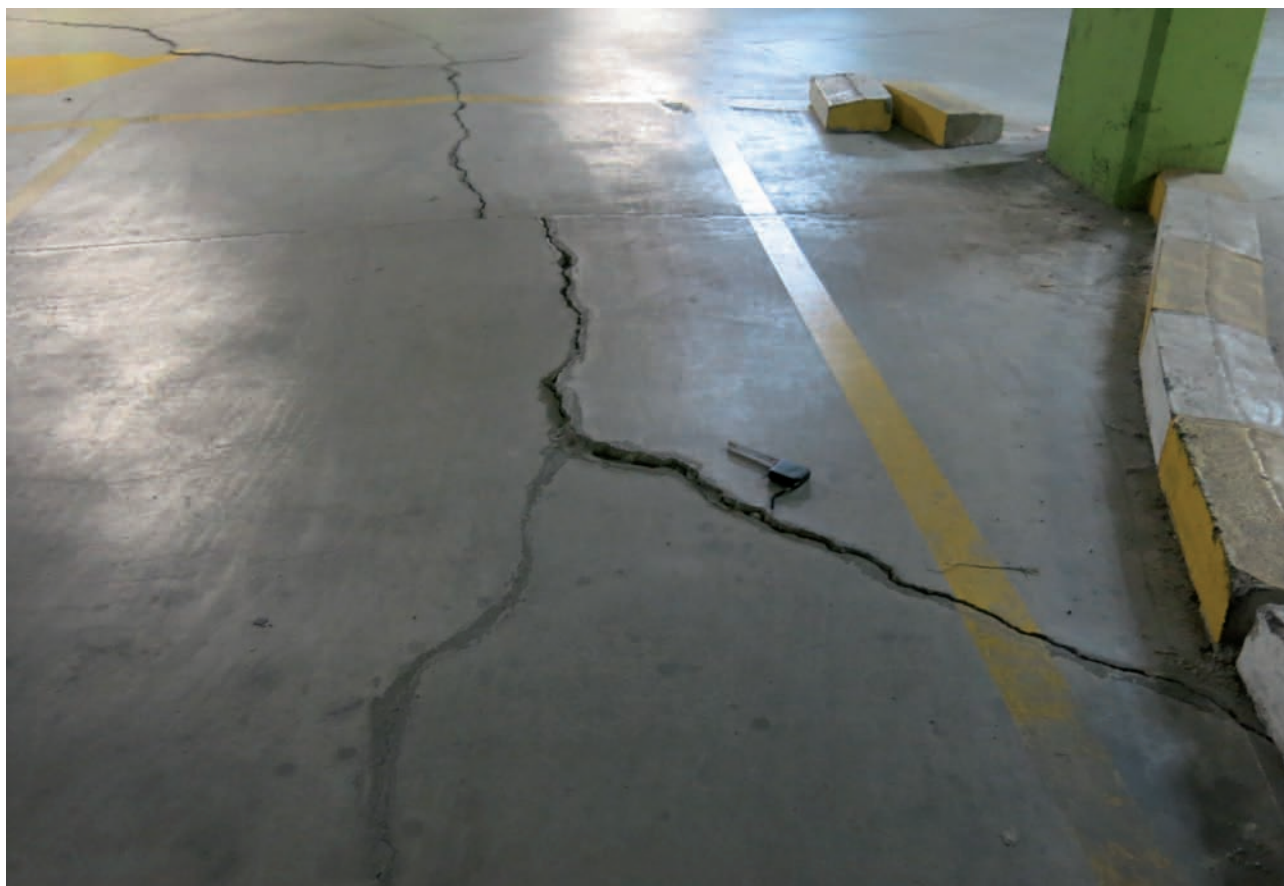
Construction of an underground parking place in Plaza Real in 2001/2002, offered a unique opportunity to estimate the order of magnitude of vertical displacements of a fault strand in Lorca during a major earthquake. The floor of the lowermost basement of that parking place was laid directly onto the geological surface of the excavated site. It was affected by the Lorca 2011 earthquake with formation of large cracks that were more abundant along a band several metres wide oriented NNE. This band followed approximately the underlying fault trace shown in Figure 8A. Some of the cracks presented relief up to 3 cm high (Fig. 10).

Following the same fault strand, we attribute the appearance of cracks in the deepest floor of the Plaza Real parking place to movement of the fault during the Lorca 2011 earthquake. These cracks suggest at least 3 cm of maximum vertical displacement produced in this accident during an instantaneous shock.

**Fig. 10.-** Cracks in the basement floor of the Plaza Real parking place, appeared as a consequence of the Lorca 2011 earthquake. They are concentrated in a band oriented NNE with the crack in the centre showing 3 cm relief. Tape measure opened 10 cm. View from the SW.

The same Las Palas-Plaza Real fault trace also offers an approximation to vertical displacement in the Plaza Real basement floor. The cracks formed as a result of the Lorca 2011 earthquake give up to 0.03 m of maximum vertical displacement (Fig. 10).

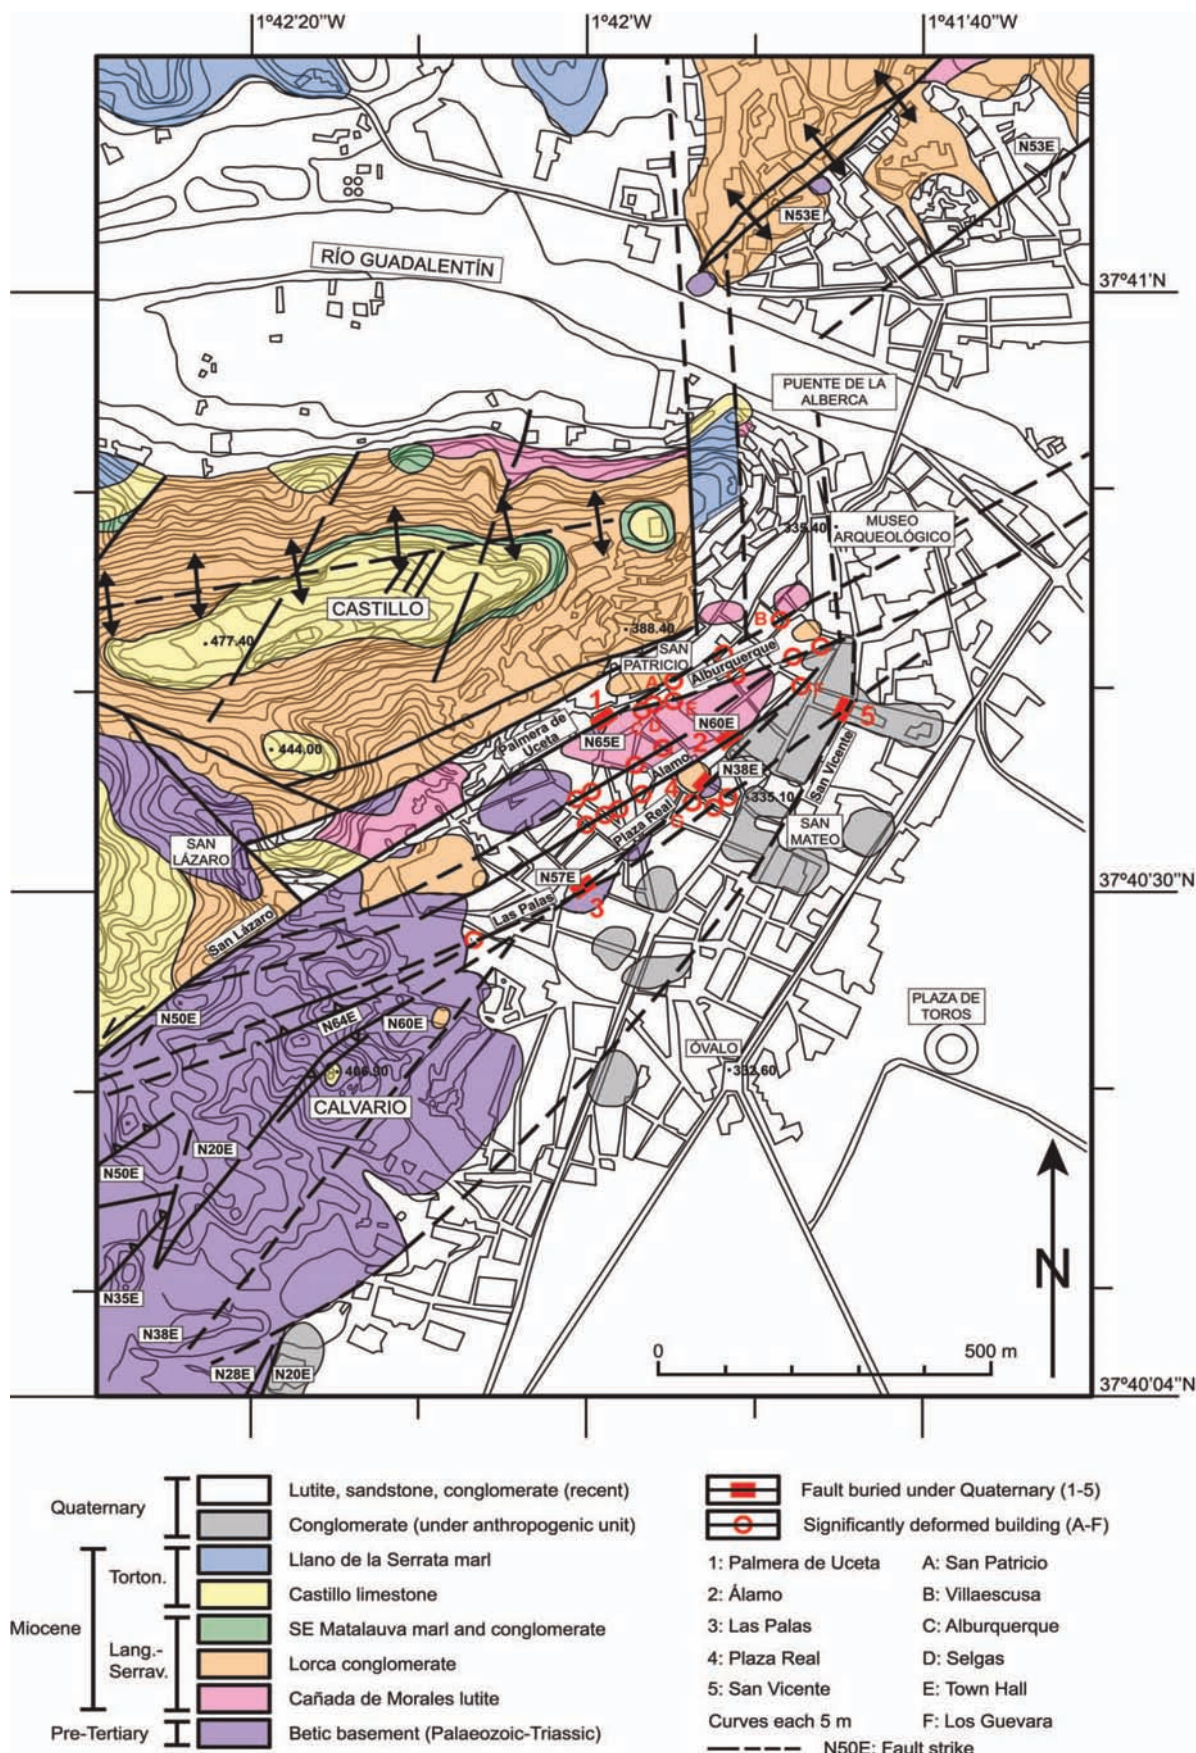
The Álamo fault trace is defined by the reverse fault observed in the Álamo site (point 2 in Figs. 2 and 11). From hypothetical correlation with related buildings, the most important of which is Los Guevara House (point F), we also deduce left-lateral movement in this fault. The facade of Los Guevara House gives  $0.006^\circ/\text{yr}$  and  $1.87 \text{ mm/yr}$  of minimum rate movements (Table I), that should be attributed to the Álamo and Las Palas converging faults. The Álamo fault trace is proposed to divert from the master AMF about 200 m to the SSW of the San Lázaro hermitage ruins (Fig. 11).

**Fig. 11.-** Geological map of Lorca with outcrops in the surroundings of the city and subcrops in the urban area, the latter obtained through archaeological excavations. Circles refer to deformed buildings (A to F) and rectangles to faults seen at excavations (1 to 5). Fault traces drawn in the urban area hypothetically link fault outcrops and deformed buildings. Unit names as in Sanz de Galdeano *et al.* (2012) and García-Mondéjar *et al.* (2014a).
