Failure analysis and repair of the telescopic beam belonging to the spreader of a reach stacker for port operations

Index Terms—Failure Analysis; fatigue; crack; beam; welding procedure.

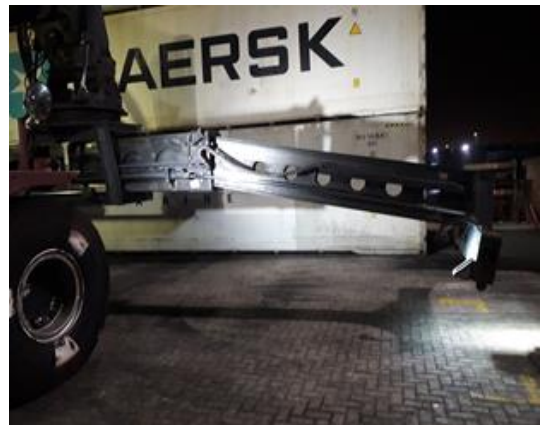
Taking the refrigerated container off the floor when lifting it, the spreader extension was split on the right side (Fig 1).

Fig 1. Fractured Telescopic Beam.

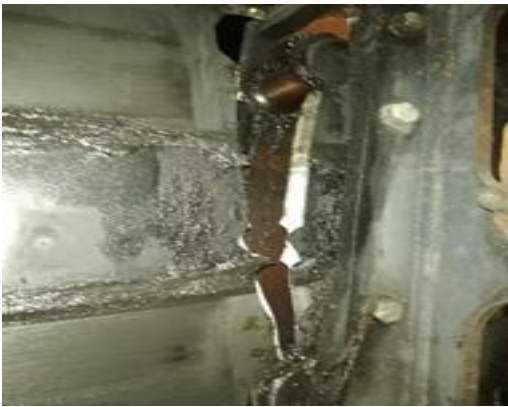
- The fracture occurs in the spreader telescopic system beam when the spreader is in the 40-foot position (Fig 2).
- The fracture begins within the tunnel of the telescopic system (2 inches measured from the outer edge).
- It is evident that the fracture area is not visible when the spreader is open at 40 feet which prevents seeing any defect in the material.
- Cylindrical elements welded along the fracture
- The fissure is presented at 2 inches measured from the edge of the frame (Fig 3).

Fig 2. Fractured area.

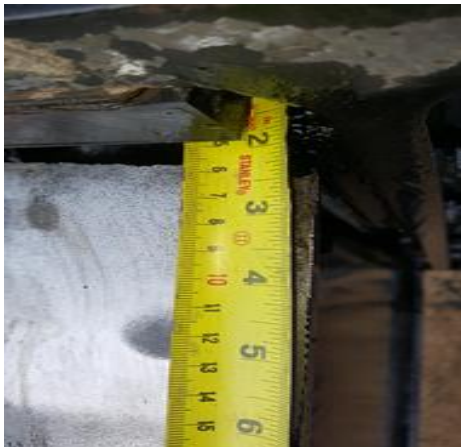
Fig 3. Fissure Length since pin separator to frame.

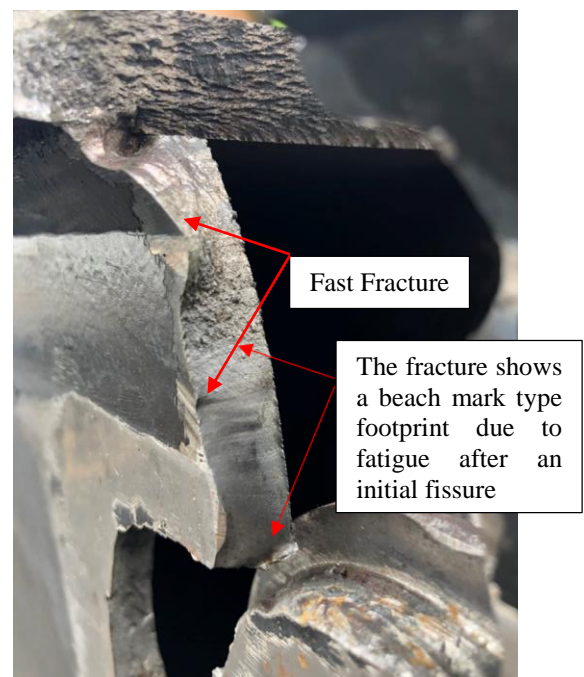
The surface of the blade fracture has beach marks and rapid fracture. Since beach marks spread away from the origin in a series of concentric arches, the site from which the crack originated can be identified by drawing an imaginary radius perpendicular to them” [11]. Therefore, it can be inferred that the fracture originated at the limit between the sheet and the cylindrical separator.

The failure could have been caused by fatigue, the most likely root cause being an inappropriate choice of the type of welded joint used, that is, a poor design. This design is not recommended for dynamic structures.

Sudden fatigue fracture failure is evidenced being nucleated in welding imperfections between the separator pin and the base material sheet. These fatigue cracks that originated in welding could not have been detected during routine inspections since these cylindrical separators are not visible as they are within the central frame of the spreader. Therefore, it should be noted that there is no deficiency in the inspection work (Fig 8).

Fig 8. Fracture surface of the base material sheet, fractography analysis.
