# *Angra B*: the Lead-sheathed Wreck at Porto Novo (Angra do Heroísmo, Terceira island, Azores-Portugal)

KEVIN CRISMAN

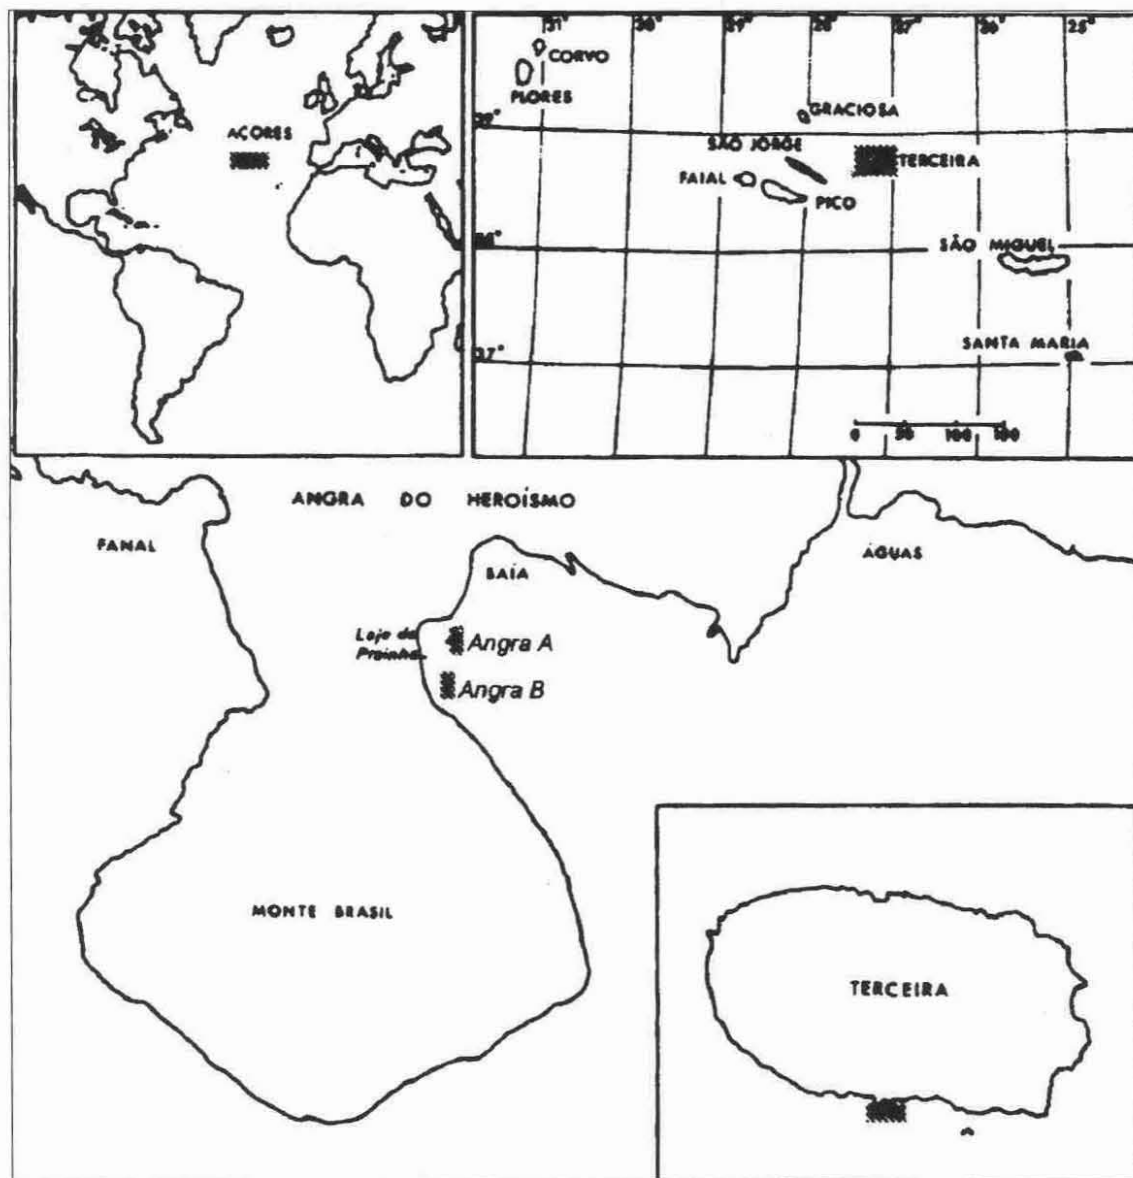
Fig. 1

*Angra B* or the "Lead-sheathed Wreck" is one of the three known wrecks in the Porto Novo area of Angra Bay (fig. 1). The site lies beneath 5 meters of water and is comprised of a stone ballast pile measuring roughly 15 m in length by 11 m in width. A substantial portion of a wooden hull, of approximately the same dimensions as the ballast mound, lies beneath the stones. A second, smaller ballast pile to the north-west of the primary ballast mound suggests that the ship struck the large boulder adjacent to the wreck site and broke in two.

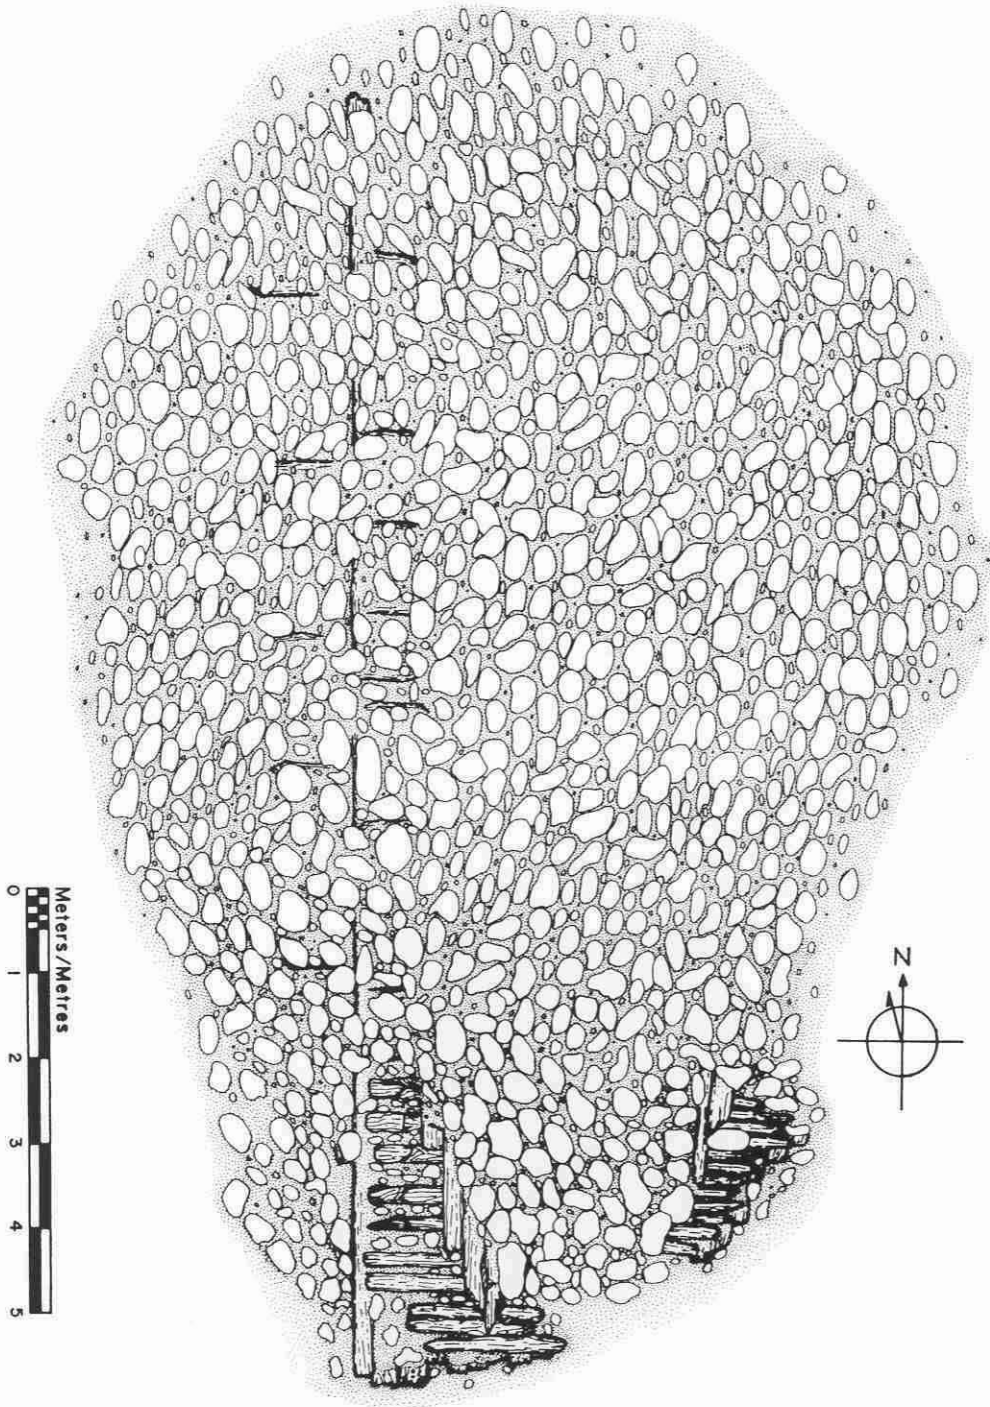
Fig. 2

The extant remains of the keel measure approximately 15 m in length and are oriented along a north-south axis (Fig. 2). The portion of keel exposed by hand-fanning at the southern end of the wreck was 17 cm moulded by 27 cm sided. The timber surfaces were extremely eroded, but indications of a rabbet were apparent about 7 cm below the top of the keel. Bolts or other types of large fasteners for attaching the frames and keelson to the keel were not observed at this time. The exposed section of keel was covered by a soft blue-grey coating that was almost certainly lead oxide produced by the deterioration of lead sheathing. Small nail holes with bits of lead around them could also be seen on the side of the keel.
