Failure analysis of clutch disc in a two-ton truck

DIEGO LEÓN PEREA SALCEDO*

Abstract

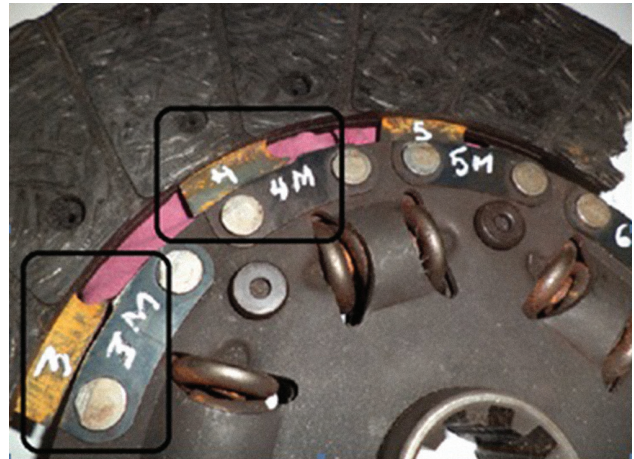
The cushioning plate was transmitting varying loads and presented the fault shown in Figure 3.

Figure 3. Failure parts

- The friction facing (see Figure. 2) not have wear, because likes new, as shows in Figure. 6.
- The broken parts (cushioning plate) are thin sheets of carbon steel, with a lot of oxidation shown in Figure 3.

- The surface finish of the cushioning plate can be improved by blasting.
- It is recommended that when starting a vehicle is made smoothly.
- It is recommended that automotive marketers provide training on the operation to users.
- The Metallography reveals inclusions in the materials.

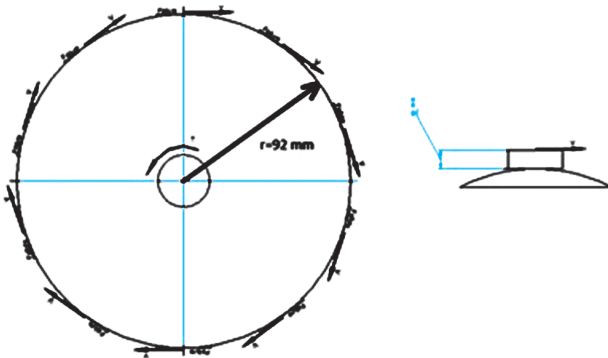
To find the maximum stress on the failure parts, first it finds the shear V. Shows in Figure 5:

Figure 5. Free body diagram

And finally, the safety factor is: $SF = \frac{55}{23.6} = 2.3$ This indicates that the design is good.

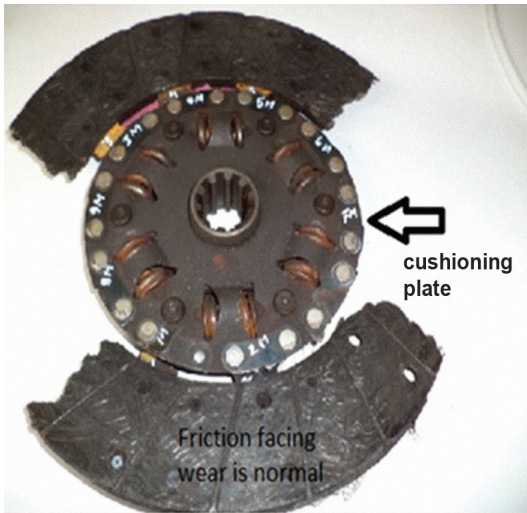
Figure 6. Friction facing

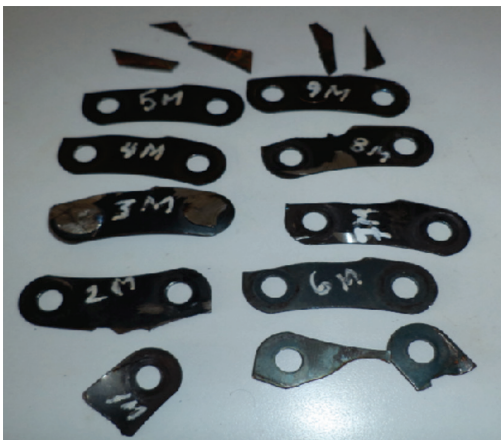
The clutch assembly is dismantled and selected 14 pieces with the presence of failure, shown in Figure 7 and Table 3, for:

Figure 7. Cushioning plate from clutch disc.

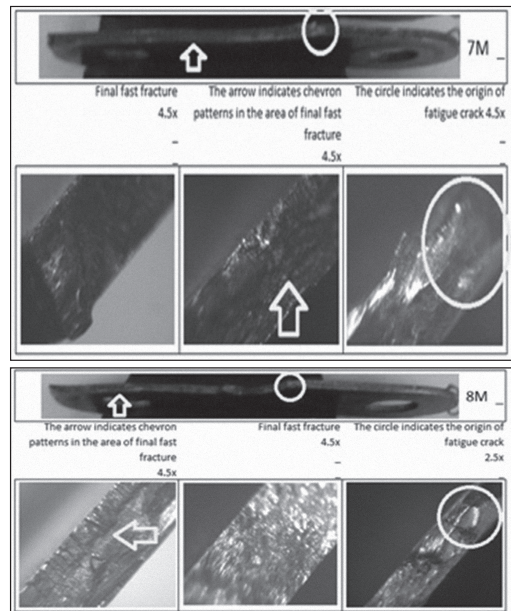
Since this component is very thin (0.95 mm), the beach marks (Avner, 1987) are not well defined, but can see in Figure 8. The end fault zone is very large.

Figure 8. Fracture surface

- The initial failure was presented in cushioning plate by fatigue loads and then was accompanied by a sudden fracture.
- The driver can generate the shock load of ultimate failure.

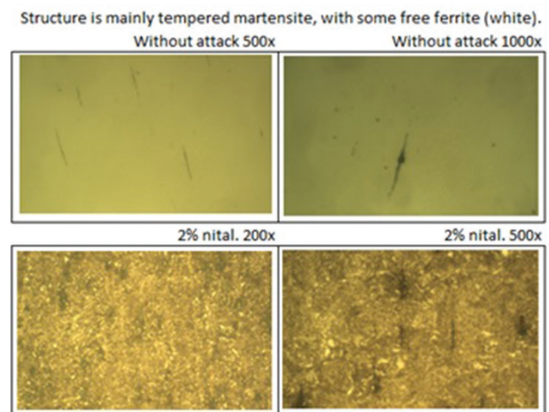
Metallography results reveal that structure is mainly tempered martensite, with some free ferrite (White) as seen in the (ASM INTERNATIONAL, 1992a) and Figure 9

Figure 9. Metallography

According to the results of the Metallography and the hardness of the cushioning plate; the material is hardened 1070 carbon steel according to the Figure 9, Table 5 and (ASM INTERNATIONAL, 1992)
