Definition of the characteristic masonry house for seismic vulnerability assessment in the Historic Centre of Cuenca, Ecuador

David Cajamarca-Zuniga ^{1-2*}, Carlos Julio Calle ^{2-a}, Dorian Marín ^{2-b}, Michael Morocho ^{2-c}

Received: 1/02/2024 | Accepted: 08/03/2024 | Publication date: 6/05/2024
DOI: 10.20868/abe.2024.1.5232

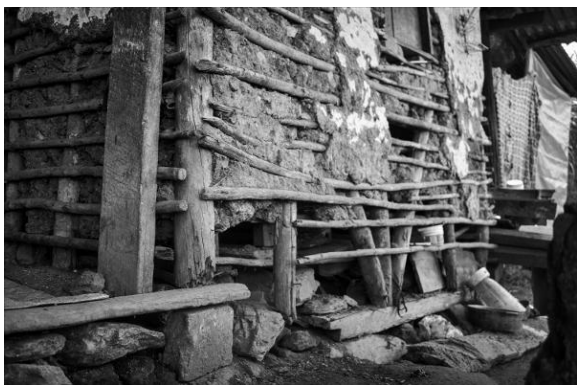
Fig. 1: Regional traditional "bahareque" construction technique.

The analysis of the development of housing construction characteristics in Cuenca reveals that one of the initial building methods employed was dry-stone masonry or masonry with natural stones and mud mortar joints. This was followed by the traditional “*bahareque*” construction method, consisting of wooden frames and reeds (*Phragmites australis*) bound together with ‘*cabuya*’ (*agave fibre*) and filled with fibre reinforced mud with the use of vegetable fibres [14].

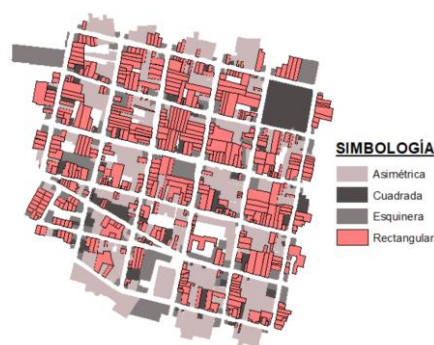
Fig. 5: Number of houses by plan configuration.

As shown in Figure 5, houses with rectangular floor plan configuration (525) are the most representative for this parameter, followed by asymmetrical (301) and in smaller proportion and which do not represent the sample are buildings with "L" shaped floor plans (197) and square floor plans (88).

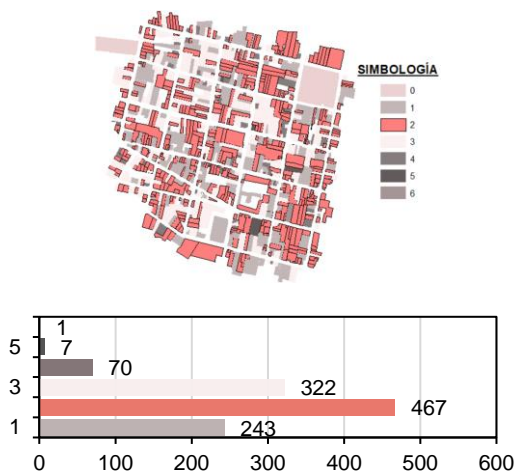
Fig. 7: Number of houses by number of storeys.

Number of storeys: In order to determine the natural vibration period of the structures, it is important to know their height; therefore, the number of storeys of the building is an important parameter to consider. The dwellings in the statistical sample have 2 and 3 floors (467 and 322 respectively). The dwellings with 1, 3, 4, 5 and 6 storeys are smaller in proportion to the required sample and represent 287 buildings and will not be taken into account for the determination of the characteristic dwelling.

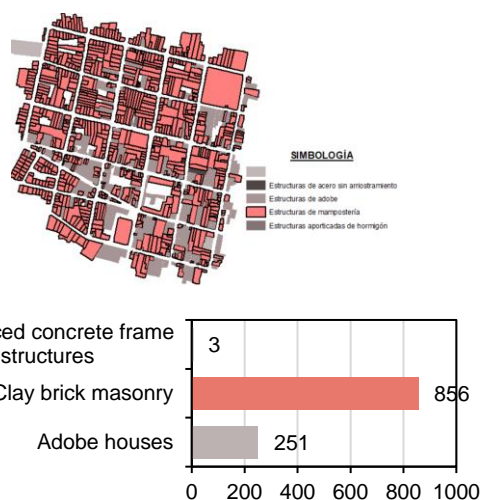
Fig. 10: Number of houses by type of structural system.

Structural system: This is a key parameter for modelling as it depends on the building's structural configuration. This parameter considers the materials that constitute the load-bearing structural elements. The structural system with reinforced concrete portal frames and masonry walls (856) represents the statistical population as it greatly exceeds the minimum sample size (287). The other structural systems will not be studied.

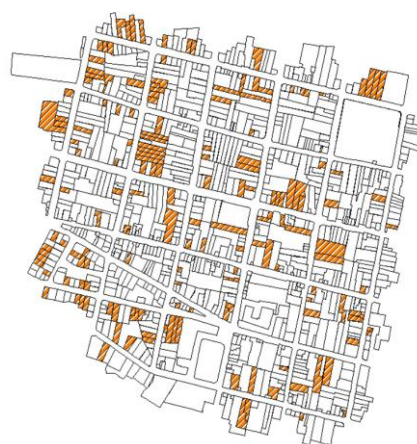
Fig. 12: Group of characteristic dwellings selected based on the most representative variables.

To determine the type of dwelling for the subsequent mathematical model and corresponding seismic vulnerability study, we consider the variables that are statistically representative of the sample universe. On the basis of the minimum statistical sample size, if 287 houses have the same similarity, the variable is considered to be statistically representative. Once the variables have been defined, we identify a group of houses that meet the minimum defined variables. This process was carried out using ArcMap software through a process of overlapping layers. The programme identifies a group of houses that meet the minimum set of parameters and selects only those polygons that meet the minimum criteria (Figure 12).

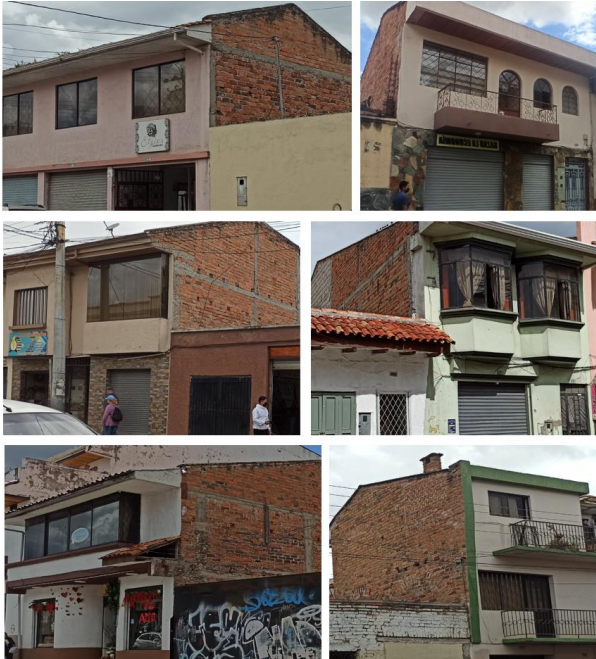
Fig. 13: Samples of houses representing the characteristic clay brick dwelling in the HCC.

The result shows that 164 dwellings of the sample universe meet the minimum established parameters and have the most representative characteristics (Figure 13). From this group of dwellings, relevant configurations and properties are analysed to create a "characteristic masonry house" model. This model further will be the object to the numerical modelling.

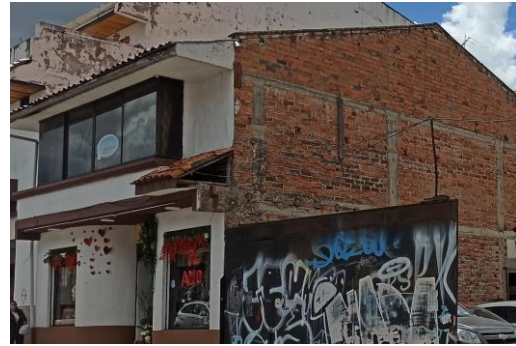
Fig. 14: Samples of houses representing the characteristic clay brick dwelling in the HCC.

From the detailed study of the group of houses with the most representative characteristics, one house was selected. This house was built in the 1980s and consists of 2 storeys, 2 transversal spans, 3 longitudinal spans, a gable roof, concrete columns and beams, ceramic brick masonry walls, rectangular plan configuration, and a façade consisting mainly of openings for doors and windows.

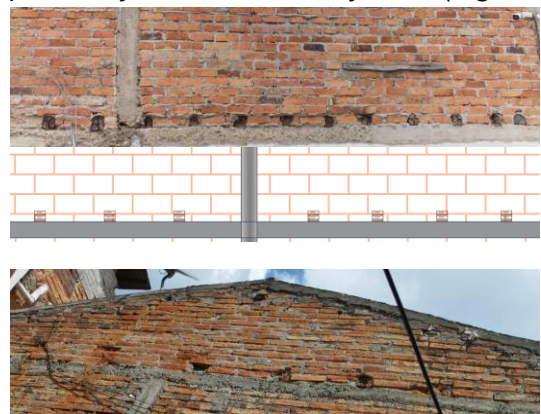
Fig. 20: Timber beams side-embedded in the masonry.

Most of the houses in the historic centre of Cuenca have timber floor structures, made up of 15×15 cm eucalyptus beams supported by concrete side-beams and embedded in the masonry. The roof structure is similar. In this case the bearing eucalyptus beams are supported by the side masonry walls (Figure 20).
