**SIMULATION OF THE 1755 TSUNAMI FLOODING AREA IN THE ALGARVE (SOUTHERN PORTUGAL) : THE CASE-STUDY OF PORTIMÃO**

**Fantina Tedim, João Gonçalves**  
Faculdade de Letras, Universidade do Porto  
fpedrosa@letras.up.pt

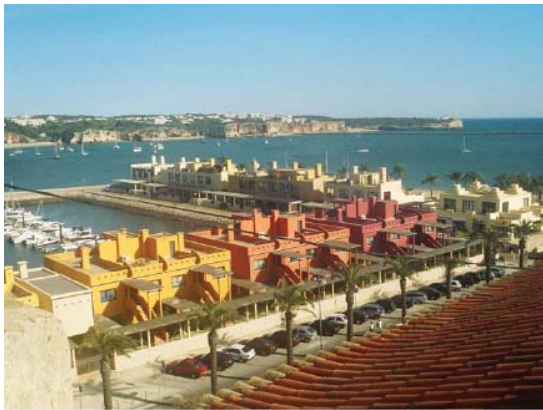
Photo 1 - The vulnerability of these buildings is very high.

We estimate that approximately 5,000 buildings would be affected, many of which would be destroyed or severely damaged, including hotels. However, the vulnerability of the hotel units is highly variable and the units located in the low-lying parts of the city of Portimão would be the most seriously affected. We identified 67 hotels, of which 26 are located in the potentially flooded area (Figure 5). The newest resorts are located in highly susceptible areas, as it is the case of the hotel, restaurants and marina built in the mouth of the River Arade, which would represent the first structure to be struck by the waves of a tsunami (Photo 1).

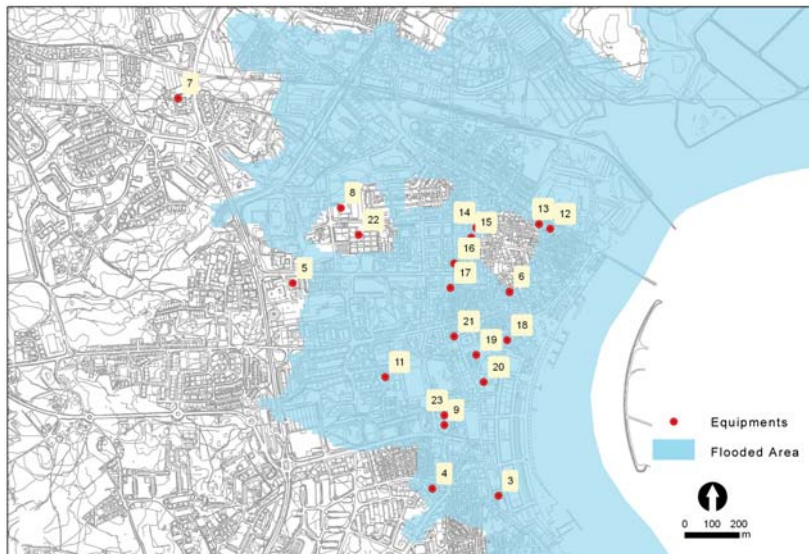
Figure 6- Institutions: 1 - Portimão Private Hospital, 2 - Alvor Health Centre, 3 - Public Health Centre (SSP), 4 - Public Health Centre, 5 - Portimão Misericórdia Hospital, 6 - Red Cross, 7 - National Republican Guard (GNR), 8 - Portimão Volunteer Fire-fighter Association, 9 - Police Force (PSP), 10 - Water and Residues Company, 11 - Prison, 12 - Revenue Payments Office, 13 - Revenue Office, 14 - Civil Registration Office, 15 - Employment Office, 16 - Portimão Local Government, 17 - Cape Verde Consulate, 18 - Sweden/Iceland Consulate, 19 - Criminal Police, 20 - Portugal Telecom, 21 - City Hall, 22 - Graveyard, 23 - Municipal Police, 24 - Aerodrome.

In a disaster situation, the management of rescue means and security forces is essential. From our analysis, it is possible to conclude that in the established scenario the structures of civil protection agents would not be severely damaged (Figure 6). Only the police headquarter is located in a potential flooded area but fire-fighter brigades and other security forces will not be affected.

The aerodrome, important equipment allowing easy access of rescue means or the evacuation of inhabitants, is located in freguesia de Alvor in an area easily affected, since it is located at a height of 5 metres and on the bank of the Alvor River, up which the tsunami would advance.

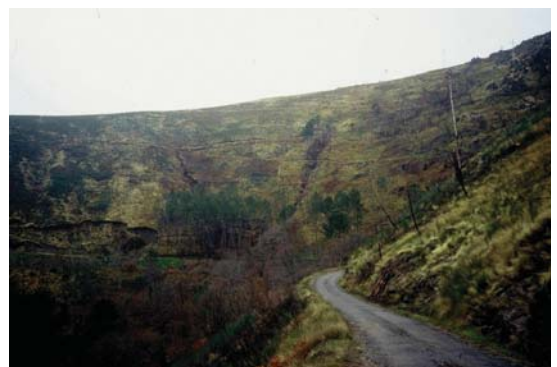
Photo 1 - Schist slope regularised by Quaternary deposits.

recent Quaternary and which were caused by the freeze/thaw action. As such, they correspond to colder climates, which are responsible for a very rapid evolution of the slopes (Photo1).

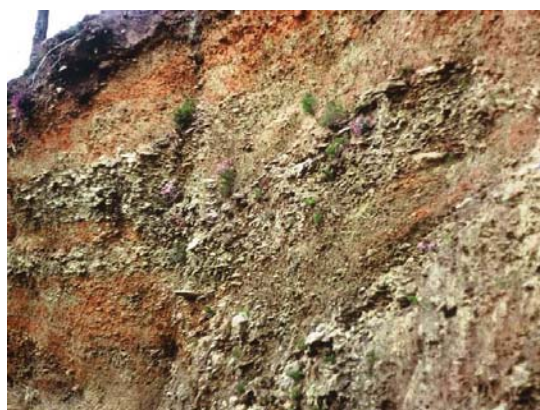
Photo 2 – Stratified slope deposit near Campanhó, where it is possible to observe paleogullies.

The analysis of these deposits demonstrated that the main process of transportation along the slopes was the action of the ice – gelifluction, further proved by the existence of coiffes (VALDES, 1984). Other processes such as the action of gravity are, however, not to be ignored. The study of the stratified slope deposits does not exclude the possibility of other movements such as debris flows at least in some parts of the slopes.

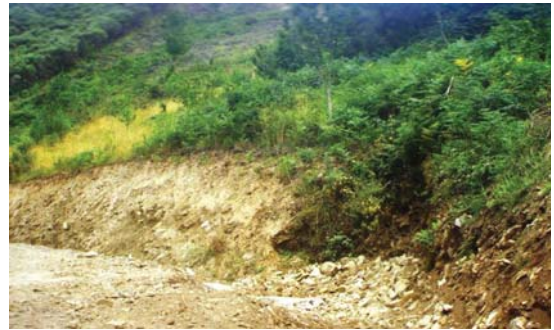
Photo 3 – Tardiglacial deposit regularising great part of the slopes of the Serra do Marão.

It is possible to find a great heterogeneity in the Tardiglacial deposits, which depends on the exposure of the slopes, on their rock substratum and on their inclination (PEROSA, A., 1994b; MARTINS, 1999); but the fundamental factor must have been the snowfall during a part of the year and its thawing in the warmer period, which was probably the time of the heaviest rainfall. The most important processes must have been the solifluctions which were responsible for the regularisation of a great part of the slopes as well as the occurrence of slides especially extensive debris flows, whose marks can still be traced on the bottoms of the valleys (Photo 3).

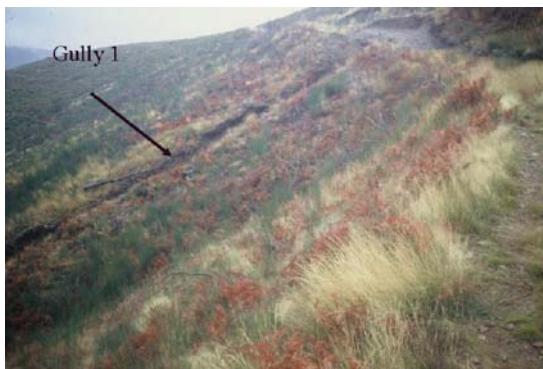
Photo 4 - Gullying in the area of Paradela do Monte.

In July 1992, on a slope near the village of Paradela do Monte (municipality of Santa Marta de Penaguião) there was a very heavy shower. Unfortunately, it is not recorded, owing to the small geographic extension of the area on which it rained and the non-existence of pluviometers, but it is estimated to have reached values very nearly 30 mm while it lasted (about 1 hour); in consequence, two big gullies appeared (Photo 4).

In July 1991 there had been a fire which had completely destroyed the vegetation covering that slope. Due to the altitude and the inclination of the slope ( $30^\circ$ ), the growth of new vegetation is rather slow. The whole slope is regularised by a deposit which in some places is more than 2 meters thick. More or less in the middle of the slope two tracks were opened on the slopes to lay a system of waterpipes. This was the background in which the slope gullying began. At first the runoff flowed along one of the tracks and formed gullies. Later the drainage stopped flowing along the tracks, turned in the direction of the steeper incline and formed two gullies whose depth is clearly conditioned by the depth of the deposit which regularises the slope. As soon as the water reached the schists in situ the gully thalweg could not become deeper; it became wider and the water transported the slope material which was not well consolidated. One of them deepened a pre-existing gully while the other developed at first parallel to a small valley that existed on the slope, later using only its final part; as a consequence, its thalweg became deeper.

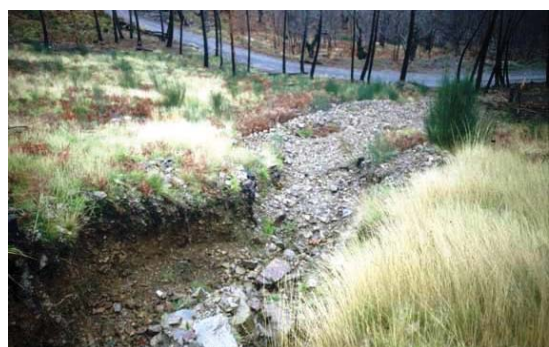
Photo 5 - Detail of the material deposited in the slope after gullying.

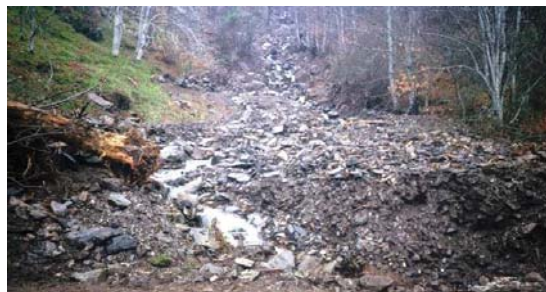
Photo 7 - Another detail of the debris flow in Póvoa da Serra.

In 1992 several debris flows occurred in consequence of a long period of precipitation (A. Pedrosa, 1993); they happened near the villages of Montes e Póvoa da Serra, whose slopes are steep and covered with trees; but the fundamental reason was the fact that they were regularised by deposits (Photos 6 and 7).

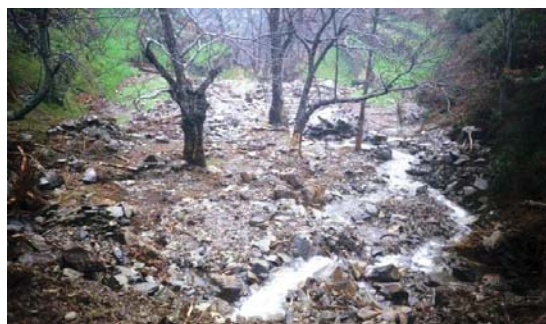
Photo 6 - Characteristics of the debris flow of Póvoa da Serra.

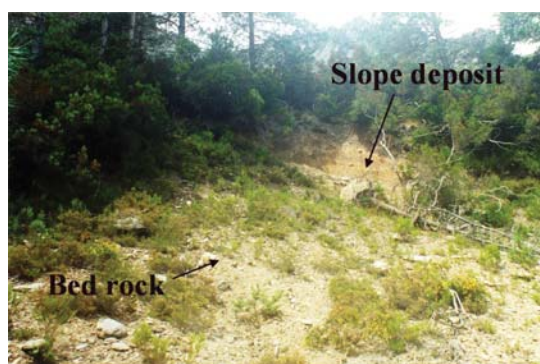
Photo 8 - Detail of the place where the debris flow of Portal da Freita began, whose failure is clearly related with the contact of the deposit with the bedrock.

Later, in 1997, after a few very rainy days, some more debris flows occurred in slopes with the same characteristics as those already described. This is the case of Portal da Freita (Photo 8) and of Carvalhada de Baixo (Photo 9) both near the village of Montes.

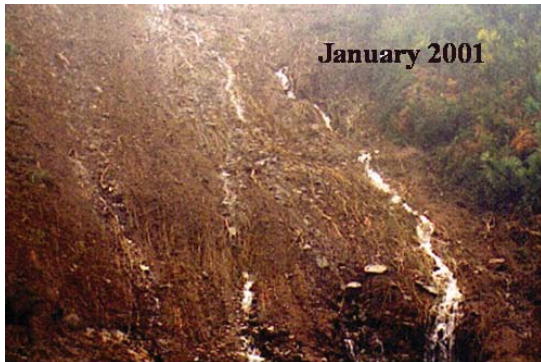
**Photo 10** – Location of the occurrence of the debris flow of Volta Grande which affected road N101 and dragged two cars causing one death among the car occupants.

The one that had the most serious consequences happened place near Mesão Frio (Volta Grande) (Photo 10). It reached road no N101 (Amarante – Peso da Régua), dragging two cars that were driving along it and causing the death of one of the drivers. This example shows clearly the risk of building roads on the foot of slopes with the characteristics that have been described because processes of rapid change in the characteristics of the slopes often occur in these circumstances, leading to a greater instability of the regolith materials that regularise the slope.
