APPLICATIONS OF INNOVATIVE COMPOSITE MATERIALS FOR SEISMIC STRENGTHENING OF MASONRY STRUCTURES

FRANCESCO MICELLI

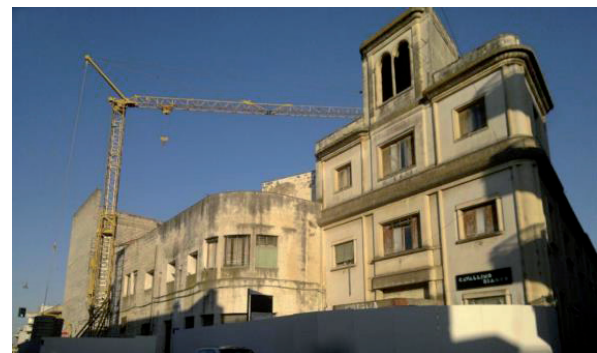
Figure 1. General layout of the building.

The building object of study is the cinema/theatre “The White Little Horse” in South of Italy, which was built after the II world war (starting of the theatre activities in 1949) and consists of three adjacent building systems with different roof levels (see figure 1):

1. The foyer
2. The auditorium.
3. The tower that houses the stage.

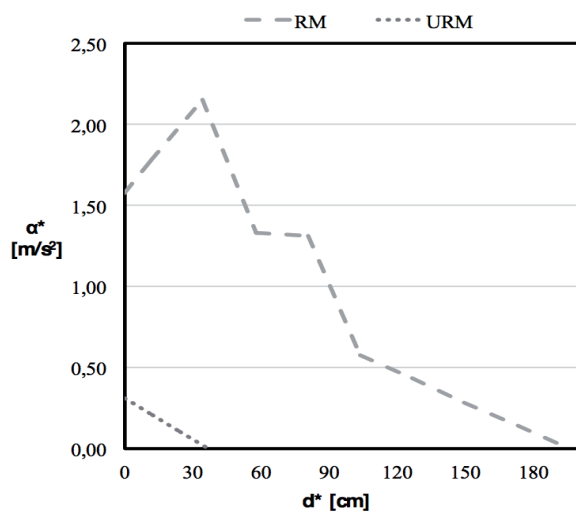
Figure 8. Capacity curve of the Un-Reinforced Masonry (URM) and of the Reinforced Masonry (RM)

In figure 10 the capacity curves of the unreinforced and reinforced wall (URM and RM respectively) are compared. The centroid of the wall was chosen as control point. It is evident the different shape of the two curves: linear or pseudo linear for the unreinforced wall and segmented for the reinforced one. In both cases the first point of the curve, relate to the 0 displacement, is calculated as in the linear analysis because the initial value of a_0^* represents the minimum acceleration required to make the overturning start.

The importance of the FRP wire installation is immediately underlined by this value, which appears three times more for the RM with respect the URM. In a first range of displacement, eligible between 0 and about 30 cm, different behaviour is observable. The URM required gradually less acceleration with the increase of the rotation because the most is the deformation the most is the vulnerability. On the other hand, the RM shows linear proportion between the acceleration and the displacement due to the passive confinement action, which increases in relationship with the displacement that stresses the ropes. This trend continues until a certain value after that the inclination change. This critical point corresponds to the failure of the top rope. The wall overturning continues causing the failure of the remaining FRP ropes until the ultimate displacement is reached and the kinematics bring the structure to collapse. The maximum horizontal displacement the centroid of the wall can support was at least six times more for the RM with respect the URM.

The comparison in term of energy is also representative because the area underlying the capacity curve of the URM is entirely included in the area underlying the RM ones, and it is of relevance since these areas represent the absorbed energy under seismic

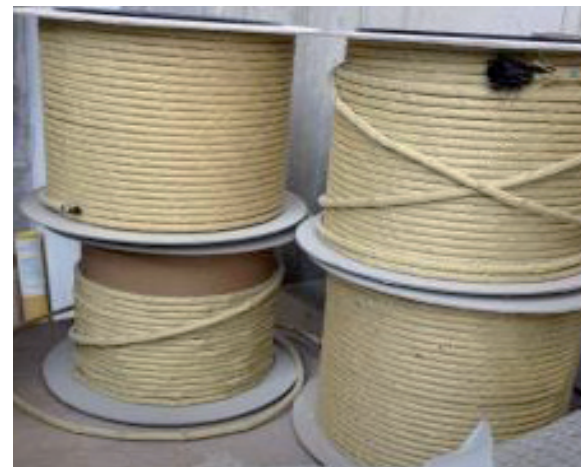
FRP material remains elastic until rupture so the efficiency of using this material increase with the increase of the deformation of the element which the FRP is acted to counteract. Carbon fibres are not prone to creep as same as steel that is commonly used for tendons in masonry, and they not require protection against galvanic corrosion. A 40 kN pre-stress force was designed in order to make the wires to perform as active ties from the beginning. The intervention regards the walls of the tower, which appear vulnerable due to its high slenderness (see figure 9).

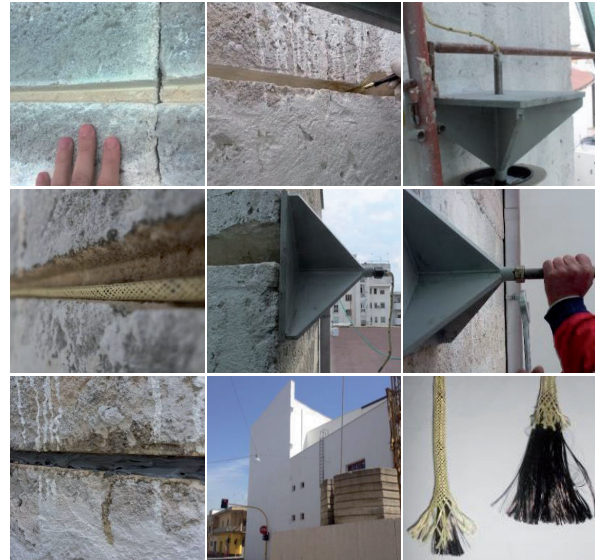
Figure 10. Process steps (1-11) and detail of the CFRP wire.

The strengthening process is listed in the following and is illustrated in figure 10:

- Cutting the surface in order to derive an engraving depth of about 25 mm to allow the housing of the cable and the subsequent adhesion by means of epoxy paste.

- Cleaning of the surface obtained after cutting by dry blowing.
- Laying of a layer of epoxy primer with low viscosity on the wall surface machined in order to avoid additional dusting of stone parts and, at the same time, to create a substrate chemically affine to the next thixotropic resin bonding.

- Housing of the ends of the rope reinforcement in the sleeves metal terminals that have to be clean, perfectly dry and free of any residue of mechanical processing.

- Bonding of the sleeves through structural epoxy resins with low viscosity and rapid curing.
- Manual stringing of the FRP rope in the wall incision reported in point 1.

- Positioning of the anchoring plates by means of temporary works such as to prevent the fall of the same.
- FRP ropes pre-stress.
- Bonding of the stretched cable to the wall by injecting epoxy thixotropic and subsequent regularization of surface by manual means (spatula).

- Restoring the finish wall by mortar made of powder of the same stone.
- Laying of any plaster and finishing layers.

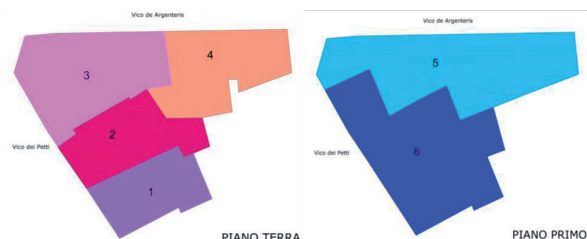
Figure 11. Masonry building - construction steps.

The figure 11 shows by numbering the different construction phases; the different steps of construction started in 1650 and ended in 1836 according to the collected information.

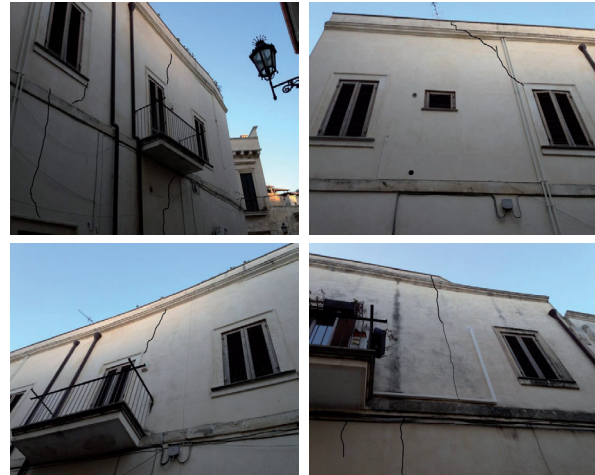
Figure 13. Cracks on the external walls.

The lack of connection between the different construction blocks and the presence of the thrusts, in conjunction with settlements that were present along the centuries, generated cracks along the masonry walls that needed to be analyzed and contained. Another problem was also discovered in the vault at ground floor in apartment 2 (see figure 11), in which the mortar between joints was reduced to dust, and thrusts of the vaults was reduced, by causing extensive cracks along the vault surface. In figure 12 the cracks in the mentioned vaults are sketched. In figure 13 the cracks in the external walls are illustrated.

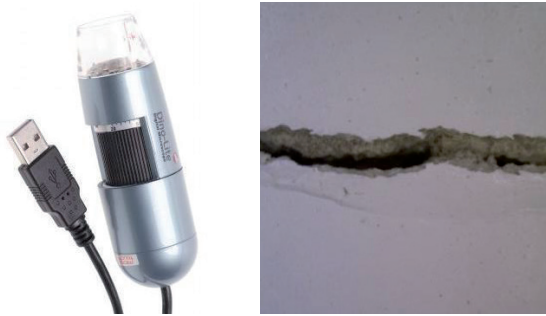
Figure 16. Digital microscopy lens – typical crack image 60 x.

A campaign of structural monitoring and testing was organized and performed. Different aspects were studied, since different purposes emerged from the first analysis of the building. A ground penetrating radar campaign was performed to know the presence of possible cavities and voids along the foundations line (figure 14). An additional ground penetrating radar scan was performed to know the internal geometry and possible discontinuities along the cracked vault at the ground floor (figures 12 and 14). Crack monitoring was performed within a period of 12 months by using visual crack-gauges (figure 15) and a digital microscopy device with magnification factor up to 250 x (figure 16).

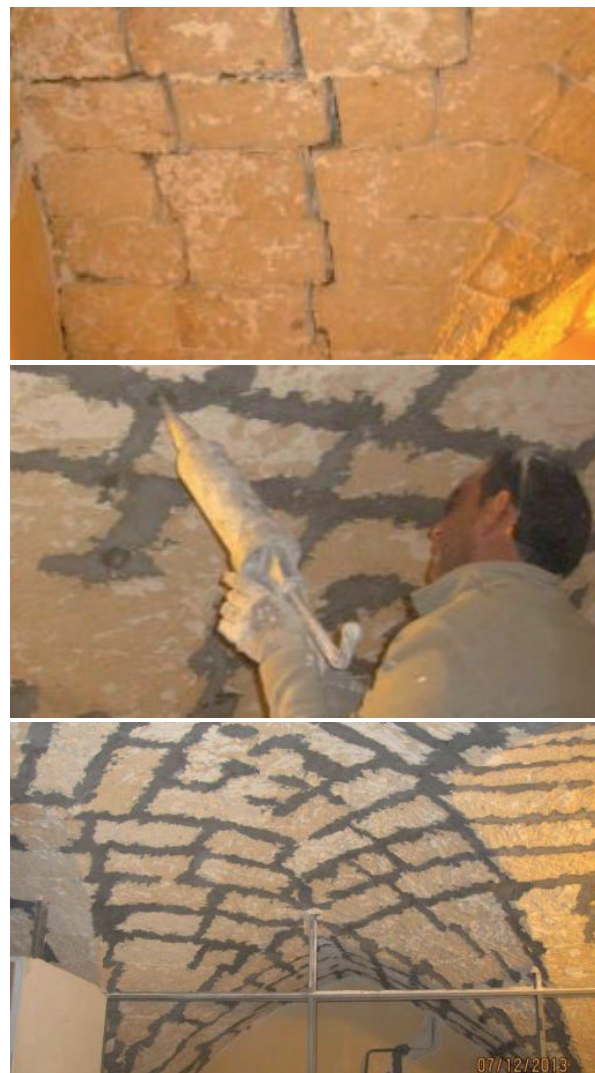
Figure 17. Injection of mortar at the vault intrados. a) before strengthening b) strengthening c) after strengthening.

A cementitious mortar was injected in order to create a renewed stiffness of the vault, controlled viscosity and special valves were use to avoid the mortar to come out form the masonry shell. This strengthening phase is illustrated in figure 17.

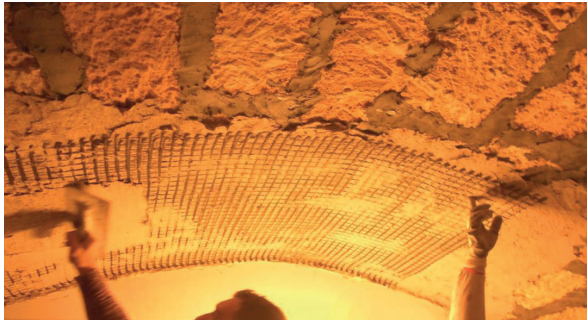
Figure 18. Installation of FRCM glass fiber system.

After the injection of the mortar a monolithic vaulted structure was achieved, allowing to increase the stiffness and to develop the compression forces between the masonry blocks that were disconnected due to the loss of the mortar joints. Then a glass fiber net was bonded with mechanical anchorages along the intrados of the vault. Alkali resistant glass fibers were used to increase the durability of the materials, the dry fiber mesh 0/90° had a density of 220 g/m². A cementitious mortar was used as matrix and bonding agent, thus an FRCM (Fiber Reinforced Cementitious Mortar) system was installed, as visible in figure 18.

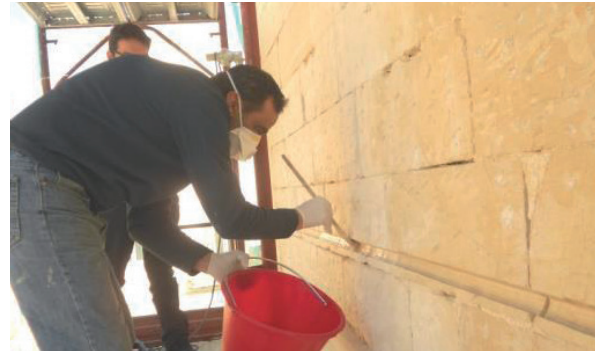
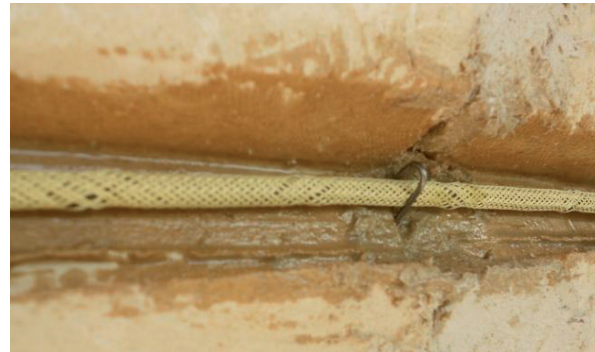
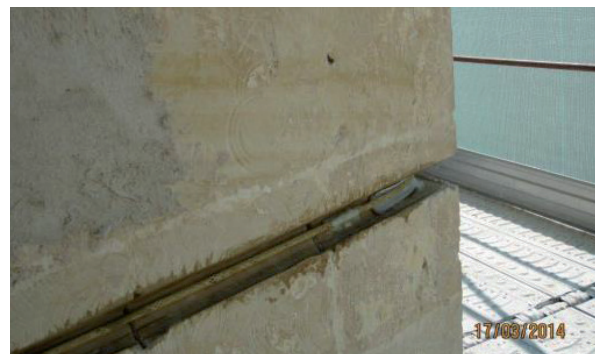
Figure 20. Application of the CFRP pre-tensioned wires.

figure 20 illustrates the strengthening phases, which are the same as followed for the case study 1 of the present paper. figure 21 illustrates how the design pre-tensioning load was controlled by measuring the elongation of the wire through the advancement of the screwed terminal region outside the steel anchorage.

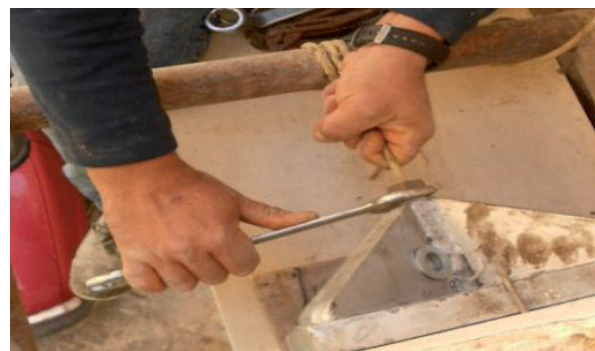
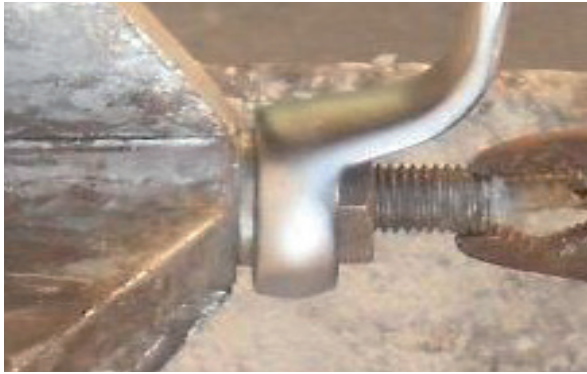
Figure 21. Controlled pre-tensioning and anchorage of the CFRP wires.
