# Changes in land cover in coastal erosion hotspots in the southern Caribbean of Costa Rica during the period 2005-2017

**Luis Sandoval-Murillo<sup>1</sup> • Gustavo Barrantes-Castillo<sup>1</sup>**

Received: Jan/27/2020 • Accepted: Sep/6/2020 • Published: Jul/31/2021

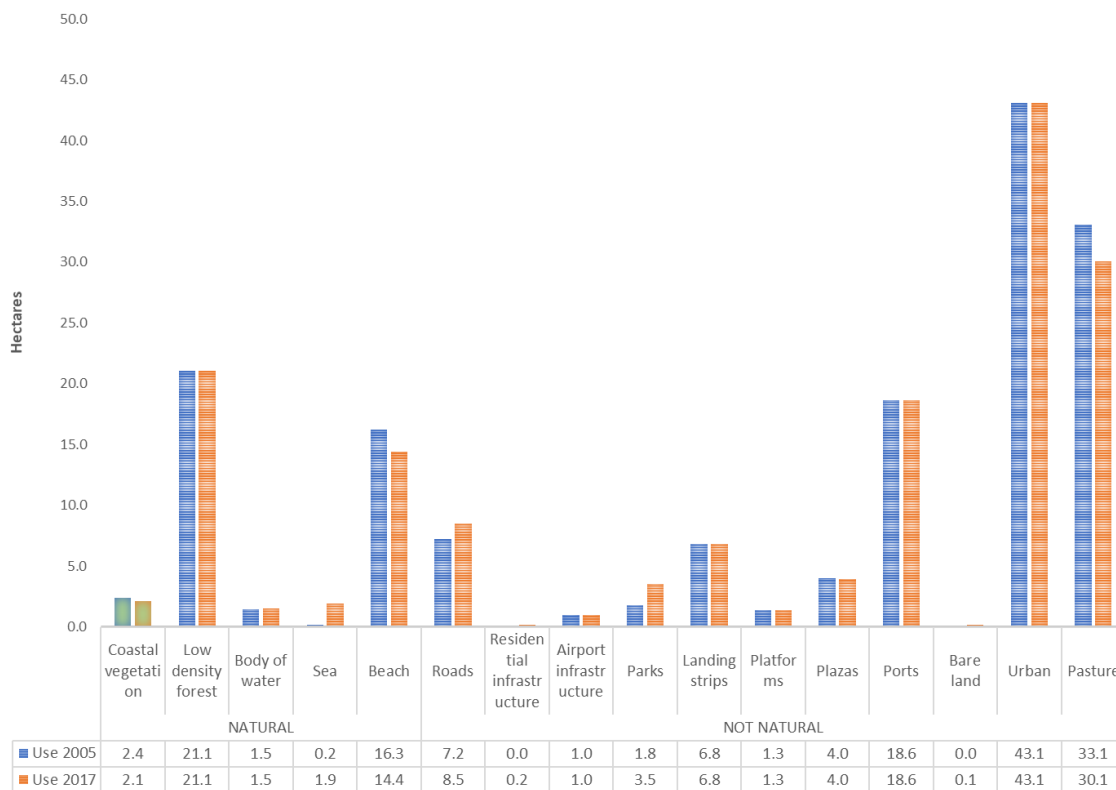
**Graph 1. Cieneguita–Airport Sector: Land cover 2005 – 2017 period.**

In the Cieneguita-Airport sector, natural cover in 2005 consisted of: low density forest (21 ha), coastal vegetation (2.41 ha), body of water (1.45 ha), sea (0.18 ha) and beach (16.25 ha). An analysis shows significant changes in the surface areas of the beach and sea categories, with total beach area decreasing by 1.84 ha and the total area of the sea increasing by 1.76 ha. From these data it is possible to conclude that most of the beach loss is related to an advance of the sea towards land (Figure 3 and Graph 1).

Source: Prepared by the authors based on land cover data 2005 - 2017, generated during the investigation.

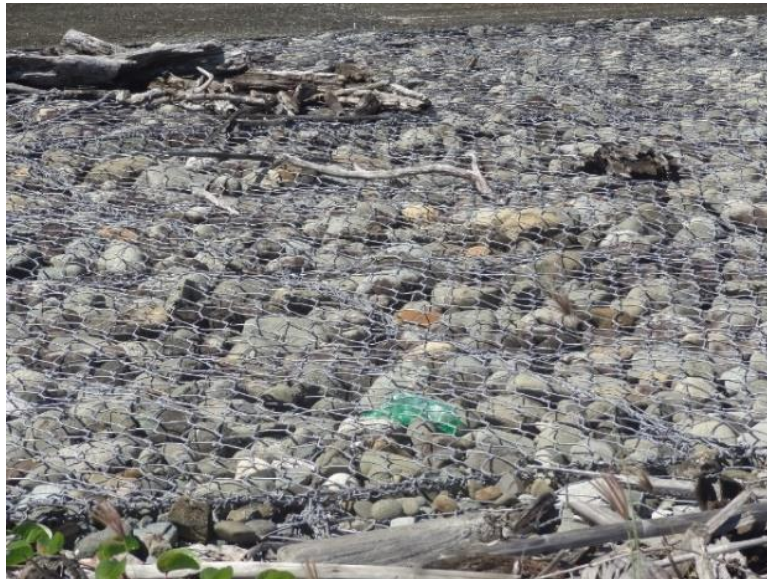
From the data provided by Barrantes et al. (2020) it is estimated that the erosion rate in this sector for the 2005 – 2016 period was 0.39 ha / year, which is reflected in the data presented here and in the construction of mitigation measures to protect the exposed works (Figure 2), as well as the placement of a stone dam to protect the Cieneguita bike path.

Figure 2. *Airport Sector: Installation of gabions.* Taken in the field on December 6, 2017.

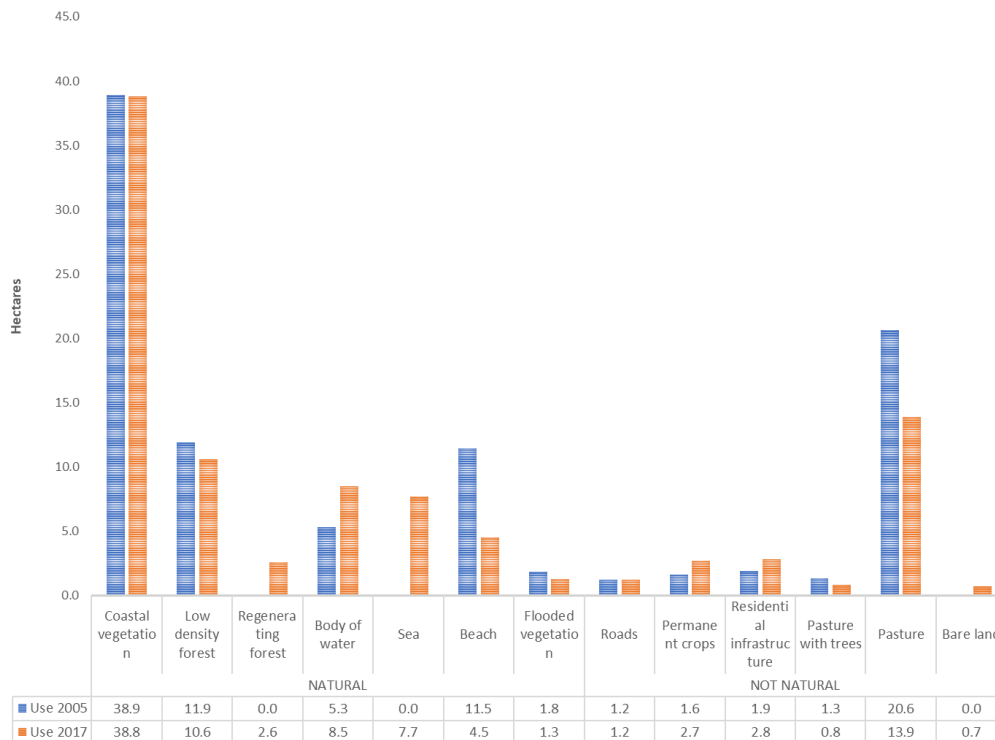
**Graph 2. Westfalia Sector: Land cover during the 2005 – 2017 period.**

In the case of non-natural types of land cover, there was an increase in permanent crops, going from 1.6 ha (2005) to 2.7 ha in the year 2017, while residential infrastructure, which covered an area of 1.9 ha in the year 2005 and 2.8 ha in the year 2017. However, it is important to highlight the pasture reduction by 6.7 ha during the study period, which primarily changed to the sea (figure 4). This retreat of pastures and beaches is in accordance with what was reported by [Barrantes et al. \(2018\)](#); from their data, the erosion rate in the sector is estimated at 0.56 ha / year, higher than in the case of Cieneguita-Aeropuerto, which according to these same authors is due to the migration of the mouth of the Banano River during the study period.

Source: Prepared by the authors based on land cover data during the 2005 – 2017 period, generated during the investigation.

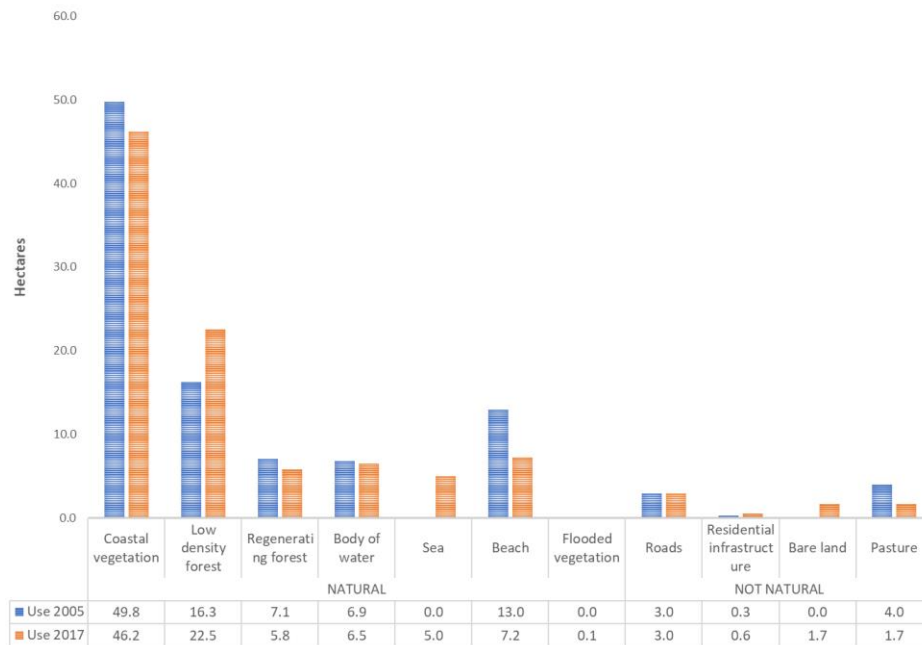
**Graph 3. Bananito Sector: Land cover during the 2005 – 2017 period.**

For natural land cover in the Bananito sector in the year 2005, coastal vegetation cover predominated with a total area of 49.8 ha, followed by low-density forest (16.3 ha), and beaches with 13 ha (Graph 3). All natural surfaces showed a reduction during the study period except for low-density forest, which increased from 16.3 ha in 2005 to 22.5 ha in 2017, with the increase occurring mainly behind the coastal road (towards the land) (Figure 6). In the case of the beach category, its area decreased by 5% (5 ha), a change which was associated with the dynamics of the mouth of the Bananito River. With regard to anthropic activities, there was a slight increase in residential infrastructure, from 0.3 ha in 2005 to 0.6 ha in 2017, while the area covered by road infrastructure remained constant (Graph 3).

Source: Prepared by the authors based on land cover data during the 2005 – 2017 period. generated during the investigation.

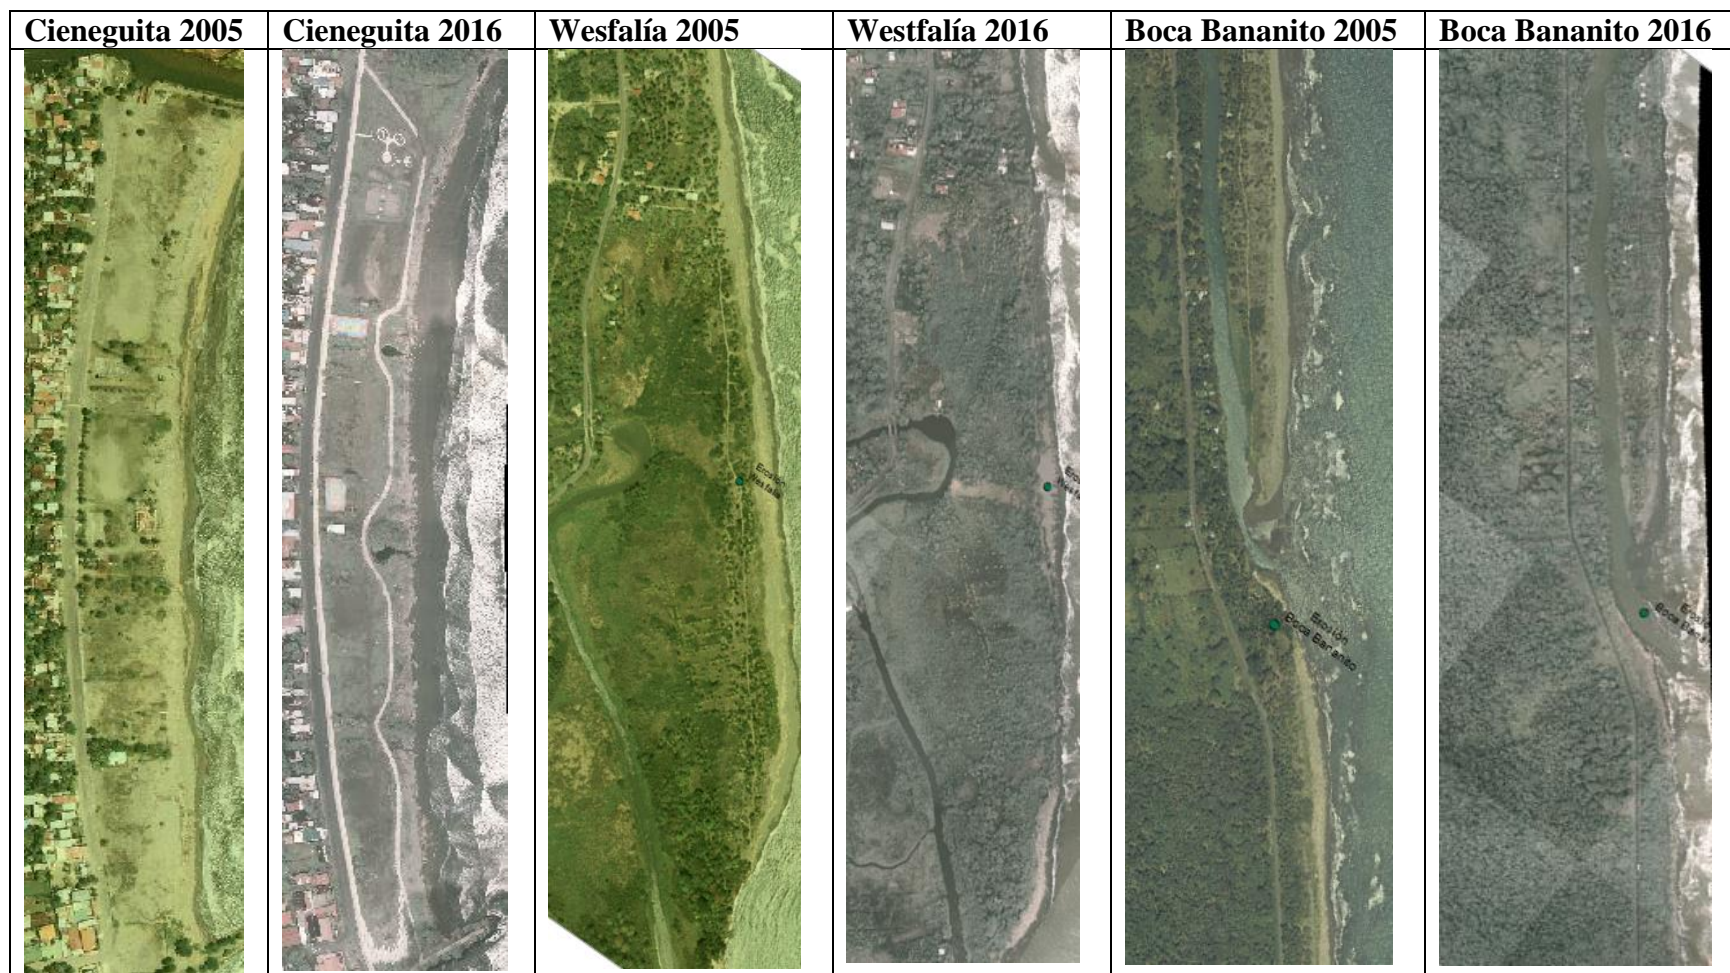
Figure 5. Changes in land cover according to aerial photography 2005 - 2016. Made from a mosaic of orthophotos from 2005 at a scale of 1: 5 000, with a spatial resolution of 0.5 meters (from the National Registry), 2) Orthophotos from 2016 at 1: 1 000 scale, with a spatial resolution of 0.1 m (property of the National Emergency Commission (CNE)).

According to [Barrantes et al. \(2020\)](#), changes in the mouth of the Banano River are important in this sector, since the direction of coastal currents in the Caribbean ([Lizano, 2018](#)) caused erosion of the left bank of the river mouth and accumulation of sediments on the right bank, leading to the reinforcement of the road to prevent its destruction. As a result of these changes, coastal vegetation, bare land and beaches decreased in area as the area covered by sea increased (Figure 6). However, beaches also decreased in area as a result of increases in the coastal vegetation that grows on the sandy bar north of the river mouth (Figure 5).

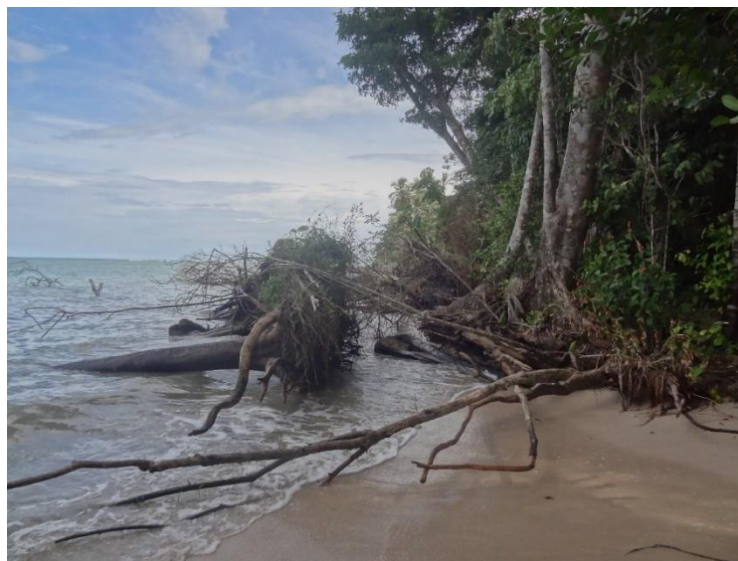
*Figure 7. Cahuita-Puerto Vargas Sector: Forest cover affected by coastal erosion.*  
Taken in the field on December 6, 2017.

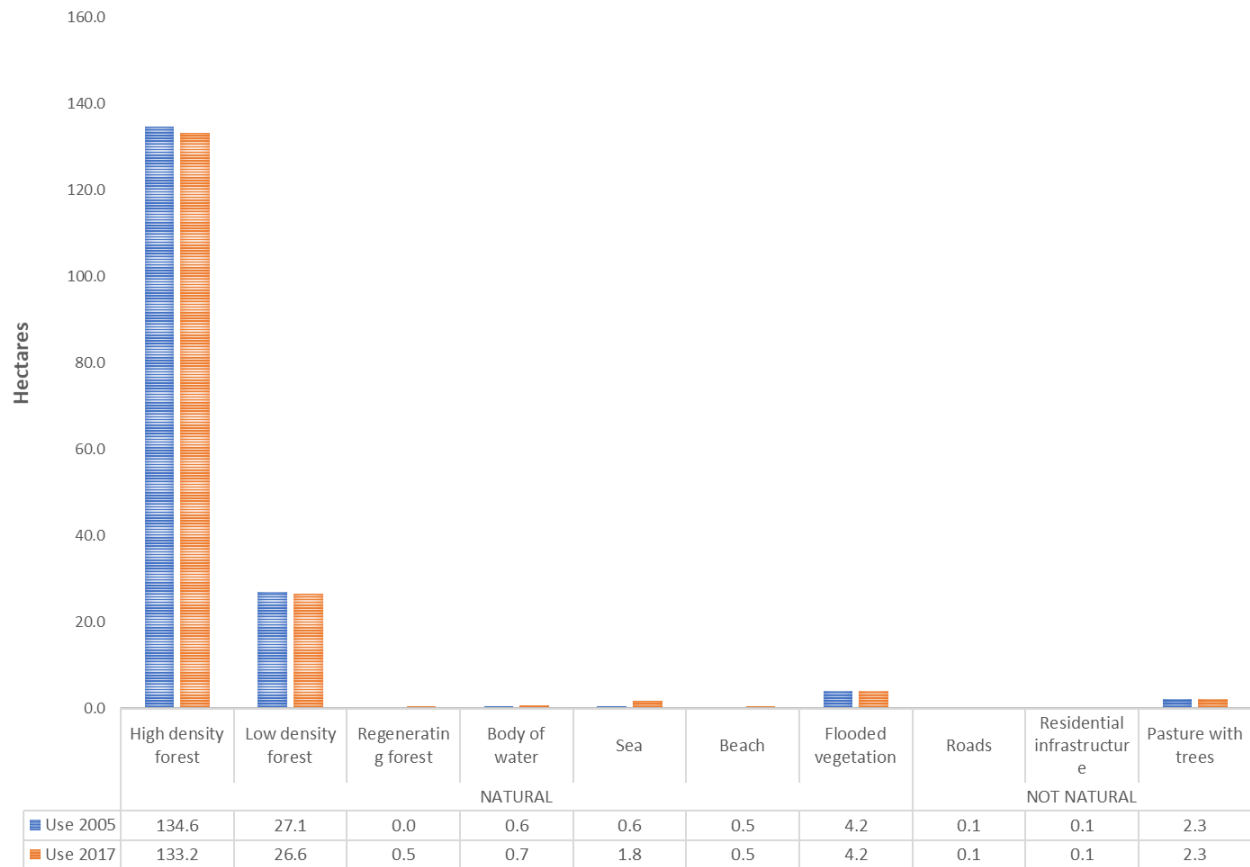
**Graph 4. Cahuita-Puerto Vargas Sector: Land cover during the 2005 – 2017 period.**

As can be seen in Graph 4, the area of residential infrastructure increased slightly, going from 0.084 ha to 0.129 ha. It is important to emphasize the impact of severe waves on infrastructure, which led the park administration to relocate its house and office, as can be seen in the remains left where the old building was located; likewise, sections of the trail within the park disappeared, which led to its relocation (Soto, 2014). According to the data presented by Barrantes et al. (2020), the average erosion rate in the sector is estimated to be 0.46 ha / year, a figure that is considered intense.

Source: Prepared by the authors based on land cover data during the 2005 – 2017 period, generated during the investigation.

Land cover for the Cahuita-Puerto Vargas sector is characterized by the predominance of natural cover throughout the study area. As can be seen in Graph 4, the area covered by high-density forest decreased by 1.4 ha during the study period, while the area covered by low-density forest decreased by 0.5 ha. Most of the decrease in high-density forest is due to increases in the area covered by the sea, showing an accelerated retreat of the shoreline in this sector (Barrantes et al., 2018) (Figure 7). On the other hand, there was a slight increase in the area occupied by beaches (in 0.1 ha) which, according to Barrantes et al. (2018) is the result of the accretion (growth of beaches and other forms of coastal accumulation) of a small segment of beach located to the northeast of the point of greatest erosion (Figure 8).

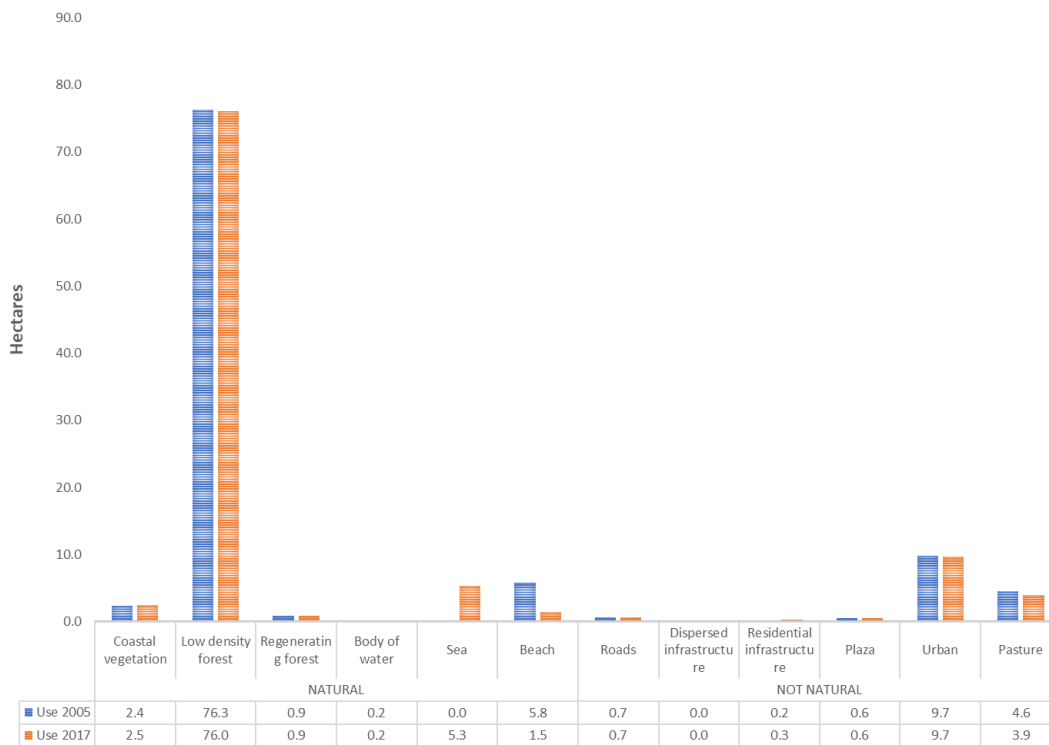
**Graph 5. Manzanillo Sector: Land cover during the 2005 – 2017 period.**

The distribution of land cover in Manzanillo shows a predominance of natural cover: 85.6 ha in the year 2005 and 86.4 ha in the year 2017. As shown in Graph 5, there was a significant increase in the area occupied by the sea at the expense of areas of low-density forest (0.08 ha), areas of natural regeneration (0.04 ha), and, most notably, beaches (4.2 ha). The area covered by beaches shows a significant decrease between 2005 and 2017, going from 5.8 ha to 1.5 ha, as the area covered by the sea increased substantially (4.1 ha), and the area covered by coastal vegetation increased slightly (0.29 ha ) (Figure 9). An average erosion rate for this sector of 0.12 ha / year was estimated based on the data presented by (Barrantes et al. 2020), which is considered to be mild, due to the size of the sector.

Source: Prepared by the authors based on land cover data during the 2005 – 2017 period, generated during the investigation.

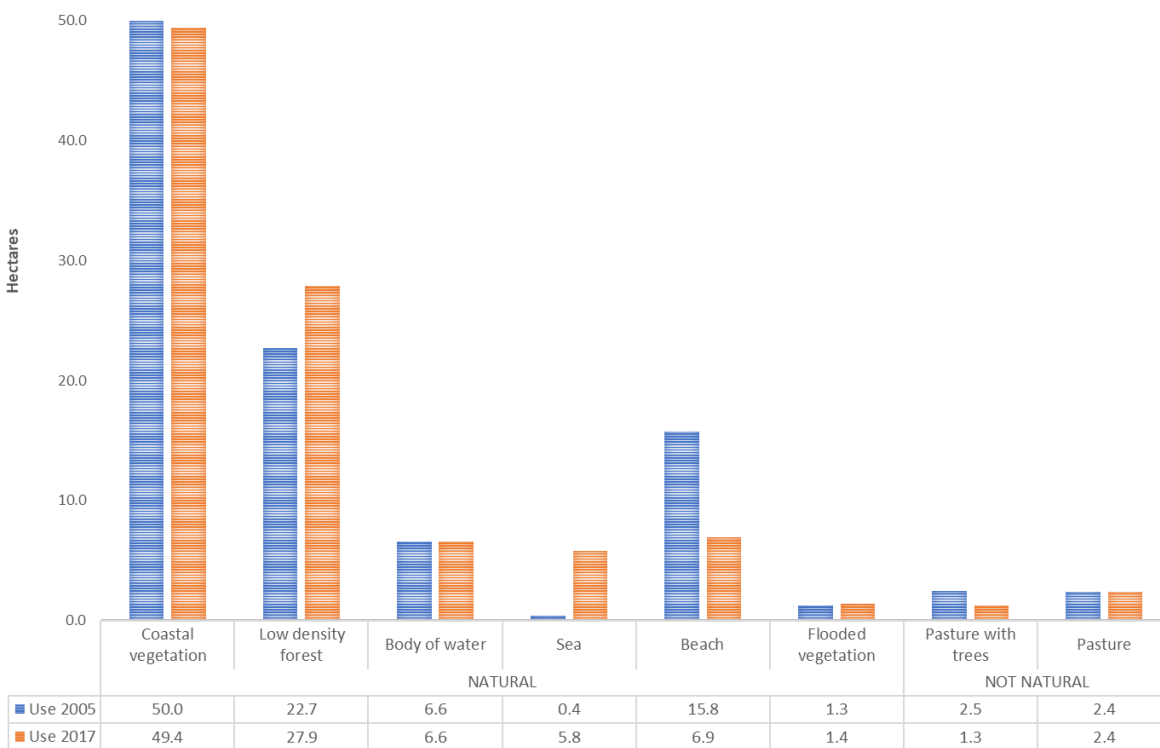
**Graph 6. Sixaola Sector: Land cover during the 2005 – 2017 period.**

Barrantes et al. (2020) identified three hot spots of erosion in Gandoca, one of them near the mouth of the Sixaola river. When comparing changes in land cover, there is evidence of a marked decrease of the area covered by beaches between 2005 and 2017, to 6.9 ha (Graph 6). This reduction in the surface is associated with an increase in the area of the covers such as sea (5.2 ha) and low-density forest (3.8 ha) (Figure 10). The rest of the covers showed little change.

Source: Prepared by the authors based on land cover data during the 2005 – 2017 period, generated during the investigation.

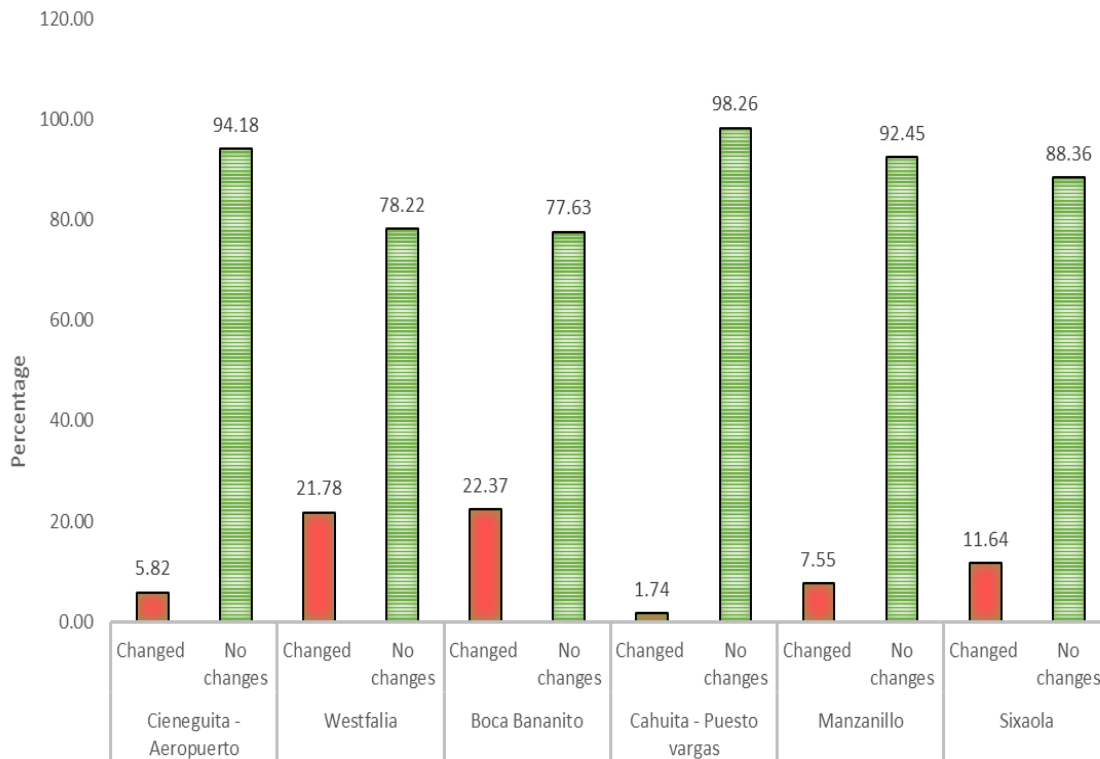
**Graph 7. Changes in land cover by erosion sectors South Caribbean, period 2005-2017.**

In general terms, based on the analysis carried out in each sector (Graph 7), it is clear that the largest changes in land cover occur at the mouth of the Bananito River and in Westfalia. When comparing the 2005 land cover map with the areas eroded between 2005-2016, reported by Barrantes et al. (2020), it was found that areas in the Bananito sector, surfaces mainly associated with coastal vegetation (3.49 ha), beaches (0.99 ha) (which formed part of sand bars) and grass (0.01 ha) and residential infrastructure (0.03 ha) were lost (Graph 8), while in Westfalia mainly coastal vegetation (2.65 ha), grass (2.97 ha), forest (0.95 ha) and beach (0.26 ha) were lost.

Source: Prepared by the authors based on land cover data during the 2005 – 2017 period. Generated during the investigation.

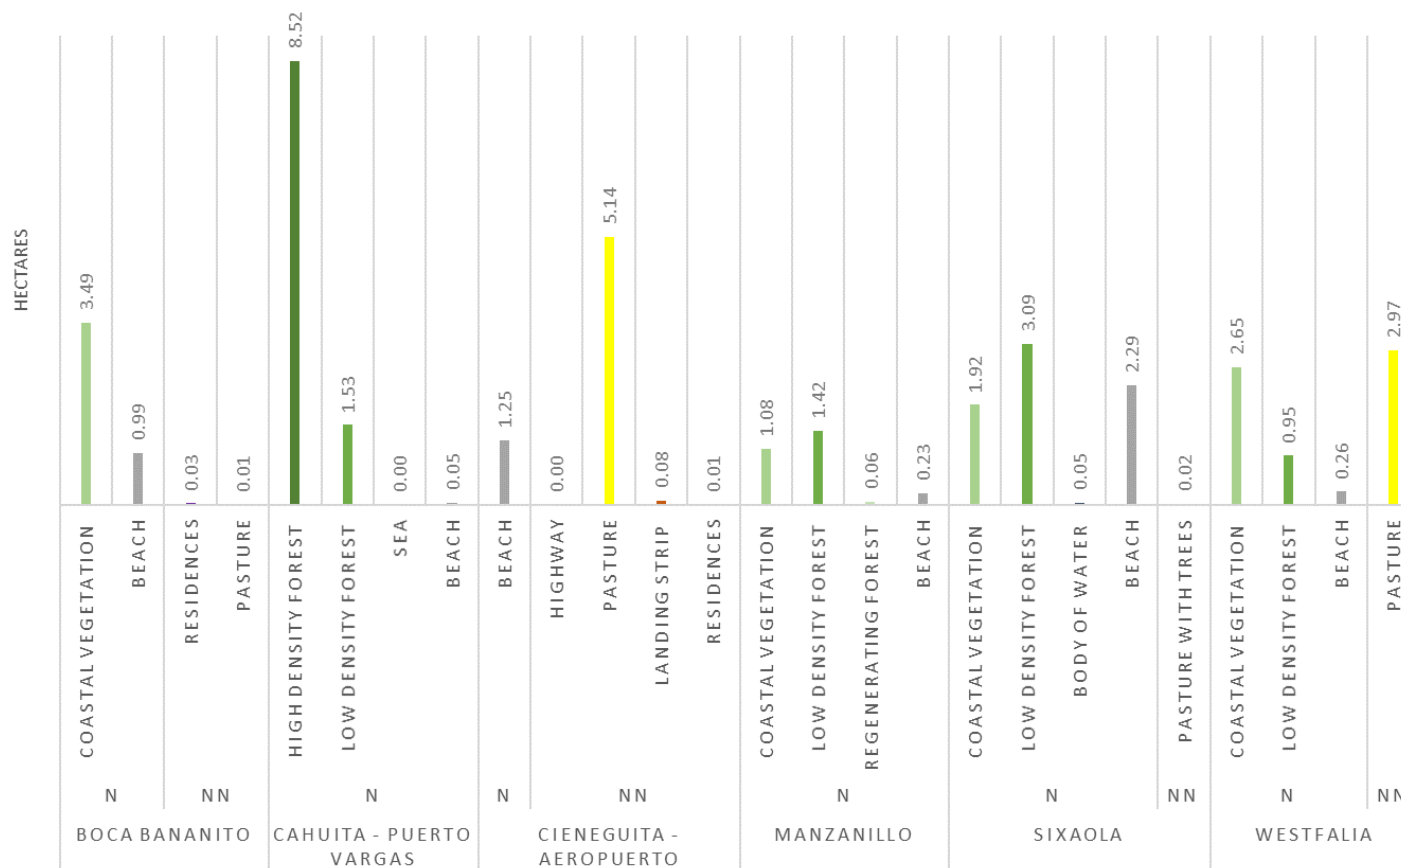
**Graph 8. Land cover in 2005 affected by erosion between 2005 and 2016.**

forest by 3.09 ha (Graph 8). When comparing areas that were affected by erosion processes between 2005 and 2016, there is evidence of a greater impact on the natural covers that are part of the pioneer vegetation that populates these environments.

Note: N: Natural; NN: Not natural. Prepared by the authors based on other mosaics from 2005 and 2016, updated with field work in 2017.

Next, Manzanillo is protected from the direct impact of waves by the presence of a reef, but there was a significant loss of beach in a small sector. As shown in Graph 8, 0.23 ha of beach was lost to erosion between 2005 and 2016, which also affected 1.08 ha of coastal vegetation and 1.42 ha of low-density forest.
