The use of the pile integrity test (PIT) to detect anomaly such as reinforcement exposure in short caissons

Tiago de Jesus Souza ^a & André Querelli ^b

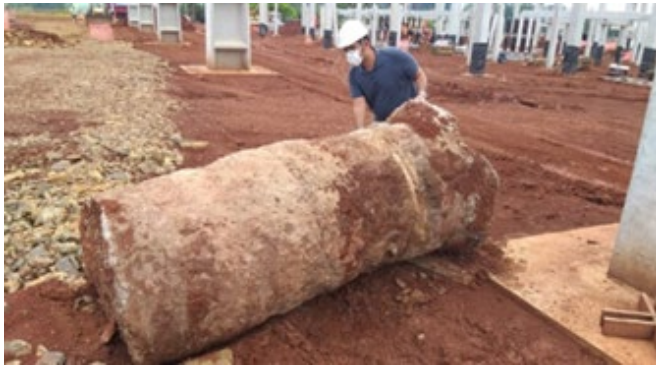
The inspection of deep foundations can be carried out based on ground excavation to directly observe the foundation element (Fig. 1a). According to Wu et al. [1], the advantage of

Figure 1. Foundation element excavation for visual inspection (a) and the evidence of exposed reinforcement (b and c).

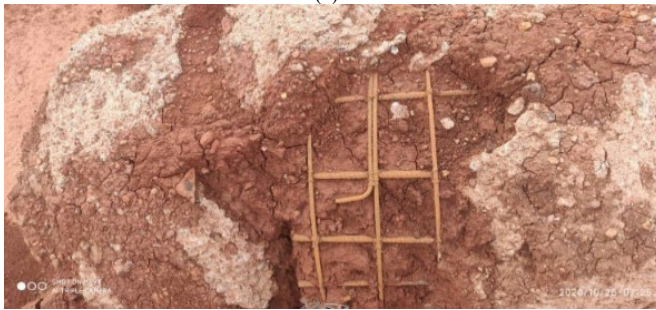
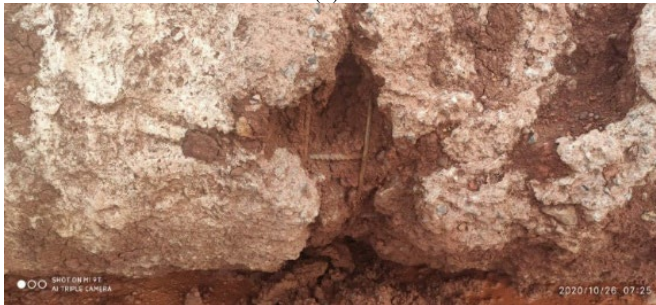
this procedure is the possibility of visually verifying the integrity of the pile and possible concreting defects (as shown in Figs. 1b and 1c). However, there are clear disadvantages, since the process is inviable for long elements, the impossibility to verify internal defects, the difficulty to excavate resistant soils, possibility of damaging the element when the process is mechanically carried out, the presence of water table, the loss of part of the lateral friction resistance, among others.

From the excavated caissons, the pathologies found were either joints in the concrete or exposure of the reinforcement. In fact, the exposure of reinforcement in the caissons belonging to the new structure was the initial motivation for carrying out PIT as a method of integrity assessment, followed by the visual inspection. Two examples of reinforcement exposure are shown in Fig.1b and 1c, and identified in Table 2.

It is understood that the reason for this pathology may be that some caissons were executed during the intense rainy season, with the soil saturated and with disturbance from the mechanical excavation. Unfortunately, that lacks results from PIT tests carried out in caissons, which harms to compare the results obtained with the literature. Kormann [15]) have excavated long piles and have observed damage in the pile's stem.

It can be seen from the two PIT reflectograms that there is a large variation in impedance in both cases, which is characteristic of a pathology. Based on the results of the PIT test and the visual inspection, B1B-06 and B1B-08 were required to be treated and foundation reinforced.

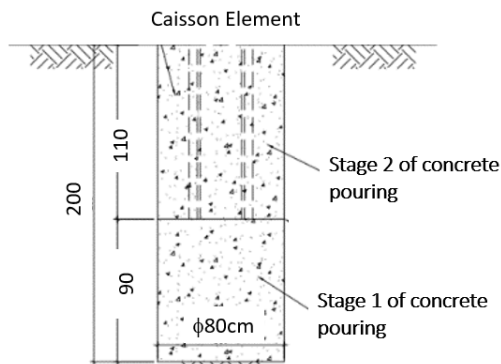
The caissons were designed with diameters of 0.8 m and lengths of 2 m (Fig.3), consisting then of short caissons. The integrity checks were carried out on some of the caissons belonging to new structures built to expand the substation. In order to speed up the execution, the caissons were built using an unconventional executive process.

The excavation was done with a mechanical auger and without tip cleaning and manual base opening. Usually, the process of excavation would be manual, and there would be a base opening.

Figure 3. Foundation design of the caissons. Source: Authors' own production

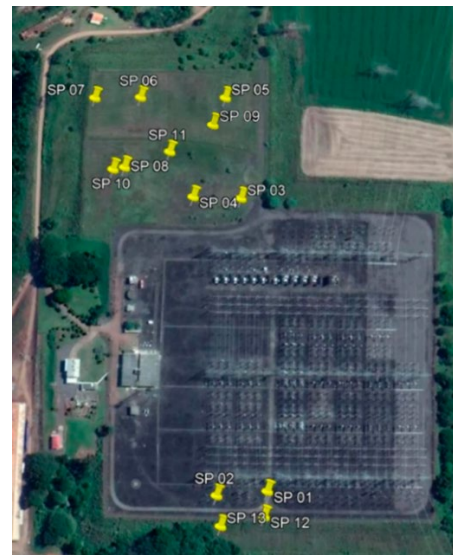
For the substation extension, thirteen Standard Penetration Test (SPT) boreholes were drilled at the locations shown in Fig.4. The number of boreholes was determined according to our national standard (NBR 8036 [14]), considering the projected area of the structure. The borehole locations were randomly selected. The boreholes were advanced until reaching the impenetrable to percussion level, which occurred at depths of approximately 2.55 m to 13.10 m, for SP 12 and SP 09. Fig.5 shows the soil profile according to the SPT tests.

Figure 4. Location of the standard penetration tests. Source: Authors' own production

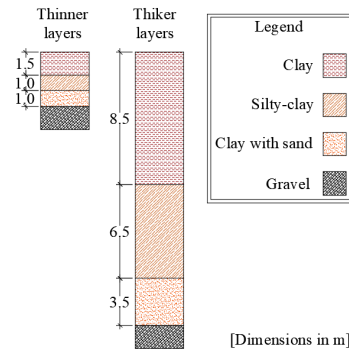
Figure 5. Soil profile according to the SPT boreholes. The is a presence of a surficial red clay layer, medium to hard in consistency, with thickness varying from 1.45 to 8.45 m, followed by 1.00 to 6.00 m of a brown silty clay, medium to hard, and by a layer of brown clay with sand, medium to hard, 1.00 to 3.00 m in thickness. Further down, a hard gravel layer was found, determining the impenetrable to percussion. Source: Authors' own production

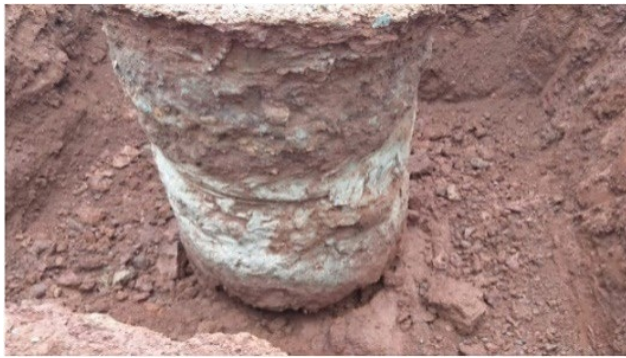
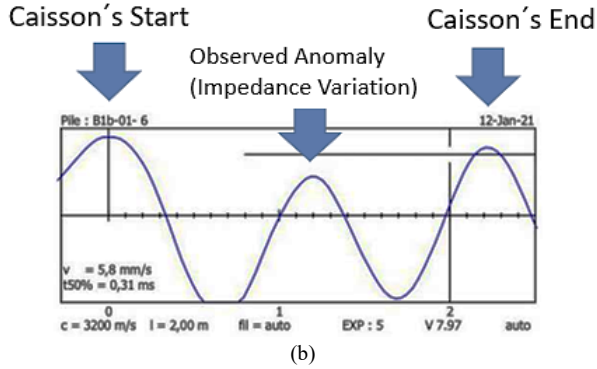
After the blows are applied, a curve is generated, showing the wave speed variation with time (related to the depth of the pile). Initially, there is a positive inflexion resulting from the blow generated, and then there are oscillations in the wave speed over time. Positive or negative inflexions indicate variations in the pile cross-section associated with anomalies such as cracks or other structural issues within the material. Figs. 6 and 7 show the photographic records of the visual inspection and the PIT reflectograms for the caissons B1B-06 and B1B-08, with exposed reinforcement.

Figure 6. B1B-06 caisson joint evaluation: a) visual inspection and b) PIT signals.

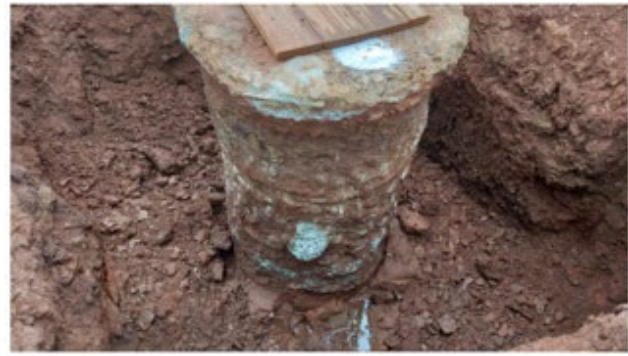
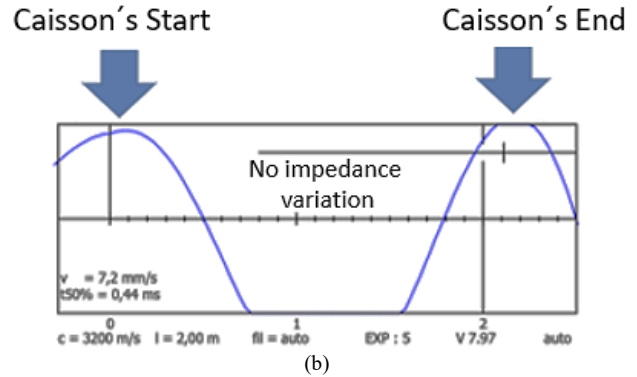
For comparison, Fig.8 illustrate the visual inspection and PIT reflectogram for caisson B2D-12, which was in intact condition (without pathology). The reflectogram did not show impedance variation, consistent with a caisson in good state of integrity. The other caissons tested showed a similar type of PIT signal.

Figure 8. B2D-12 caisson joint evaluation: a) visual inspection and b) PIT signals.

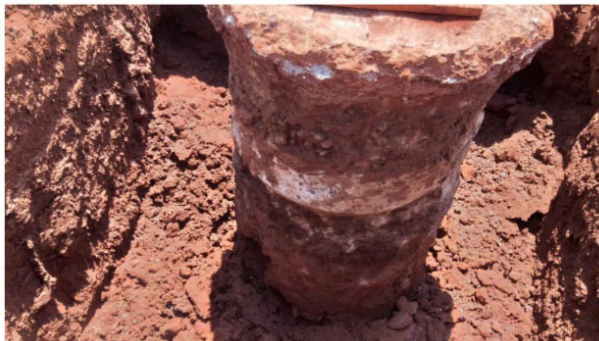
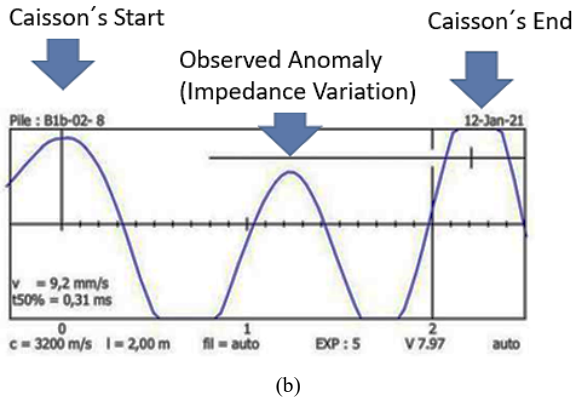
Figure 7. B1B-08 caisson joint evaluation: a) visual inspection and b) PIT signals.

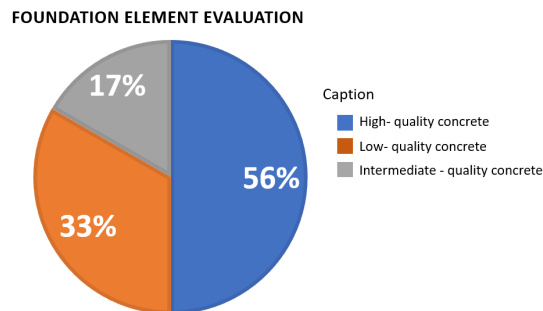
Figure 9. Concrete quality assessment through PIT (Pile Integrity Testing).
Source: Authors' own production

Based on the assessed PIT test results, a chart was generated with the primary diagnosis of the findings. Fig.9 shows the percentage of concrete quality found for the piles evaluated.

It can be observed that a significant portion of the piles have good-quality concrete (56%), whereas 33% displayed poor-quality concrete, and 11% had inconclusive diagnoses, necessitating retesting or foundation reinforcement.
