Mechanical Deterioration by Weathering of the Adobe from the Tausa Chapel (Colombia)

Javier Camacho-Tauta ¹;

J. Camacho-Tauta, C. Uribe-Kaffure, A. Ramos-Cañón,
“Mechanical Deterioration by Weathering of the Adobe from
the Tausa Chapel (Colombia),” *Tecnológicas*, vol. 26, nro. 58,
e2733, 2023. <https://doi.org/10.22430/22565337.2733>

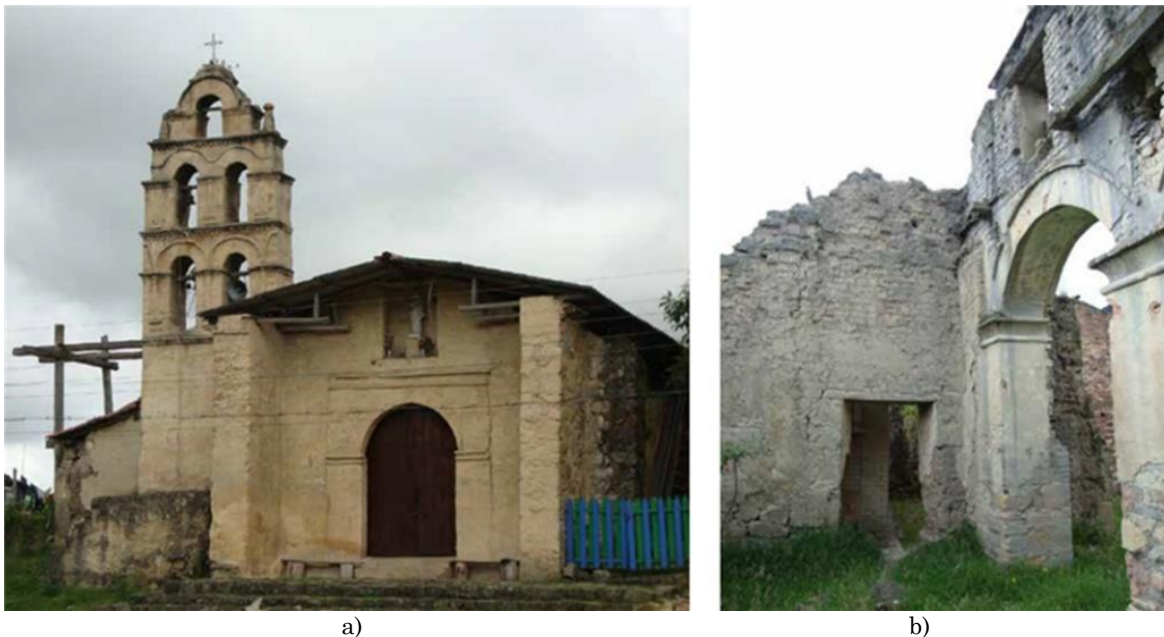
Figure 1. Doctrinal chapel in Tausa: a) frontal sector; b) rear sector. Source: Created by the authors.

atrium is built in stone, forming four staircases that lead to the street. According to the current structural preservation state, the building can be divided into two parts. The frontal sector presented in Figure 1a) is currently in use and is composed of the nave built in masonry, adobe, rammed earth, and collar roof. The rear sector in abandoned conditions as can be seen in Figure 1b) corresponds to the ruined walls of the presbytery and two lateral areas, of which it is unknown its use. A description of the architectonic distribution, constructive technique and physical, mechanical, and chemical characteristics of the materials can be found in [31].

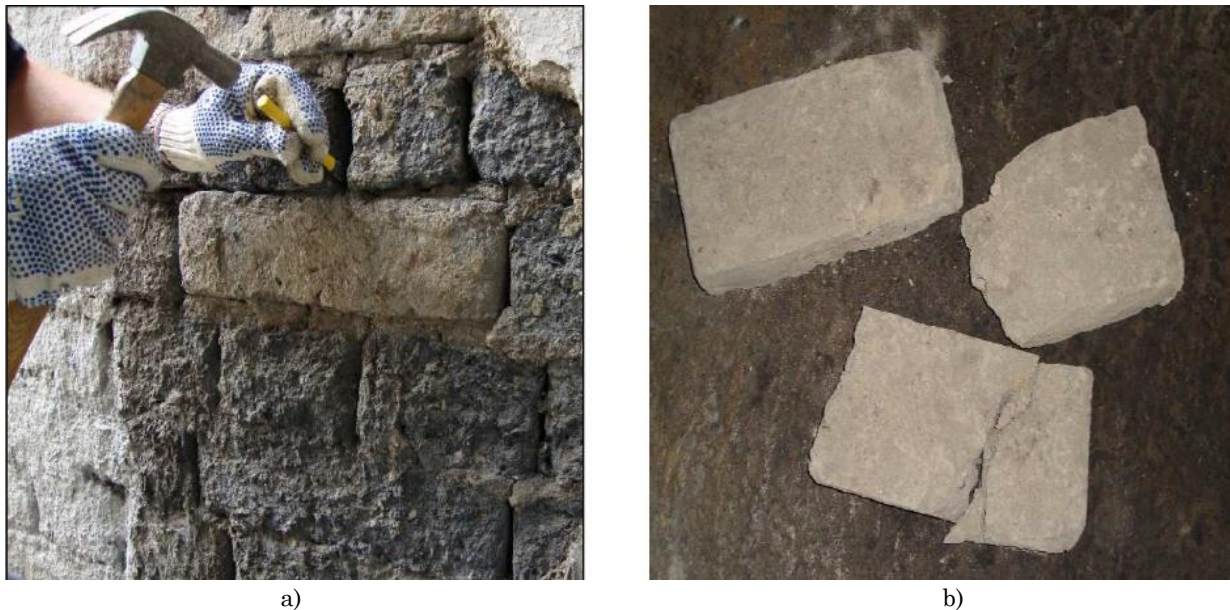
Figure 2. Samples of old adobe: a) recuperation of an adobe unit; b) recovered samples.

The experimental program was carried out on two groups of materials. The first one corresponds to adobe samples recovered from the rear sector of the chapel (old adobe). 15 complete adobe units and 24 fragments (Figure 2) composed old adobe samples. The second group was obtained from a soil deposit located in the area close to the chapel (new adobe). Three soil deposits in the locality were preliminarily studied by performing soil classification tests and the most similar soil to the old adobe was the chosen one. Only results from the selected soil deposit are presented in this paper. With the new adobe, 60 samples were prepared by compaction in cylindrical molds under controlled water content. Then, they were extruded from the mold and left to air-drying with no action of direct sunlight for 45 days (Figure 3). Compaction of samples was carried out to simulate the methods employed by ancient construction workers in the production of adobe walls. For this reason, modern procedures such as Proctor compaction were avoided to preserve the authenticity of the compaction process. The moisture conditions for compaction were those necessary for better workability, mirroring the practices of traditional construction [32]. This procedure aimed to obtain samples with similar characteristics of adobe units made with this conventional technique. A comparison of the physical characteristics of old adobe and new adobe samples are presented in Table 1. Results from old adobe are like results previously obtained on samples of the same chapel by [32]. However, plasticity limits are slightly lower than the results found in the present work.

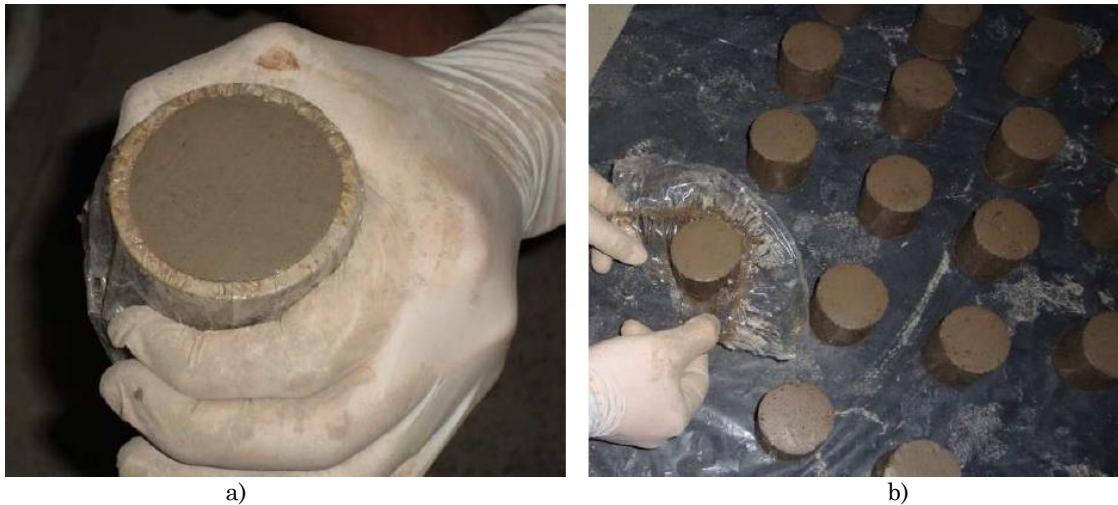
Figure 3. Samples of new adobe: a) preparation of the sample; b) air drying process.
Source: Created by the authors

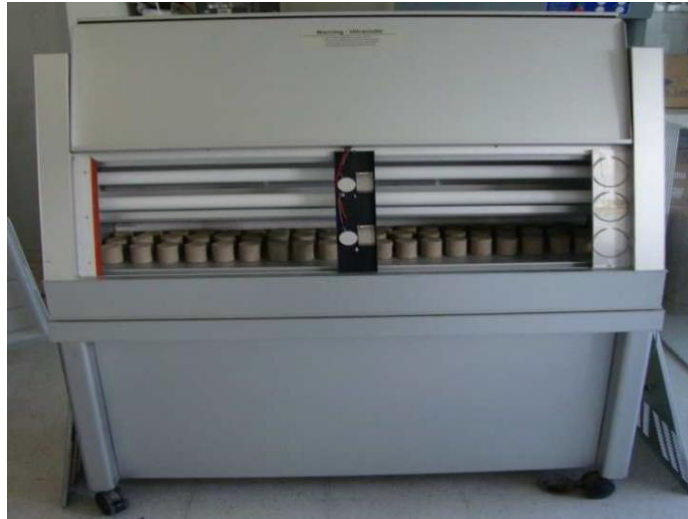
Figure 4. Accelerated weathering tester QUV-SE. Source: Created by the authors.

Cylindrical samples from old adobe were obtained from adobe samples by using a core extractor. An accelerated weathering tester QUV-SE [33] simulates the effect of ambient exposition. Figure 4 illustrates the equipment with a group of samples ready to be exposed to weathering. The equipment is capable of controlling irradiance by a closed-loop control and uses eight UVA-340 lamps simulating the sunlight from 365nm down to the solar cut-off of 295 nm. In addition, the apparatus has a condensation mechanism to simulate outdoor moisture attack by heating a water reservoir to produce a vapor that maintains a 100 % relative humidity. Radiation and condensation alternate cyclically in programmable periods. Exposition of materials to this artificial regime produces degradation in a similar way that natural ambient conditions. Proportionally time factor between natural and artificial exposition is not constant since it depends on several variables that are not fully controlled (e.g., tested material, variation in natural conditions, variables capable of controlling in the equipment). The standard ASTM G154-16 [34] covers the principles and operating procedures for apparatuses designed for UV exposition of non-metallic materials.

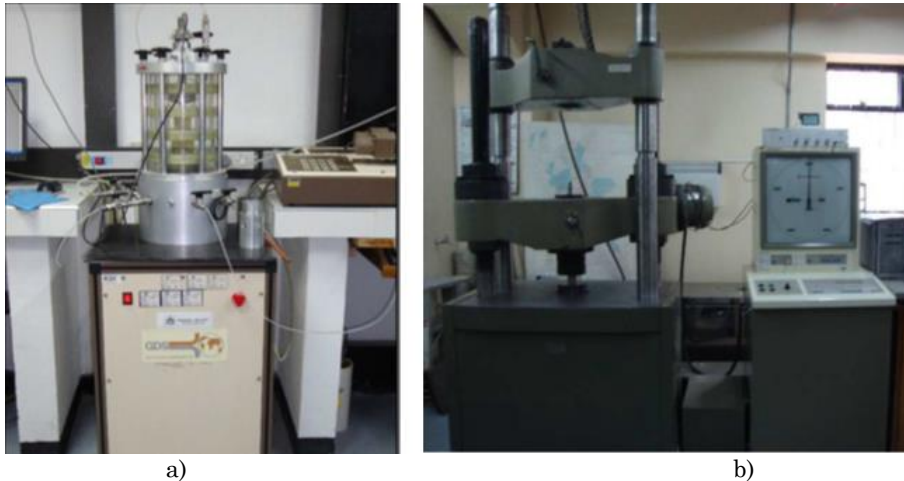
Figure 5. Mechanic devices: a) triaxial testing apparatus; b) compression tester machine. Source: Created by the authors

Mechanical tests on the samples were done by using the GDS triaxial testing apparatus shown in Figure 5a [35]. The system allows controlling confinement pressure and vertical stress. A universal compression tester machine was used for unconfined compression tests on cylindrical samples (Figure 5b). Additional equipment and accessories include scale, oven, sieves, soil classification instruments and compaction molds.

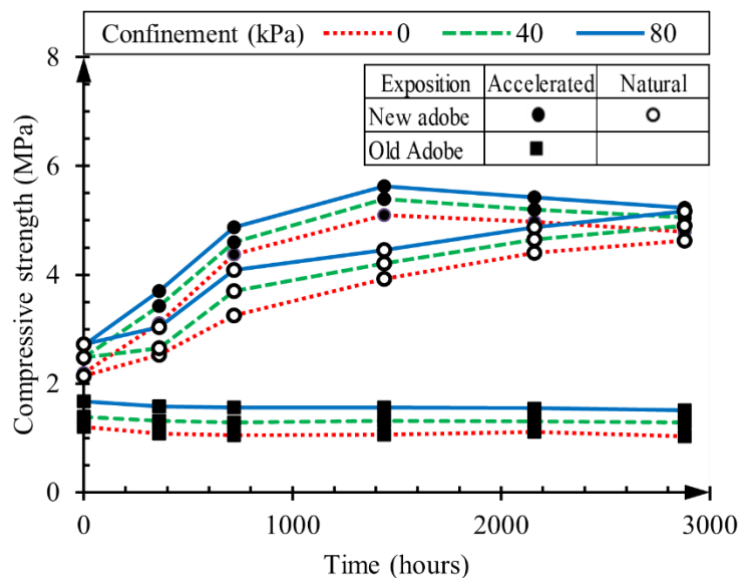
Figure 6. Unconfined and confined compressive strength of adobe samples. Source: Created by the authors

Results of compressive strength from unconfined and confined compression tests appear synthesized in Figure 6. The first characteristic is the difference between the compressive strength at null exposition time: for all the test points, new adobe samples exhibit higher strength than old adobe samples. For instance, the unconfined compressive strength of new adobe was almost twice than the same property for old adobe. The substantial difference between old and new adobe could be a result of long years of direct weathering and absence of maintenance that finally resulted in the ruined conditions in which the rear sector of the chapel was found. The second evident characteristic in Figure 6 is the almost constant behavior of the strength of old adobe along the exposition time. In other words, no further deterioration is observed by additional hours of accelerated ageing for a material that was already exposed to a prolonged time under neglecting conditions. Results of unconfined compressive strength of new adobe found in literature varies depending on the soil type, curing period, water content, among others. For instance, [40] report an unconfined compressive strength around 1.5 MPa for a sample after 28 days of natural curing and 3.5 %

water content. In the present work, for similar conditions of natural curing and water content new adobe reaches 3.2 MPa, which is similar to the value reported by [32]. Reported data for unreinforced adobe units varies from 0.55 to 3.4 MPa [41]. Changes in water content have strong influence in the shear strength of adobe materials because the soil suction increases when the soil moisture reduces [27], [42].

The natural-exposed new adobe gradually increases its strength, since during the period studied, the unconfined compressive strength raised from 2.2MPa up to 4.4 MPa with a rate of strengthening decreasing with time. On the other hand, artificially exposed new adobe showed an initial rapid increase in the strength, followed by a slight reduction of this property. By comparing natural and accelerated exposition curves from new adobe, naturally exposed curves could represent the first stages of accelerated curves, that is, 2880 hours under natural exposition could be reproduced by approximately 720 hours under artificial conditions. This ageing factor of four is approximated and only should be representative of the conditions in which the samples of this new adobe were subjected to ambient conditions. The effect of the confinement is reflected in the three set of samples: the higher the confinement stress, the greater the compressive strength is. Additional compressive strength caused by the applied confinement is practically constant irrespective of the adobe, weathering regime and exposition time.

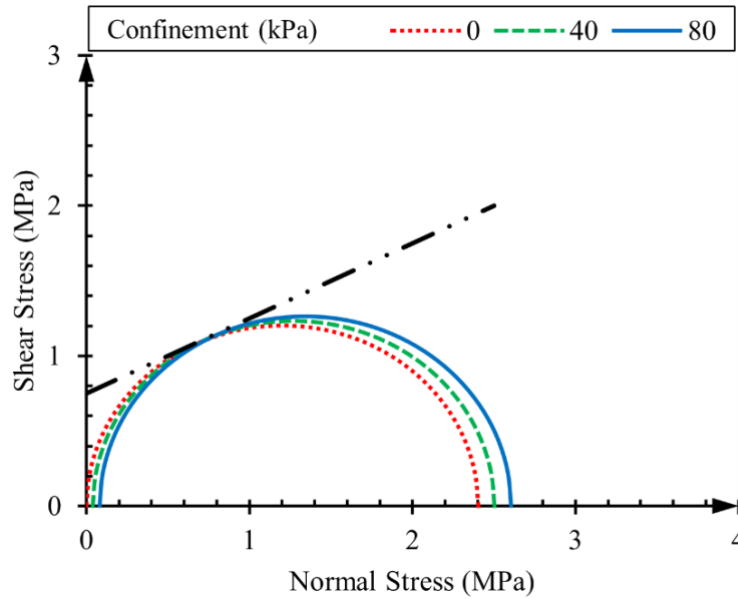
Figure 7. Mohr's circles and failure envelope of new adobe and no exposition to weathering.
Source: Created by the authors.

Stress states at failure from compression tests were represented by Mohr’s circles as can be shown in Figure 7, which includes the failure envelope according to the Mohr-Coulomb failure criterion given by (1). In this criterion, τ_f is the shear stress at failure, c is cohesion, σ is the normal stress to the failure plane, and ϕ is the shear strength angle.

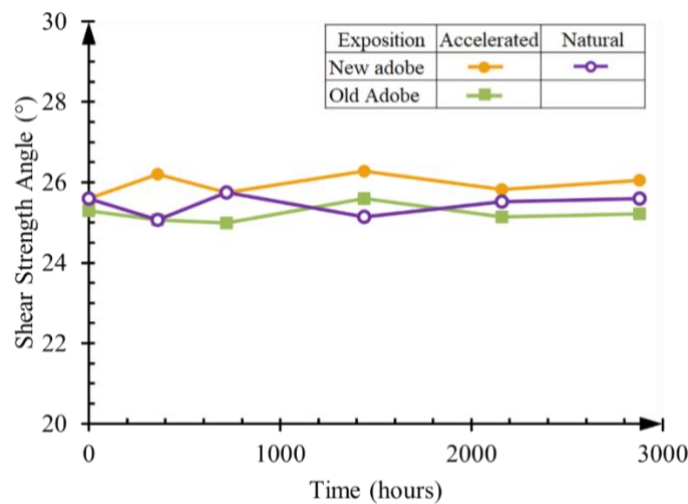
Figure 8. Shear strength angle of adobe samples. Source: Created by the authors.

Similar graphics for different adobes, exposition period and type of weathering were plotted and estimated the corresponding shear strength parameters, ϕ and c . Figure 8 presents the comparison of the different shear strength angles. It is evident that this parameter was not affected by the duration of the exposition, neither by natural nor by artificial regime. As a result of the acceleration in the weathering process, new adobe exposed to artificial conditions had a very little increment in the shear strength angle compared with the same adobe but naturally exposed. It is important to realize that old adobe retained the same shear strength angle despite the long and unfavorable conditions of natural weathering. From a practical point of view, the shear strength angle is 25° for old and new adobe, regardless the exposition conditions.

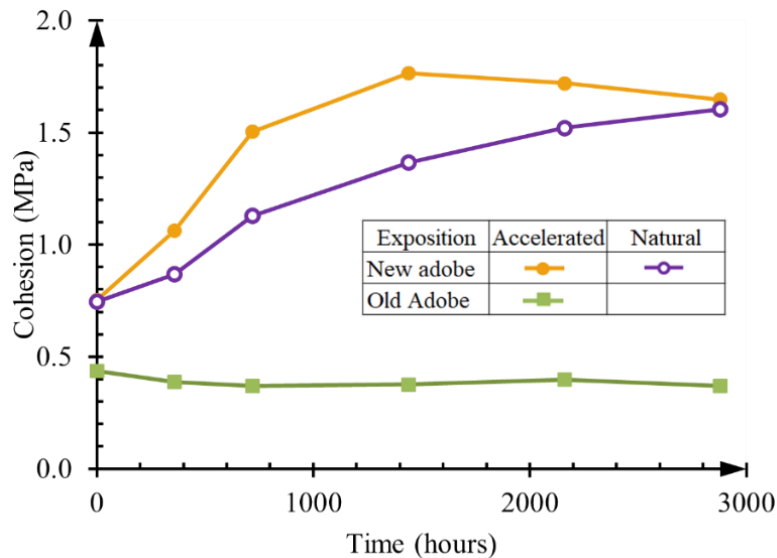
Figure 9. Cohesion of adobe samples. Source: Created by the authors.

The patterns observed in the compressive strength analyzed in the preceding section, are reflected in the cohesion parameter (Figure 9). This observation indicates that the growth in the strength is primarily governed by an increase in the cementation of the clay minerals by cause of exposition to natural or artificial ageing. Old adobe is nearly insensitive to accelerated exposition because after approximately 300 years of natural exposition to weathering, almost 3000 hours of additional accelerated exposition are insignificant. Nevertheless, prolonged exposition to ambient conditions without preventive or reconstructive interventions seriously diminished the cohesion of adobe units. Reduction in cohesion values after 1500 hours of accelerated exposition evidenced in new adobe samples could be due to the same mechanism that occasioned the gradual reduction of cohesion in old adobe after many years from its construction until the present.

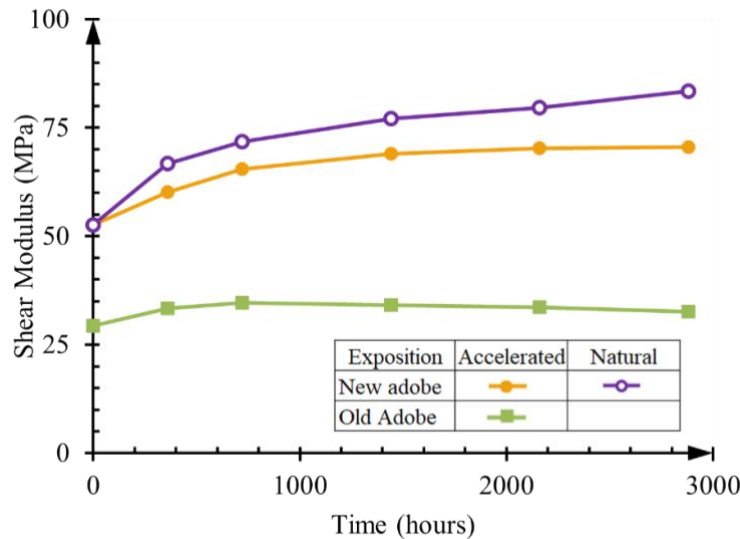
Figure 10. Shear modulus of adobe samples. Source: Created by the authors.

The initial slope of the curve shear stress against shear strain is suitable to estimate the shear modulus. Despite the deficiency in the resolution of the sensors regarding the small strain range in which the material is elastic, results presented in this section are useful for comparative purposes. Figure 10 compares the evolution of the shear moduli for the samples studied. As other results presented in previous sections, shear moduli from old adobe are not significantly affected by additional weathering.

Regarding new adobe, naturally exposed samples were stiffer than artificially exposed samples for all the periods of exposure to weathering. This fact could be due to the condensation cycles that allow more flexibility to the material as a consequence of the gain in moisture. New-adobe samples artificially exposed reached a kind of stabilization at the end of the weathering period imposed by the accelerated tester.

Comparing shear moduli of new adobe against old adobe, it is clear the significant difference along the entire period studied. Moreover, the ratio between new-adobe modulus and old-adobe modulus from samples artificially weathered is around two for all the exposition periods. The substantial reduction of the modulus observed in old-adobe samples could be caused by the careless conditions of the structure throughout the last century during which the walls were non-protected with a roof.
