Earthquake Archaeological Effects (EAEs) triggered by the Middle Age Catalonian seismic crisis in the Romanesque heritage (NE Spain)

Rodríguez-Pascua M.A.⁽¹⁾; Perucha, M.A.⁽¹⁾; Pérez-López, R.⁽¹⁾; Giner-Robles, J.L.⁽²⁾; Martín-González, F.⁽³⁾; Verdaguer i Serrat, J.⁽⁴⁾

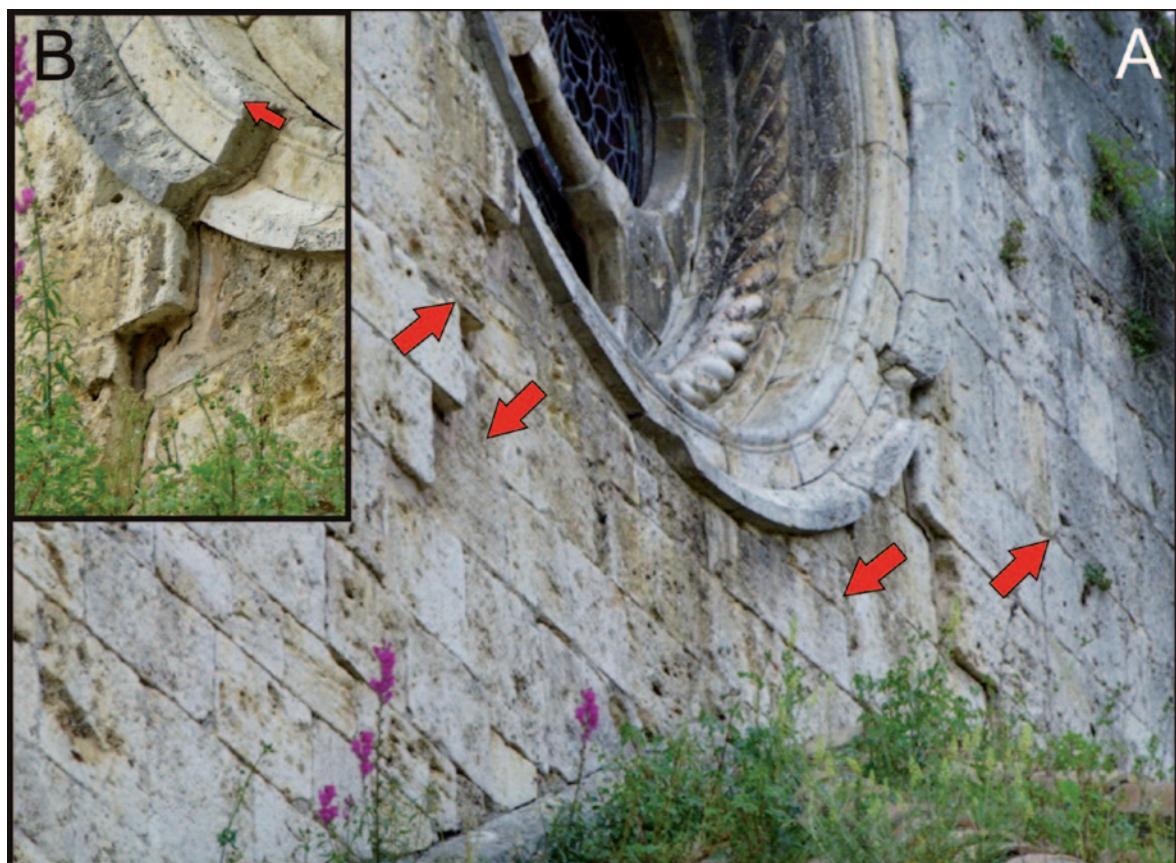
Figure 2. Displaced masonry blocks in Sant Vicent Church (Besalú): A) displaced and repaired masonry blocks in the rose window of the apse and B) close view of the displacement.

Figura 2. Bloques de sillería desplazados en la Iglesia de Sant Vicent (Besalú): A) bloques de sillería desplazados y reparados en el rosetón de encima del ábside y B) vista de detalle del desplazamiento de bloques de sillería.

- **Besalú:** it is a beautiful medieval town, plenty of Romanesque monuments located 30 km at the SE of the epicentre. In this town we have studied six buildings (religious and civil), but the most interesting examples of EAEs are recorded in the Sant Vicent Church, where penetrative fractures in masonry blocks, dipping broken corners and displaced masonry blocks (Figure 2) are observed. This set of EAEs is compatible with a NE-SW seismic ground motion at N045°E. Other interesting site is the ruins of the Pujada de Santa María Church, where restored dropped key stones in the window of the main

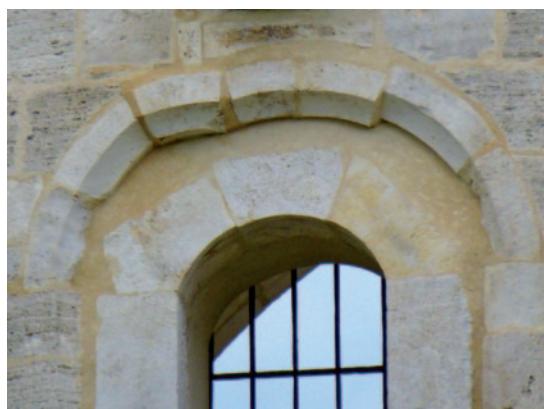
Figure 3. Dropped and repaired key stones in the window of the main apse of the Pujada de Santa María Church (Besalú).

Figura 3. Claves caídas de arco en la ventana del ábside principal de la Iglesia de Pujada de Santa María (Besalú).

apse are nicely preserved today (Figure 3). This EAE is compatible with a similar ground motion direction at N164°E. The rest of the EAEs recorded in this Medieval town are fairly bracketed between these two reported orientations.

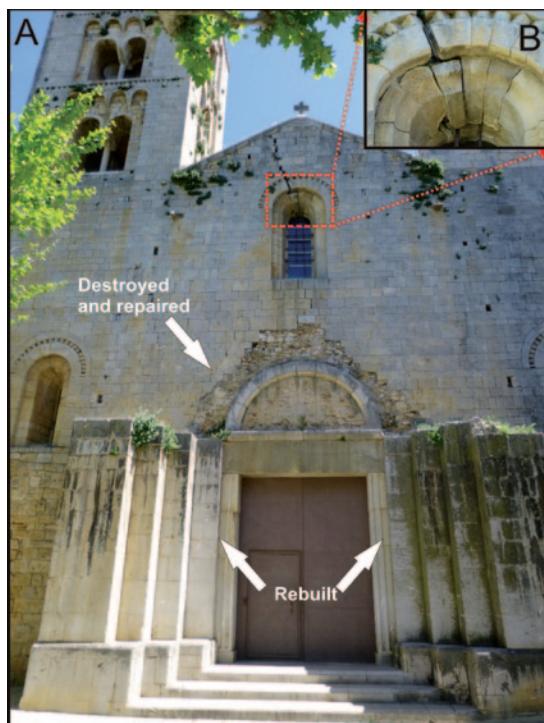
Figure 4. EAEs of the Canonica de Santa María de Vilabertrán: A) main facade of the monastery and B) close view of the dropped key stone of the window.

Figura 4. EAEs en la Canónica de Santa María de Vilabertrán: A) fachada principal del monasterio y B) vista de detalle de la caída de la clave del arco de la ventana.

- **Canonica de Santa María de Villabertrán:** This monastery, located 50 km east of the epicentre displays an interesting collection of EAEs. The main gate of the church was destroyed and repaired after the earthquake (Figure 4A). The window located in this same frontal facade shows displaced masonry blocks, dropped key stones

(Figure 4B) associated to a large crack running towards the roof of the building. These EAEs are large penetrative strain structures and it is possible to observe them inside of the church. In the cloister of this building are also preserved repaired arches and displaced masonry blocks are also preserved. In the NW wall of the refectory the key stones of a window were horizontally displaced (Figure 5). This set of EAEs is compatible with a NW-SE ground motion of N165°E.

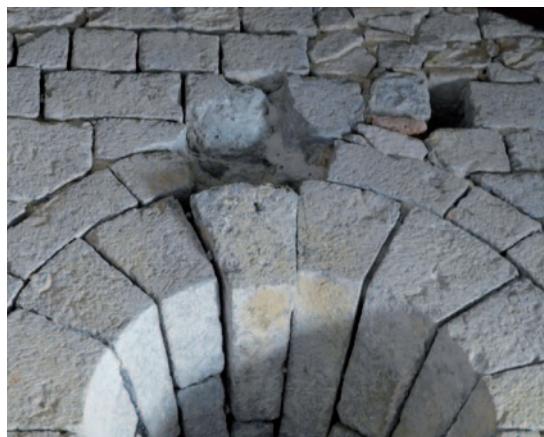
Figure 5: Key stones displaced horizontally in the refectory of the monastery of the Canonica of Santa María de Vilabertrán.

Figura 5. Desplazamiento horizontal de las claves del arco en el refectorio del monasterio de Canónica de Santa María de Vilabertrán.

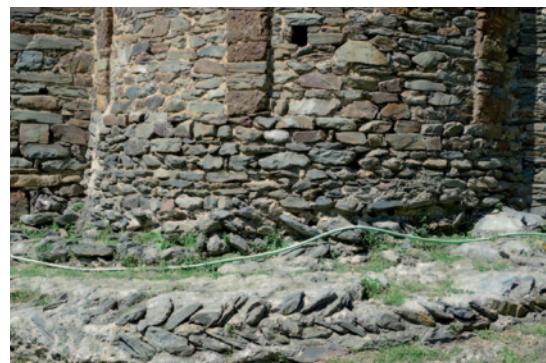
Figure 6. Apparent anti-seismic structures formed by assembled stones with spike-like disposition in the original foundations of the Sant Quirze de Colera Monastery.

Figura 6. Posibles estructuras antisísmicas formadas por disposición en espiga de mampuesto de roca en los cimientos del Monasterio de Sant Quirze de Colera.

- *Sant Quirze de Colera Abbey:* This medieval building founded in 927 AD was rebuilt in 1123 AD and it is possible observe the original foundations with apparent anti-seismic structures formed by assembled

stones with spike-like disposition (Figure 6). Later was seriously damaged by the 1428 AD earthquake and in 1441 the abbey was eventually abandoned by ruin. The building is located 58 km ENE of the epicentre and the main set of EAEs preserved in this building is composed by tilted walls, dropped key stones, warped arches (Figure 7), penetrative fractures in masonry blocks and repaired arches. The orientations of all these EAEs are compatible with a NW-SE seismic ground motion of N170°E.

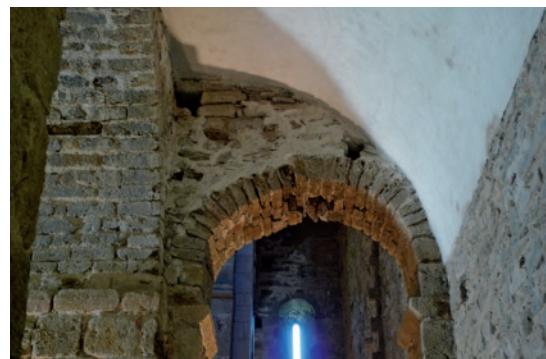
Figure 7. Warped arch and repaired key stones (made of bricks) in the monastery of Sant Quirze de Collera.

Figura 7. Arco deformado y claves de arco reparadas (realizadas con ladrillo) en el monasterio de San Quirze de Collera.

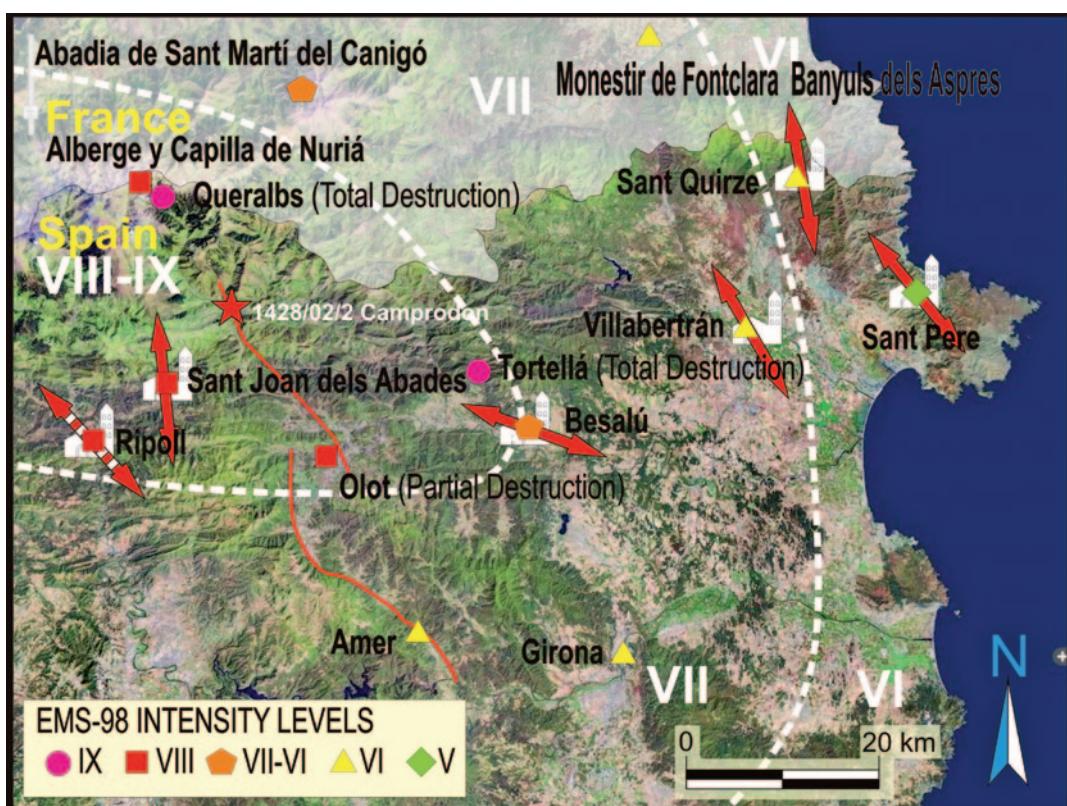
Figure 8. Isoseismal lines of the Camprodón earthquake (1428; I=IX; EMS98) (modified from Oliveira *et al.*, 2006). The red lines are segments of the Amer Fault. The solid red arrows represent the mean ground movement during the earthquake obtained by geological structural analysis of EAEs. The dashed arrows are interpreted from EAEs reported in historical documents.

Figura 8. Isosistas del terremoto de Camprodón (1428; I=IX; EMS98) (modificado de Oliveira *et al.*, 2006). Las líneas rojas son los segmentos de la falla de Amer. Las flechas rojas sólidas representan el movimiento medio del terreno durante el terremoto, obtenido mediante análisis estructural geológico de los EAEs. Las flechas a trazos son interpretaciones realizadas a partir de los datos documentales.

vince of Girona (NE Catalonia). The EAEs reported in this study are located between 10 km (Sant Joan de les Abadeses) to 70 km (Sant Pere de Rodes) from the epicentre, but damage was strong in a radius of 50 km around the epicentre (e.g. Villabertran and Besalú): The extensive damage recorded in Sant Quirze de Còlera at 60 km from the epicenter can be explained by a possible topographic amplification (narrow mountain valley), but its early abandonment after the earthquake (1441 AD) might amplify some of the reported EAEs. In any case is evident that Intensity VI EMS assigned to this zone (Figure 8), mainly collected from littoral sites (Oliveira *et al.*, 2006) does not explain the observed damage.

This study shows the most relevant EAEs presently preserved in the Romanesque heritage of the area. The geological structural analysis of the different set of EAEs collected in six localities/sites indicates a mean and consistent NW-SE direction for the seismic ground motion (Figure 8) in the southern zone of the epicentral area. Only in the case of the locality of Besalú two perpendicular orientations of ground motion are recorded in the studied buildings. Therefore, seems evident that this locality was also struck by the previous Amer earthquake in 1427 AD; VIII EMS) located about 28 km SW in an orthogonal direction to the Camprodón event (1428 AD; IX EMS), located 30 km NW from Besalú (Figure 1). It is necessary to highlight that all the affected towns or buildings analyzed in this work were severely affected by the 1428 Camprodón event (Oliveira *et al.*, 2006), which is the largest one recorded in the Pyrenees. The reported archaeoseismological data and analysis is useful to improve the knowledge on the seismicity of the area and on a particular event. This kind of data can be also used in future restoration works of the Romanesque heritage in the zone, identifying those elements and/or orientations of the ancient buildings prone to undergo severe damage during future seismic events generated by the same seismic source.
