# FAILURE ANALYSIS AND REDESIGN OF A WAGON WHEEL SHAFT FOR SUGAR CANE TRANSPORT

FERNANDO CASANOVA

**ABSTRACT:** In this study, a failure analysis of the wheel shafts of wagons for transporting sugar cane is carried out. Several shafts have broken with a small fatigue propagation zone and a large sudden-fracture zone. The material and load condition of the shafts were examined. Stress measurements on a vehicle with a similar suspension system were conducted to find the dynamic loads and calculate the impact factor. An impact factor higher than the one reported in the literature was found. According the manufactures, AISI 1045 steel was the material of the shaft; however, it was found that the material of some shafts did not have the specifications of AISI 1045 steel. Moreover, even if the shafts were made with good quality AISI 1045 steel, the stresses are so high that the element will fail due to fatigue. Finally, some recommendations are given to increase the reliability of the shafts, and a new design and manufacturing process are proposed

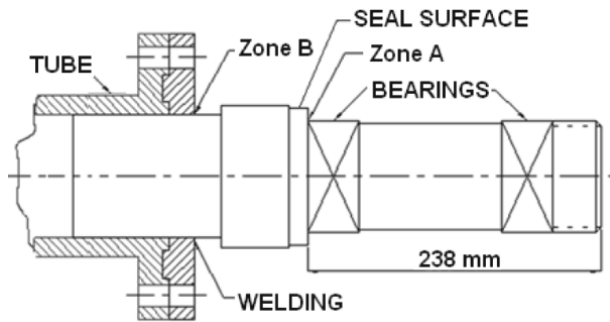
Figure 1. Schematic diagram of the shaft

Several fractures have occurred on shafts of 12-ton wagons where the wheel is assembled on the shaft with two tapered roller bearings and the shaft is assembled with the suspension springs by using a bolted flange. Fig. 1 shows a schematic assembly of the flange shaft. Most fractures have occurred on the change of section zone (zone A in Fig. 1) where a rounding radius of 5.5 mm exists. The flange is welded on the shaft and a few fractures on the welded zone (zone B) have also occurred. The other flange is attached to a tube that connects the wheels of the two sides and it is attached to the suspension springs. The failure analysis of some of those shafts is shown in this paper.

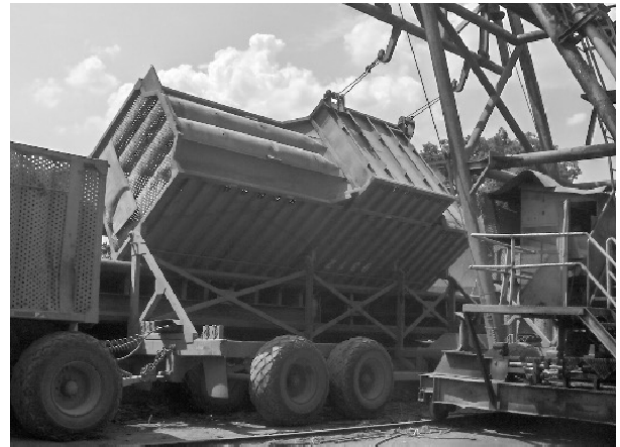
**Figure 4.** Wagon during the unloading process

considerably is when unloading the sugar cane, because it is necessary to turn the wagon over, as shown in Fig. 4. Because of the fluctuation of the loads due to impacts with road roughness, eventually the upper surface of the shaft presents traction stresses, producing fatigue propagation cracks also from the upper surface; an example of this case is shown in Fig. 2c. This change of direction of the stresses is also due to centrifugal forces during the turning of the wagon.

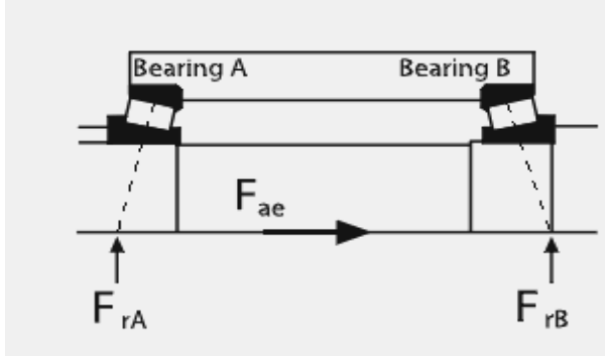
**Figure 8.** Forces on the shaft-bearings system

The weight of a 12-ton capacity wagon was measured. A weight of 20.837 tons with the wagon fully loaded was obtained. On flat terrain, this load is equally distributed among the four tires; so each tire will carry 51102 N. Each wheel is assembled with two identical, single-row tapered roller bearings. The equal size and kind of the bearings allows for us to assume that the resulting force is located at the mean point between the two bearings. Tapered roller bearings also generate an axial force as Fig. 8 schematically shows. According to the bearings manufacturer, the axial force ( $F_a$ ) is given by:

Where  $F_r$  is the radial force on each bearing (25551 N), and  $K = 1.45$ ; therefore,  $F_a = 8282$  N.

According to the bearing manufacturer,  $F_{rA}$  and  $F_{rB}$  are located at 190.5 mm and 6.35 mm, respectively, from the fracture zone. With these distances and the radial force, the bending moment and the stress produced on the failure zone can be calculated, knowing that the diameter of the shaft at the failure zone is 88.82 mm. The stress produced by the axial force produces traction stress on the failure zone, which should be added to the stress produced by the bending moment that, at the bottom of the shaft, is also traction. As this stress was calculated in static conditions, it can be taken as the mean stress. The calculated value is:

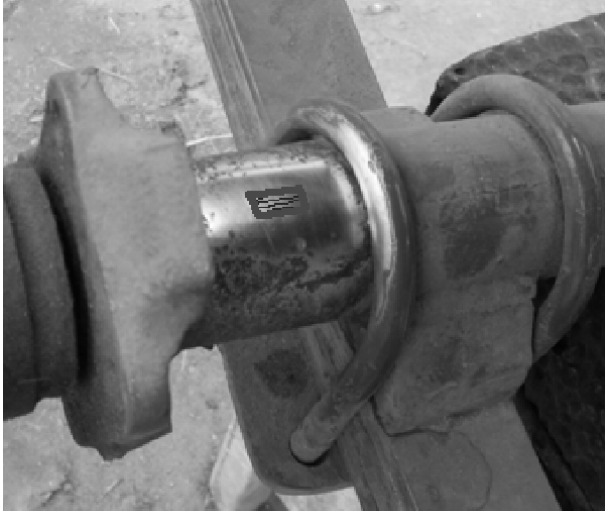
**Figure 9.** Strain gauge on the shaft of a spring suspension vehicle

To reduce the uncertainty of the impact factor, field tests were conducted on a small spring suspension vehicle. Fig. 9 shows the strain gauges on the vehicle shafts. 14.46 MPa was the stress in static conditions.

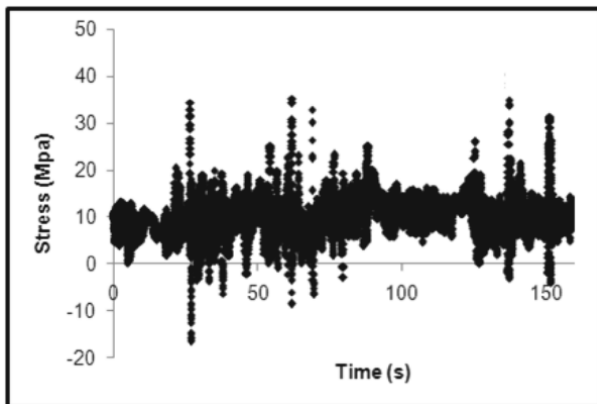
**Figure 10.** Stresses on the shaft

Fig. 10 shows the resulting stress under dynamic conditions where the maximum value obtained was 35.11 MPa. An impact factor of 142% was found. With this impact factor, the maximum stress on the wagon shaft is:

The value obtained for  $n$  is 0.93, meaning that the shaft will fail because of fatigue. This security factor could be even lower because impact factors higher than 142% could be present in the shaft when the wagons enter the sugar cane *field*, which is rougher than any road.
