## Analysis and repair of historical roof structures: Two examples, two different concepts

Rainer Barthel  
H. Maus

Two historical roof structures are presented. The history and sequence of alterations, damages and deformations during life time is described. The history is the key for understanding the damages and for developing the appropriate repair concepts. The two structures are similar but the alterations they suffered are different. A suspension truss is the main feature of both structures. Both structures show big deformations, but caused by different reasons. Two different concepts of repair measures are derived. The advantages and disadvantages of the measures are discussed.

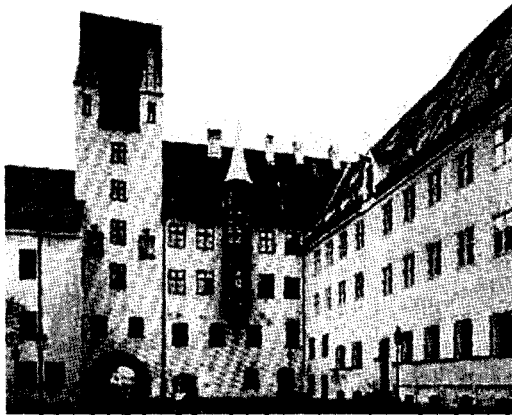
Figure 10  
«Alter Hof» Munich

The historical roof structure of the «Alte Hof» in Munich is the second example (Fig. 10). The main feature of the structure is a suspension truss, too. The «Alte Hof» is a castle founded in the 12<sup>th</sup> century. It has been the residence of the German Emperor Ludwig the Bavarian from 1328–47 (Burmeister 1999). The oldest part of the historical roof dates from 1525 and is one of the oldest original roof structures in Munich. The part which is presented in this paper dates from 1562 (Figs. 11 and 12).

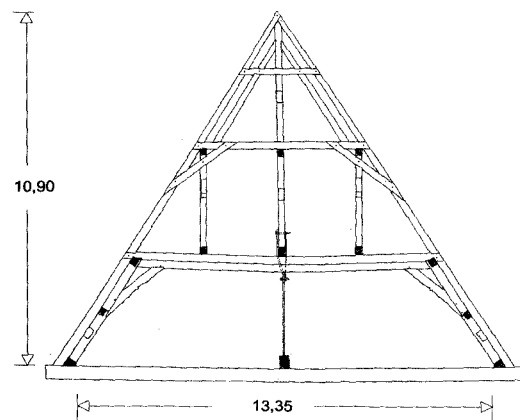
Figure 11  
Cross section of the roof structure

In the original situation the roof structure had a free span of 13,35 meters. It had to take the load of the ceiling above a huge hall. The ceiling is rather heavy due to a filling between the beams. The beams are supported in the middle axis by one big upstand beam. Its length is 18m and its cross section is 40 by 30 cm. This beam is hanging at suspenders consisting of wrought iron. They are anchored at the suspension truss situated in the upper storeys.

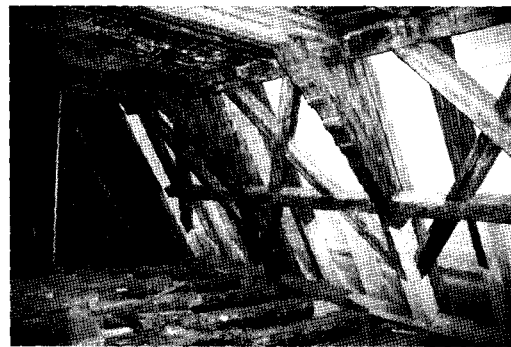
Figure 12  
First storey inside the roof structure

1. local damages due to a leaking roofing, mainly at the west side
2. big deflections at all the floors
3. broken joints due to overloading, especially at the connection of the braces and the rafters in the second floor (Figs. 13, 14).
4. local damages caused by fire. These damages are dated from the time of second world war. The repair was done very roughly.
