The experimental earthen cottages at Amesbury, England: A long term condition assessment

Richard Burt

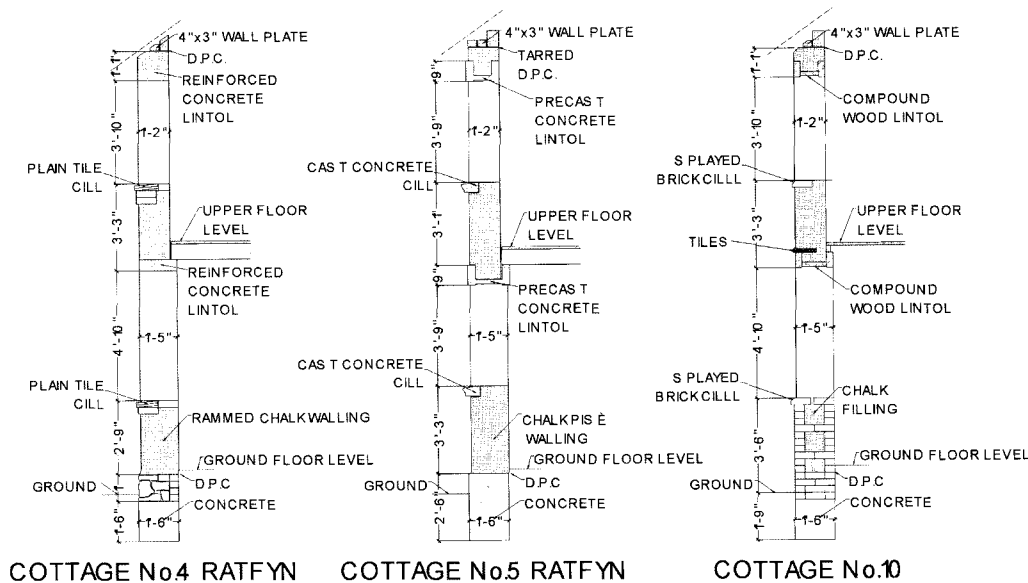
Figure 2
Construction of External Walls of Experimental Cottages

shown in Figure 1. Chalk was used as the main walling material for many reasons; it was available on the site and it had previously been used as a building material locally, evident from many surviving cottages in the village (Jaggard 1921, 17). The three cottages used variations of Pisé that utilized a standard form of timber shuttering. The main walls for the three cottages were constructed as follows and are shown in Figure 2.
