Angra A: the Copper-fastened Wreck at Porto Novo

(Angra do Heroísmo, Terceira island, Azores-Portugal)

A B S T R A C T The *Angra A* wreck – or Copper-fastened wreck – at Porto Novo; Angra Bay, Terceira Island, Azores, was briefly examined during the general survey of the inner harbor area in 1996. The frames of *Angra A* exhibited very low dead rise, suggesting that the vessel was nearly flat-bottomed with a pronounced turn of the bilge, indicating that the hull was designed for maximum cargo capacity amidships. The presence of copper fasteners on the wreck in Porto Novo tells us that the hull was built sometime after 1783, very likely dates to the 19th century, and most probably was built after 1840.

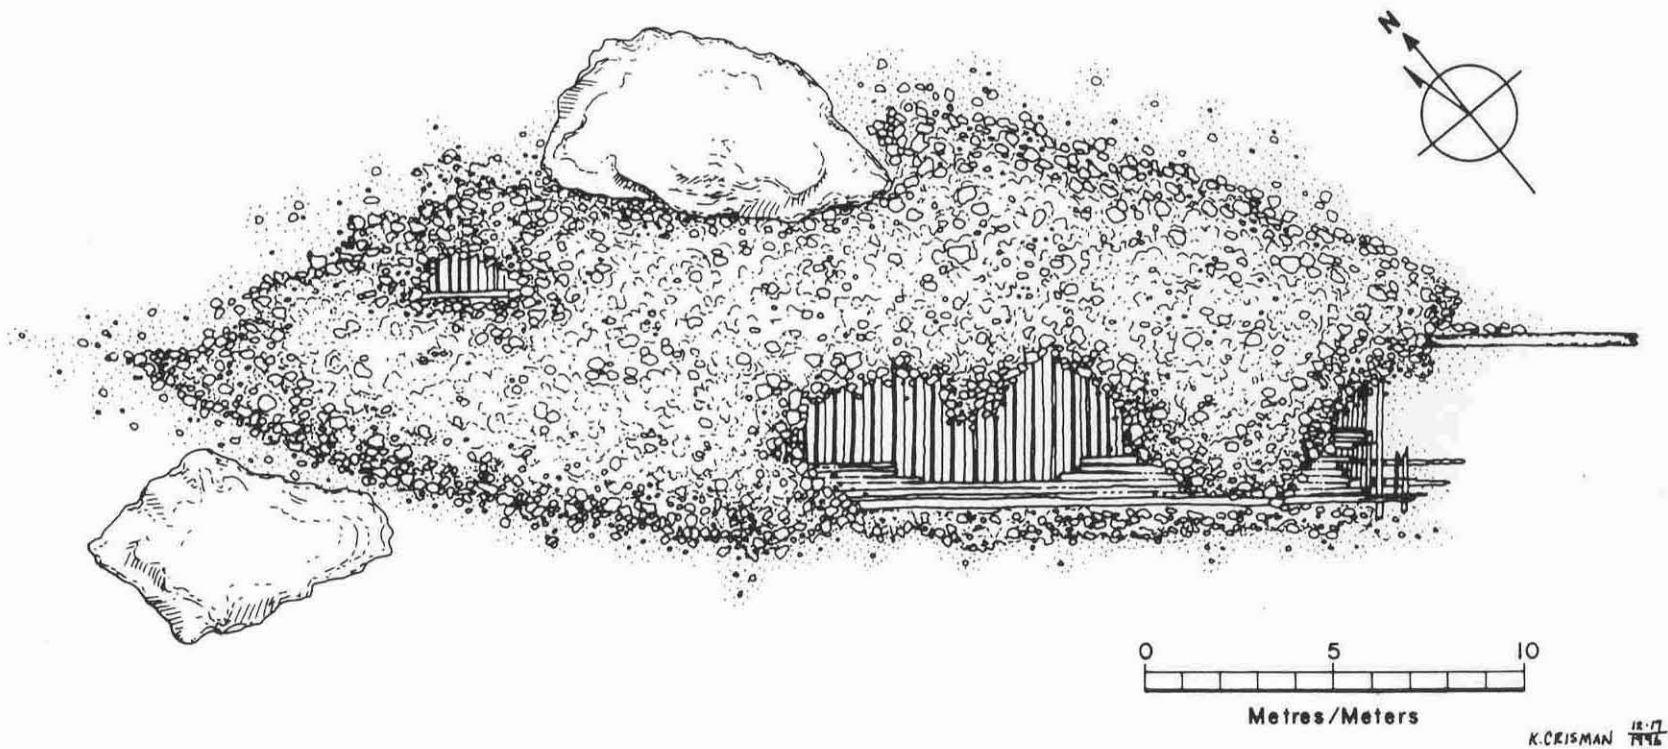
Fig. 2

K. CRISMAN 18-17
1996

The wreck underwent preliminary recording on September 16 when a MAH*/INA** team photographed the timbers and prepared a sketch of the site showing the relative positions of the ballast, timbers and boulders. Measurements were also taken of selected hull timbers. During a follow-up dive on September 20 the gross dimensions of the ballast mound and exposed hull structure were recorded.
