# Experimental investigation of 50 MPa reinforced concrete slabs subjected to blast loading

Fausto Mendonça<sup>1</sup>, Girum Urgessa<sup>2</sup>, and José Rocco<sup>3</sup>

How to cite: Mendonça, F., Urgessa, G., & Rocco, J. (2018). Experimental Investigation of 50 MPa Reinforced Concrete Slabs Subjected to Blast Loading. *Ingeniería e Investigación*, 38(2), 27-33.  
DOI: [10.15446/ing.investig.v38n2.65305](http://dx.doi.org/10.15446/ing.investig.v38n2.65305)

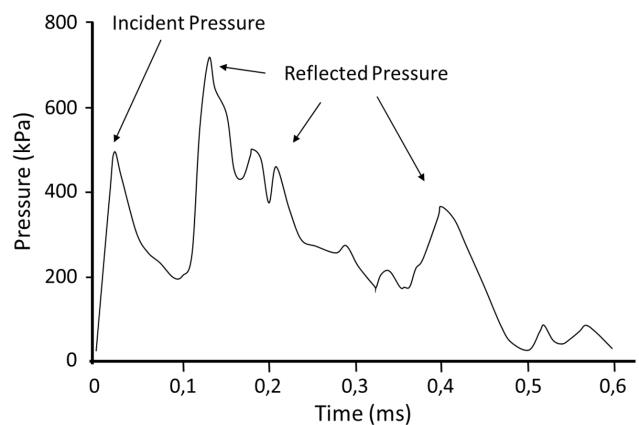
Figure 3. Time-history curve recorded for test of slab 1. Source: Authors

Explosions near structures, such as the case in the experimental test described in this paper, will experience multiple reflected pressure (PR) (Li *et al.* 2016; Maji *et al.* 2008). Figure 3 shows an example of time-history curve recorded by pressure sensors during the first slab test. It is worth to note that more than one peak of reflected pressure were recorded during the shock wave positive phase. It was due the short scaled distance.

Integration of the area under the curve of the positive phase of the blast wave results in the specific positive impulse acting on the target (Ngo *et al.*, 2007). Positive impulse is the main parameter that causes damage to structures in blast events (UNODA, 2011). The higher the reflected pressure, the higher the total impulse and it will cause more damage to the target. Multiple peaks of reflection increase the area under the curve and the total impulse as well.

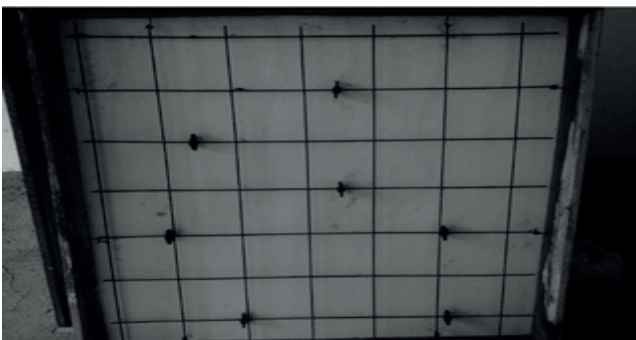
**Figure 5.** Reinforcement prepared inside the form before casting.

Both directions have 7 reinforcing steel with 5,0 mm in diameter, as shown in Figure 5. However, two more reinforcing steels of 10 mm were added along direction 1 to increase the reinforcement ratio in one direction of the slab, as shown in Figure 6. It was an option to verify the behavior of one more reinforcement ratio.

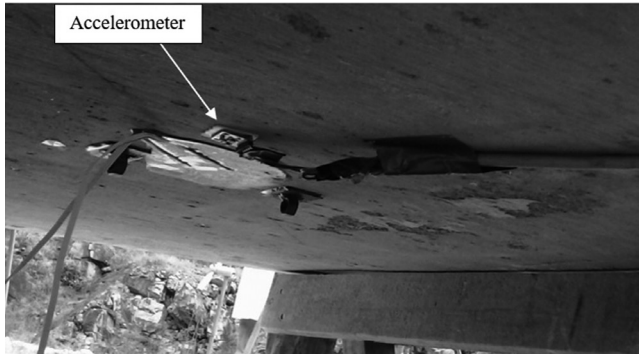
**Figure 8.** Accelerometer attached to the bottom of the slab before test.  
**Source:** Authors

consisting of a circuit with 9V DC battery supply, a memory card, and an acceleration sensor MPU 6050. The accelerometers were calibrated using a turntable calibrator to guarantee that their recording was correct. MPU 6050 was attached to the bottom of the slabs to measure the acceleration due the shock wave as shown in Figure 8. The main circuit was placed inside a heavy lead box surrounded internally by foam where it was sheltered from shock wave and debris.

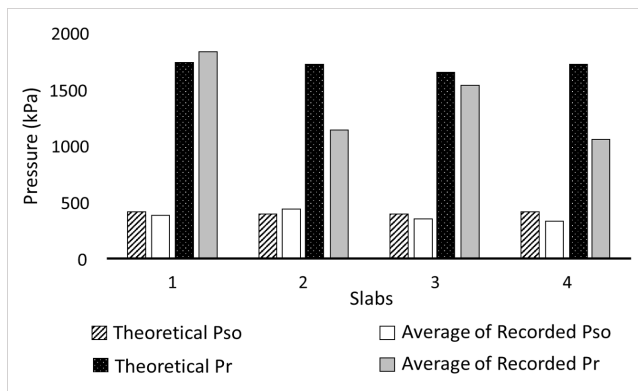
**Figure 16.** Comparison of theoretical and average of recorded incident and reflected pressures.  
**Source:** Authors

The piezoelectric pressure sensors recorded blast pressure-time history for all tests. Figure 16 shows the comparison of recorded to theoretical values of incident ( $P_{so}$ ) and reflected ( $P_r$ ) pressure given by the widely used Kingery and Bulmash curves (Kingery & Bulmash, 1984; Swisdak Jr, 1994). Recorded incident pressure was given by the results of sensors at the higher position. Sensors close to the slab gave reflected pressure. The difference between theoretical and recorded incident pressures was 7% for slabs 1 and 2, and 12 % for slabs 3 and 4.

Theoretical value of reflected pressure was given by Kingery and Bulmash curves (Kingery & Bulmash, 1984; Swisdak Jr, 1994) as well. Slabs 2 and 4 showed the highest difference from theoretical predicted values, having predicted values 35% and 38% higher than the recorded respectively. Slab 1 had recorded value 6% higher than predicted value and for slab 3 the predicted value was 7% higher than recorded. We attribute these differences because of uncertainties
