Solving color irregularities with a bioactive bulk-fill restorative system: Case report and 24-months follow up.

Grandon F, Muster M & Wendler M.
Solving color irregularities with a bioactive bulk-fill restorative system: Case report and 24-months follow up.
J Oral Res 2020; 9(5):430-436.
[Doi:10.17126/joralres.2020.086](https://doi.org/10.17126/joralres.2020.086)

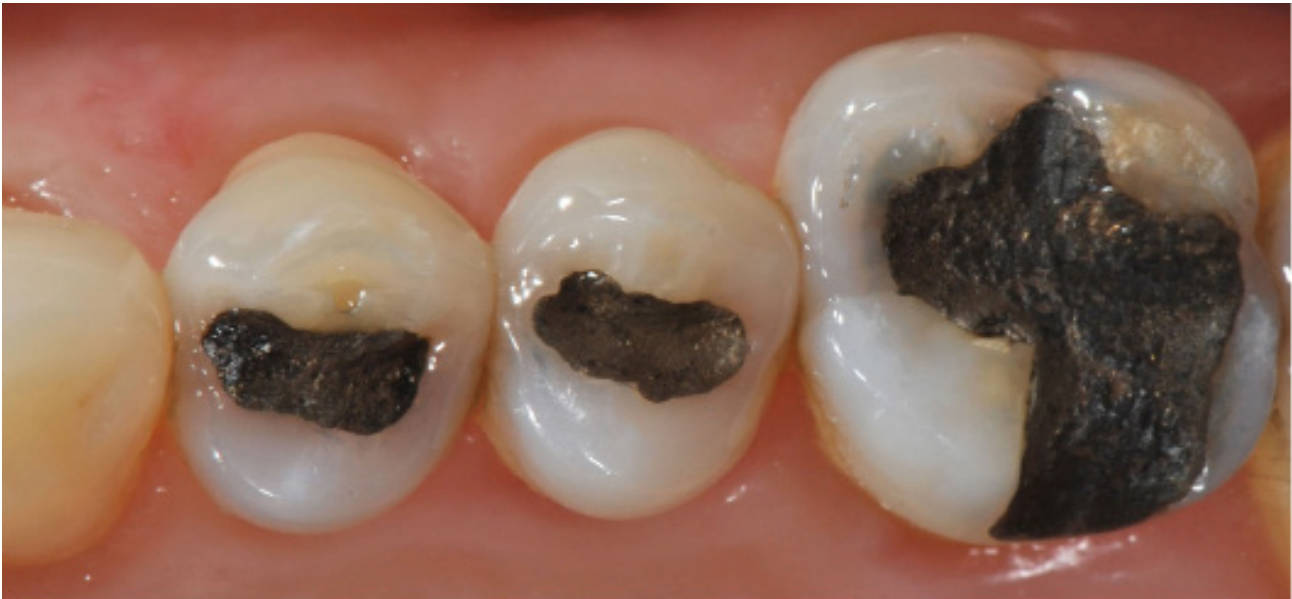
Figure 1. Initial situation. Amalgam restorations in teeth 2.4, 2.5 and 2.6 displayed an advanced stage of corrosion, with deficient occlusal anatomy, marginal deterioration and an important dark discoloration of the surrounding enamel and dentin substrates.

A healthy 36-year old female patient attended the private praxis of the authors for the replacement of three amalgam restorations in the maxillary left first and second premolars (teeth 2.4 and 2.5) and the maxillary left first molar (tooth 2.6), due to important material corrosion and deterioration (Figure 1).

After clinical examination, complemented with intraoral photographs and radiographs, all three teeth were found vital and displayed a slight rotation, with minor wear facets in the buccal cusps of 2.4 and 2.6. Amalgam restorations showed an advanced stage of corrosion, with deficient occlusal anatomy, marginal deterioration and important dark discoloration of the surrounding enamel and dentin substrates. Therefore, replacement of the three amalgams with direct resin composite was indicated. In the case of 2.6, where the old restoration covered a large portion of the occlusal table and the complete disto-palatal cusp, this conservative approach was preferred over an indirect technique, due to the favorable occlusal conditions and the integrity of both marginal ridges. In order to optimize the intervention, the restorations were planned under the bulk-fill concept, permitting their completion in only one clinical session.

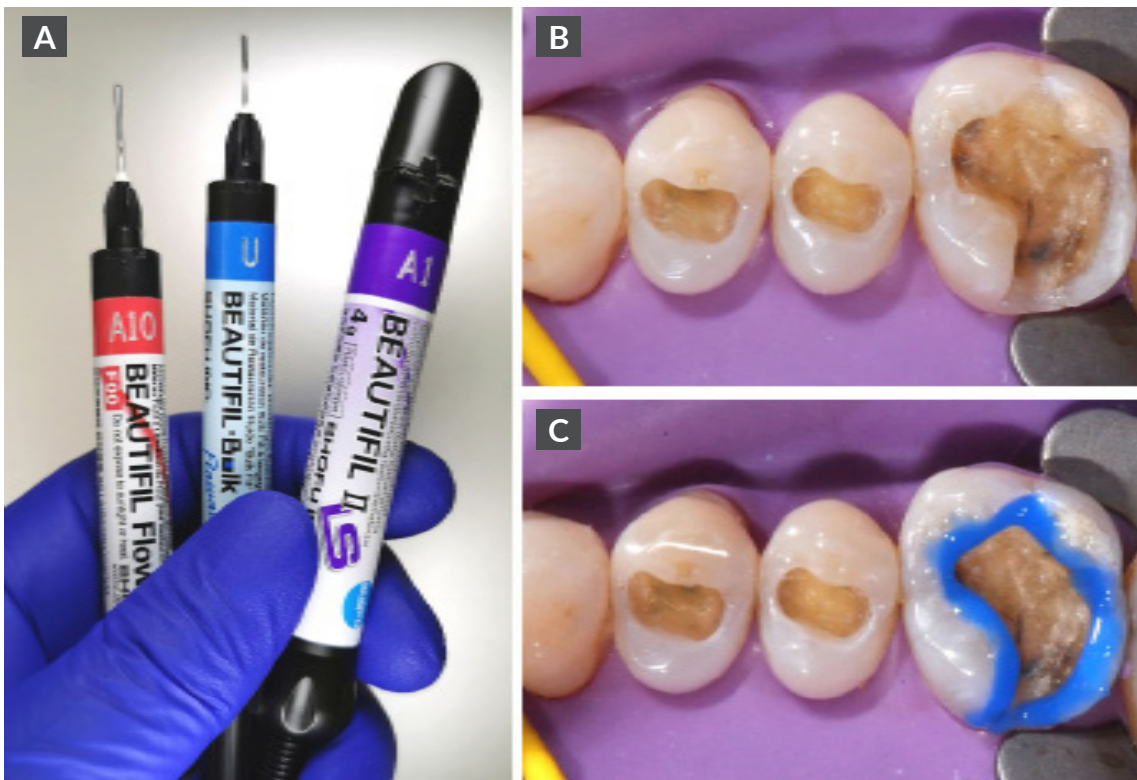
Figure 2. Giomer resin composites and tooth preparation.

A: From left to right; Beautifil Flow Plus F00 shade A10, Beautifil Bulk Flowable shade Universal and the low shrinkage Beautifil II LS shade A1. **B:** Tooth preparations after amalgam removal. Black stained areas were observable in the underlying dentin. **C:** Selective etching of the enamel margins with 35% orthophosphoric acid.

Amalgam removal was conducted under a non-latex rubber dam isolation by using transmetal burs (Talon, Tri-Hawk, Morrisburg, Ontario, Canada) and abundant water irrigation. Strong black stained areas were visible in the underlying dentin (Figure 2B), due to amalgam corrosion products,¹³ especially in the cavity floor of tooth 2.6. Masking over removal of this sound dentin was decided, following the minimal intervention philosophy. Selective etching with 35% phosphoric acid (Ultra-Etch,

Ultradent, South Jordan, UT, USA) was applied to the enamel for 15 s (Figure 2C) and then thoroughly washed with water-air spray for the same amount of time. After drying with absorbent paper points, the universal adhesive Beautibond (Shofu, Kyoto, Japan) was applied with a microbrush to the cavity walls and floor (Figure 3A and Figure 3B).

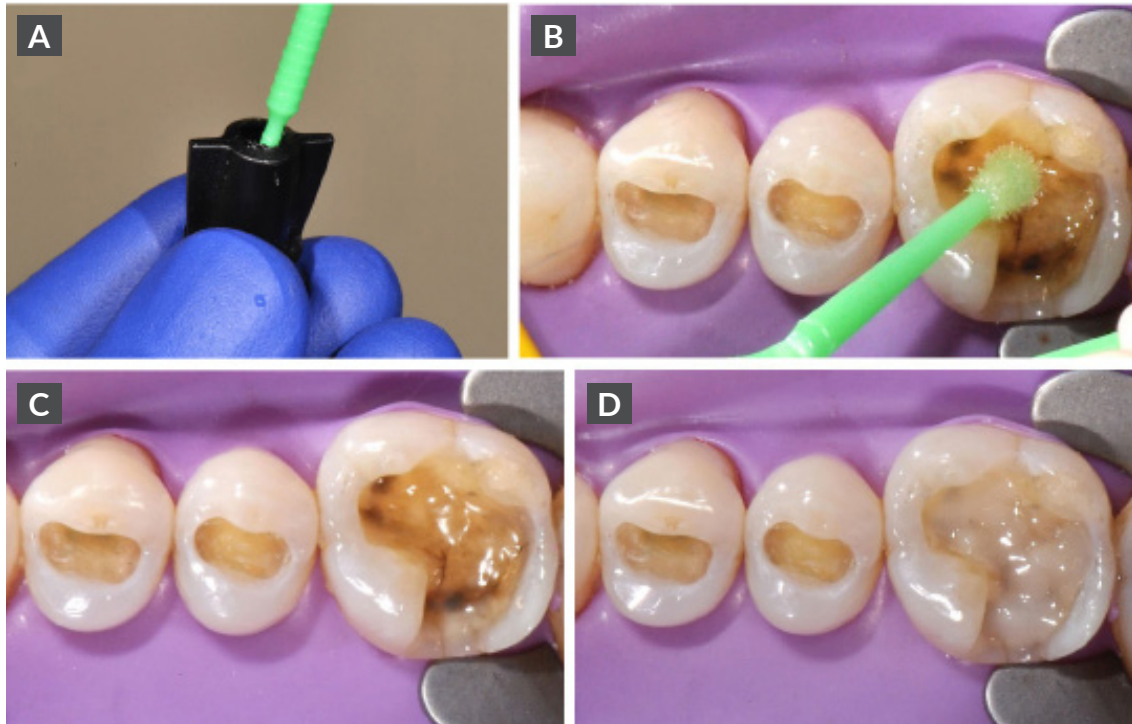
Figure 3. Bonding and substrate masking.

A: Beautibond Universal Adhesive, unit dose. **B:** Active application of the adhesive on the cavity floor and walls. **C:** Enamel and dentin appearance after the bonding technique in tooth 2.6. Black stained areas were still visible. **D:** After application of an opaque flowable resin composite, color irregularities were masked in tooth 2.6.

After a 30 s solvent evaporation time, excess adhesive was removed with a new microbrush and by gently air blowing. The adhesive was then light-cured with a LED lamp (Valo, Ultradent) for 20 s. Despite the glossy appearance of the floor cavity (Figure 3C), black stained areas were still visible, compromising the aesthetics of the future restoration. Therefore, a thin layer of opaque flowable resin composite (Beautiful Flow Plus F00, shade A1O, Shofu) was selectively applied to these areas, as depicted in Figure 3D.

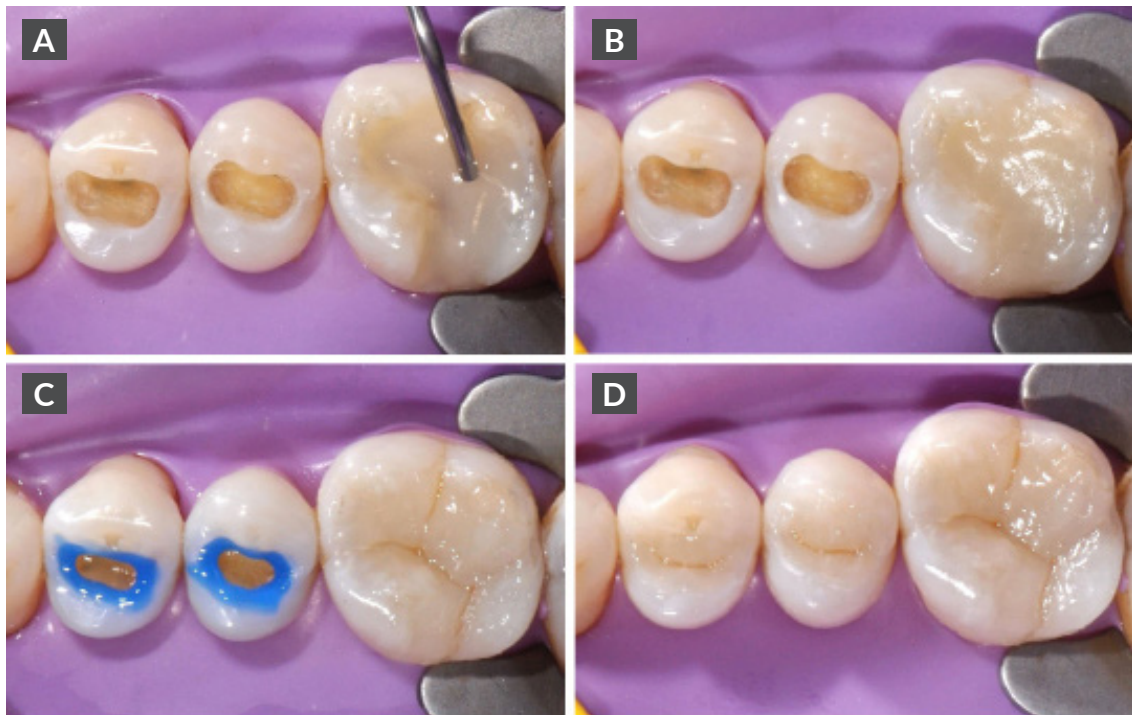
Figure 4. Restorative procedure.

A: Injection of a 3 mm thick layer of Beautifil Bulk Flowable resin composite, shade Universal. **B:** Insertion of a single increment (1.3 - 1.5 mm) of the low shrinkage resin composite Beautifil II LS, shade A1. **C:** Occlusal morphology and characterization of tooth 2.6 after light-curing. The same procedure was repeated step by step for teeth 2.4 and 2.5. **D:** Appearance of the restorations before polishing.

After light-curing, a 3 mm thick layer of the bulk-fill resin composite Beautiful Bulk Flowable (Shofu) was injected to the entire cavity, leaving 1.5 mm of space from the margin for the occlusal layer,¹⁴ as shown in Figure 4A. Polymerization of the bulk-fill material was conducted at 1000 mW/cm² for 20s. The occlusal morphology was sculpted using the low shrinkage Beautiful II LS (Shofu),

shade A1, by inserting a single increment with the composite 7 spatula (American Eagle, Missoula, USA) and ensuring good adaptation to the cavity margins (Figure 4B). Occlusal sulci and cusp ridges were modelled with the composite 1 instrument (American Eagle) and then light-cured for 20 s (Figure 4C).

Further characterization was achieved by applying a small amount of a light-brownish flowable resin (LiteArt, Shofu) inside the grooves, followed by 40 s light-curing. A glycerine gel (Liquid Strip, Ivoclar-Vivadent, Schaan, Liechtenstein) was used to prevent the oxygen-inhibition layer. The same procedure was repeated for the restorations of teeth 2.5 and 2.4. After rubber-dam removal, occlusion was adjusted using fine grain diamond burs, followed by aluminium oxide polishers (One Gloss, Shofu). Final gloss was obtained with diamond polishers (Diatech ShapeGuard, Coltene, Alstätten, Switzerland), at 8,000 RPM (Figure 4D).

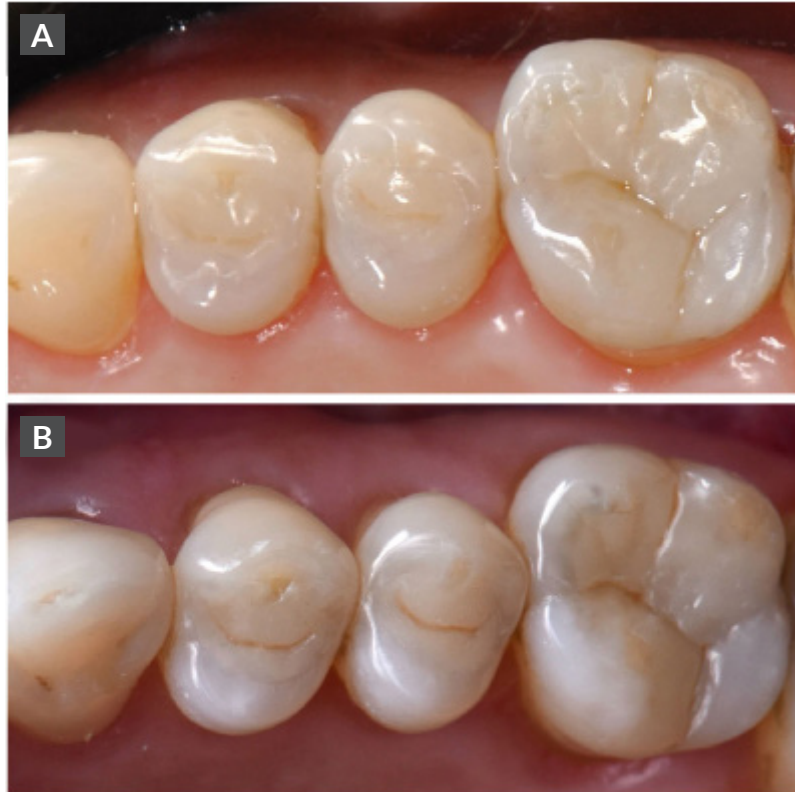
Figure 5. Recall.

A: 12-month. B: 24-month follow-up. Margins and surface gloss were well preserved. The restorations displayed good color stability.

Follow up controls were conducted at 12 and 24 months (Figure 5), including clinical and radiographic examination. Restorations were well preserved over the entire period, with no signs of marginal deterioration or secondary caries, and displaying glossy surfaces and good color stability.
